2016 High Crash Intersection Site Visits

Summary and Next Steps

February 2017

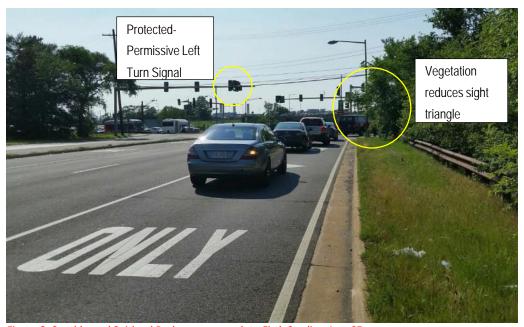
Figure 2. Southbound Suitland Parkway approach to Firth Sterling Ave. SE

As seen in Figure 2, the traffic signal arrays on Suitland Parkway provide protected/permissive left-turn phases. As part of the ongoing HSIP process, the feasibility of converting the left-turn signal displays to protected-only phasing will be evaluated. This could mitigate the left-turn angular collisions previously identified from the intersection crash history. During the PM peak-hour observations conducted on May 25, left-turn volumes and the storage capacity of the southbound left-turn bay appear to support the provision of protected-only phasing.

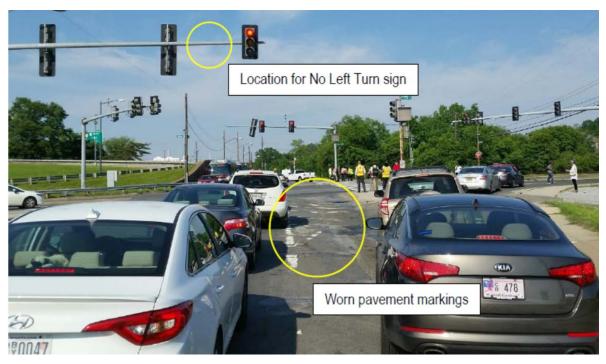
Figure 5. Eastbound Firth Sterling Ave approach to Suitland Parkway SE

The right lane on eastbound Firth Sterling Avenue ends at Suitland Parkway, with only one lane carried across the intersection (except for buses, which are allowed to cross the intersection in the right lane). The pavement markings, however, are worn, which might reflect (and also contribute to) the relatively large number of vehicles that maintain a second through lane across the intersection by driving over the pavement markings. A review of the current configuration should be undertaken to determine the Spring 2016 High Crash Intersection Site Visits

feasibility of restoring the second travel lane across the intersection. In addition, although left turns are apparently prohibited for traffic on eastbound Firth Sterling Avenue onto northbound Suitland Parkway/South Capitol Street, there are no signs mounted on the mast arm to indicate No Left Turns.

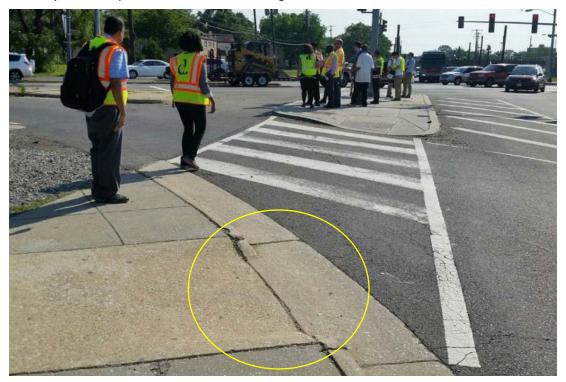
Figure 6. Southeast corner of Suitland Parkway at Firth Sterling Ave SE

The curve radius for traffic on eastbound Firth Sterling Avenue turning right onto southbound Suitland Parkway allows for relatively high travel speeds and likely contributed to one of the two pedestrian crashes, which occurred in this location. Consideration should be given to reducing the turn radius as a pedestrian safety measure. One site visit attendee questioned the need for a slip lane at all. This would dramatically slow turning vehicles, but may not be feasible without major changes because of the amount of truck traffic using this intersection.

P3. Slip lane from northbound Firth Sterling to eastbound Suitland Parkway encourages fast turns and creates pedestrian hazards.	Reconfigure intersection geometry to tighten the slip lane radius (exiting is a 189' radius) of slip lane or remove slip lane.	Evaluation: Winter 2017 Implementation: Long-term, part of South Capitol Street Phase 1 project.
P4. Some curb ramps do not meet current ADA requirements.	Assess all ramps for ADA compliance.	Evaluation: July 2016 Implementation: Long-term, part of South Capitol Street Phase 1 project.
P5. Pedestrian connection to Barry Farm community is lacking.	Component of Barry Farm redevelopment and South Capitol Street Corridor project.	Evaluation: Fall 2016 Implementation: Further study necessary to identify optimal connection solution. To be identified and implemented as part of South Capitol Street Corridor Project, Segment 3.

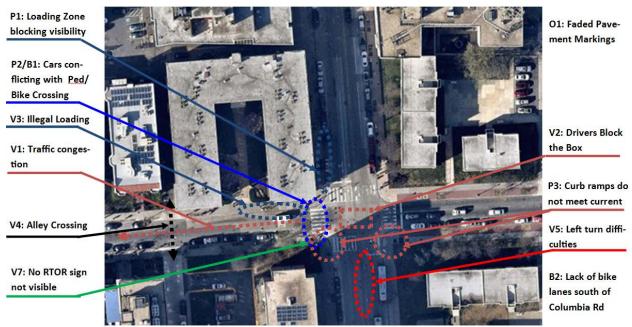
Figure 11. 14th Street and Columbia Road NW Site Visit Observations

- B1. 14th Street southbound cars turning right onto Columbia Road are conflicting with through bicyclists.
- B2.Participants noted the high volume of cyclists on 14th Street and the lack of bike lanes south of Columbia Road. This observation is confirmed by a May 2013 traffic volume count at 14th Street and Columbia Road of 171 southbound bicyclists in the AM peak period, representing over 25 percent of the southbound vehicular traffic at this intersection.

- V2. Participants observed that drivers frequently "block the box." Cars stop in the intersection after the light turns red, thereby obstructing the passage of vehicles from the cross street.

V3. Illegal loading in Columbia Rd bus zone west of 14 th St and double-parking/loading in 14 th St SB travel lane	Investigate if current loading zones are adequate; enforcement	Evaluation: Winter 2017 Implementation: Loading zones to be resized/repositioned in March 2017.
V4. Cars observed "shooting" across Columbia Rd west of 14 th from the alleys	Explore traffic calming strategies	Evaluation: Winter 2017 Implementation: Mitigation not currently possible. DDOT practice is to not implement traffic calming in alleys due to drainage and other safety concerns.
V5. Some cars in NB left turn lane at Columbia not turning left, going straight through intersection, merging into one travel lane	Refresh faded left-turn markings; identify traffic signal changes to ease left turns; consider advance signs for left turn lane	Evaluation: Fall 2016 Implementation: Markings to be refreshed in Spring; does not meet warrant for a protected left turn signal.

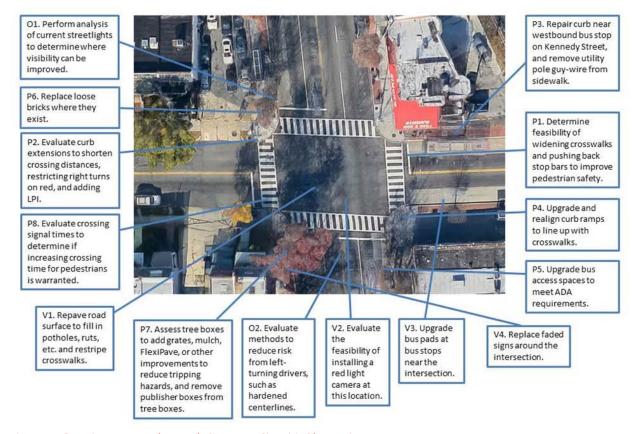
Figure 15. Georgia Avenue and Kennedy Street NW Site Visit Observations

Issue	Action	Timeframe			
P2. Three pedestrian collisions	Evaluate curb extensions to	Evaluation: Winter 2017			
occurred in the crosswalks.	shorten crossing distances,	Implementation: Curb			
	restricting right turns on red,	extensions under analysis.			
	and adding LPI.	Restricting right turns on red			
		and adding LPI are not feasible,			
		due to no exclusive turn lanes at			
		intersection and the turning			
		volume is not high enough.			
P3. Westbound bus stop on	Repair curb near westbound bus	Evaluation: Spring 2017			
Kennedy Street has a chunk	stop on Kennedy Street, and	Implementation: Repairing curb			
missing from the curb, and has a	remove utility pole guy-wire	will be addressed through			
utility pole guy-wire grounded	from sidewalk.	Kennedy Street reconstruction,			
within it.		complete by Fall 2017.Guy-wire			
		placement and bus stop location			
		will be evaluated through			
		Kennedy Street Phase 1

Issue	Action	Timeframe						
Vehicular Issues								
V1. Asphalt roadway surface on	Repave road surface to fill in	Evaluation: Winter 2017						
all approaches and within the	potholes, ruts, and other issues,	Implementation: East side of						
crosswalks are in poor condition.	and restripe crosswalks.	Kennedy St will be resurfaced in						
		Phase 1 of the reconstruction						
		project, with the west side						
		following in Phase 2.						
V2. Red light running and	Evaluate the feasibility of	Evaluation: Winter 2017						
speeding was observed.	installing a red light camera at	Implementation: Crash history						
	this location.	profile does not suggest that						
		intersection would benefit from						
		correction from a ride light						
		camera.						
V3. On street bus pads are in	Upgrade bus pads at bus stops	Evaluation: Winter 2017						
poor condition.	near the intersection.	Implementation: DDOT is

- P1. Determine feasibility of widening crosswalks and pushing back stop bars to improve pedestrian safety.
- P2. Evaluate curb extensions to shorten crossing distances, restricting right turns on red, and adding
- P3. Repair curb near westbound bus stop on Kennedy Street, and remove utility pole guy-wire from sidewalk.
- P4. Upgrade and realign curb ramps to line up with crosswalks.
- P5. Upgrade bus access spaces to meet ADA requirements.
- P6. Replace loose bricks where they exist.

- P7. Assess tree boxes to add grates, mulch, FlexiPave, or other improvements to reduce tripping hazards, and remove publisher boxes from tree boxes.
- P8. Evaluate crossing signal times to determine if increasing crossing time for pedestrians is warranted.

- V1. Repave road surface to fill in potholes, ruts, etc. and restripe crosswalks.
- V2. Evaluate the feasibility of installing a red light camera at this location.
- V3. Upgrade bus pads at bus stops near the intersection.
- V4. Replace faded signs around the intersection.

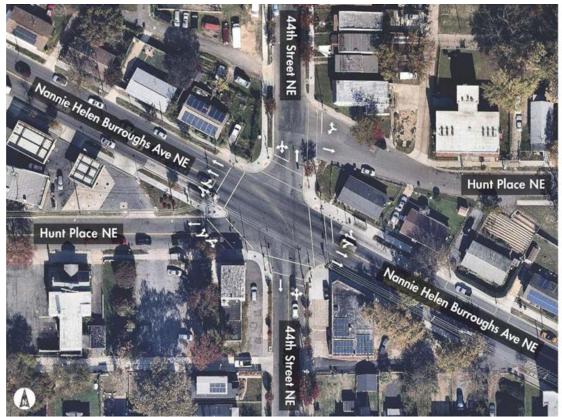
Figure 19. 44th Street and Nannie Helen Burroughs Avenue NE Intersection Diagram

In 2012, DDOT completed a reconstruction of 44th Street, Nannie Helen Burroughs, and Hunt Place. The project improved roadway markings, signage, and traffic signal infrastructure. Other recent changes include installation of new traffic signal hardware, new street light fixtures, and new bus shelters. Nearside bus stops were installed, which appear to cause congestion when buses are stopped, most notably in the WB direction.

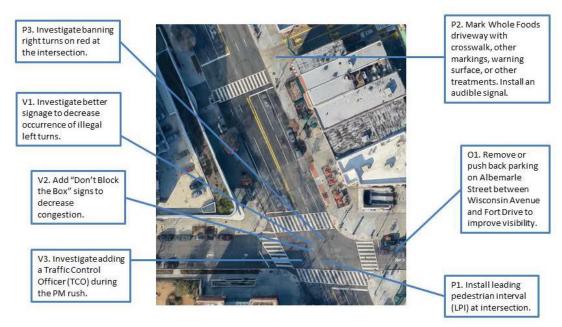
Figure 25. Wisconsin Avenue and Albemarle Street NW Site Visit Observations

Issue	Next Step	Timeframe
P3. Drivers making right turns on	Investigate banning right turns	Evaluation: Winter 2017
red present challenges for pe-	on red at the intersection.	Implementation: Line of sight
destrians.		analysis to be performed within
		120 days.
Vehicular Issues		
V1. Left turns from SB Wisconsin	Investigate better signage to de-	Evaluation: Winter 2017
to Albemarle are banned during	crease occurrence of illegal left	Implementation: Shop order
rush hour but drivers still make	turns.	submitted February 2017 for
illegal turns.		replacement "No left turn" signs.
V2. Drivers blocking the box.	Add "Don't Block the Box" signs	Evaluation: Winter 2017
	to decrease congestion.	Implementation: Shop orders
		submitted February 2017 for
		signs at Wisconsin Ave north-
		bound and southbound ap-
		proaches.
V3. Need TCO during PM rush.	Investigate stationing a TCO dur-	Evaluation: Winter 2017
	ing PM rush.	Implementation: Analysis un-

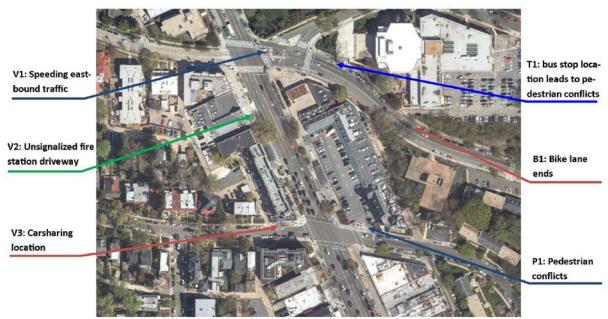
Figure 28. Connecticut Avenue and Porter Street NW Site Visit Observations

Issue	Next Step	Timeframe
Vehicular Issues		
V1. Eastbound traffic from Porter Street speeds through 30th Street and adjacent alleys due to queuing on approach to intersection with Connecticut Avenue.	Recommended installation of new off-set double yellow centerline and whiteline to create a left turn lane for northbound traffic from Porter. Crosswalk and stopbar pavement markings to be refurbished, as well as new sign installation.	Evaluation: November 2016 Implementation: Markings and sign installation completed November 2016.
V2. Fire station driveway on Connecticut Avenue is unsignalized.	Conduct signal warrant analysis for fire station driveway.	Evaluation: Winter 2017 Implementation: To be included in Cleveland Park Streetscape and Drainage Improvement Project, with completion by end of 2018.
V3. Carsharing location on the west side of Connecticut Avenue and Ordway Street conflicts with southbound vehicles turning right from Connecticut onto Ordway Street.	Eliminate one Enterprise parking location, and relocate the other to the east side of Connecticut Avenue and Ordway Street.	Evaluation: Complete Implementation: February 15, 2017
