Subject Foundry Branch Trestle Feasibility Study

Project Name Palisades Trail Feasibility Study

Date December 2019

Attachment A - Foundry Branch Trestle Inspection Report

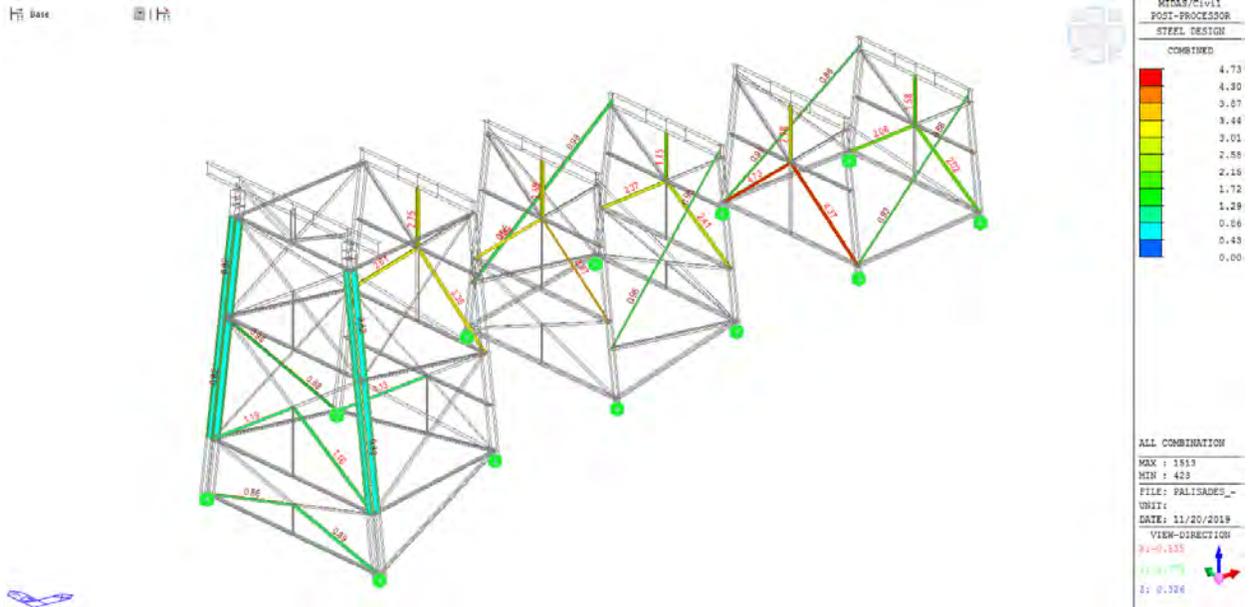
Figure 7: East Approach Results (Utilizations > 0.8 Shown)

- Figure 7 – Bracing members in the plane of the supporting columns at Gridlines 13 to 17 have utilizations greater than 1.0. The maximum utilization is 4.37.
- Figure 8 – The maximum member utilization in the truss is 0.68 in its top chord.
- Figure 9 - The maximum member utilization in the deck is 0.99 at a diagonal bracing member. The 10-inch deep longitudinal deck members typically have utilizations less than 0.7.

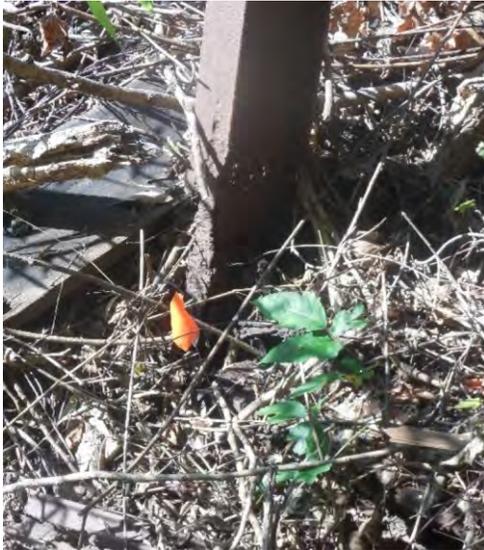
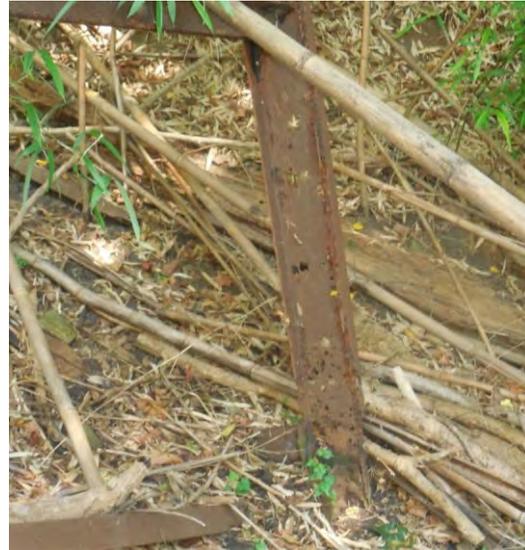
Figure 10: Column Base Gridline 3 North and South

The existing structure is in poor condition. Of most concern is the base of Gridline 3 north and south (Figure 10) and Gridline 5 north and south (Figure 11). Gridline 5 provides the primary load path for support of the main truss span.

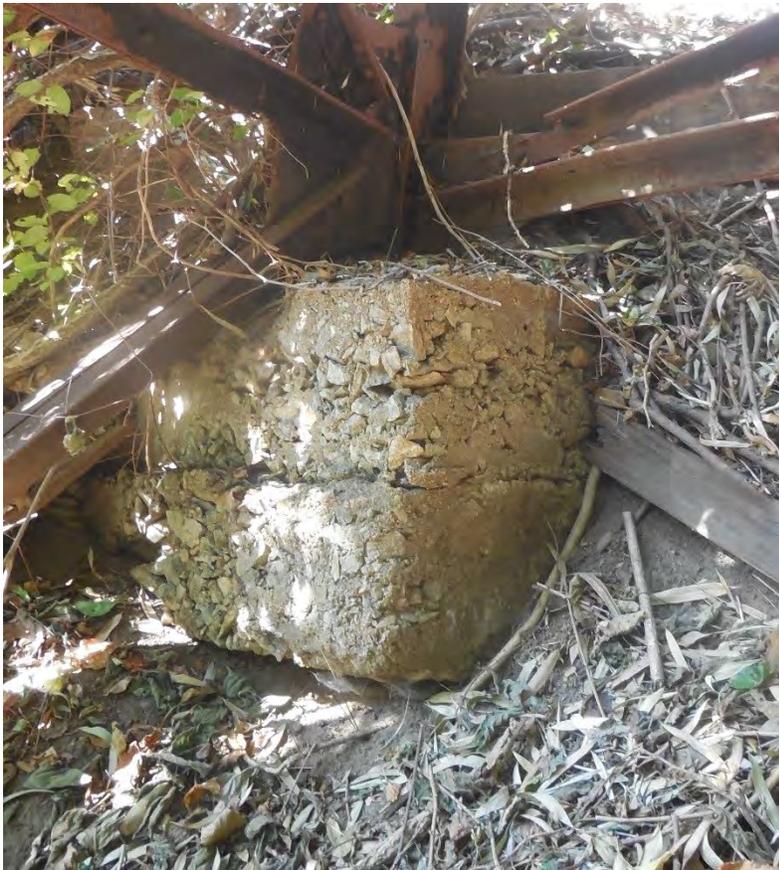
Figure 14: Undercut Footing

The approach trestles are supported on rectangular concrete footings located on the slopes in front of the abutments. All observed footings are experiencing deterioration in the form of concrete spalls and many have full width horizontal cracks. Many footings on the west side are completely buried and not visible. Concrete cores taken at Gridline 13 for the 2014 Washington Metropolitan Area Transit Authority (WMATA) inspection were not able to be tested due to being too fractured. The south trestle on Gridline 15 has a full width - 2 feet high spall that exposes inside concrete with no sign of reinforcement rebars. Also, inspection of the cores taken as part of the previous WMATA study show no signs of reinforcement. It is possible that the footings are unreinforced.

Due to the lack of regular maintenance, there is significant erosion of the slopes at either side of the bridge which has led to the undercutting of some of the footings (Figure 14). On the west side, the footings at the bottom of the slope are entirely buried with debris and not visible. The slopes will need to be reestablished during re-construction to ensure their stability.

It is recommended that the existing trestle footings are removed and replaced with new footings constructed within properly stabilized slopes with the top of the footing extending at least 2-ft above ground so that they do not become buried.

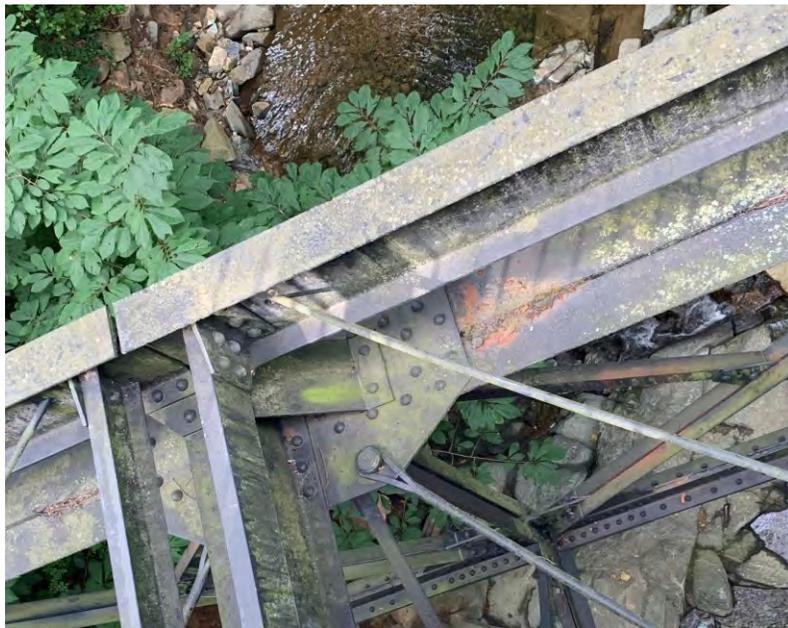
- Steel bridges are typically re-painted every 20 to 25 years. The rehabilitated steelwork will require more maintenance during its life time if it is to meet the AASHTO LRFD 75-year design life with more frequent repairs and repainting being necessary compared with a properly detailed new structure. Figure 16 shows the Glen Echo Trolley Bridge over Minnehaha Creek that was rehabilitated in 2014 where areas of the paint system have already begun to fail.

Figure 16: New Corrosion at the Rehabilitated Glen Echo Trolley Bridge (August 2019)

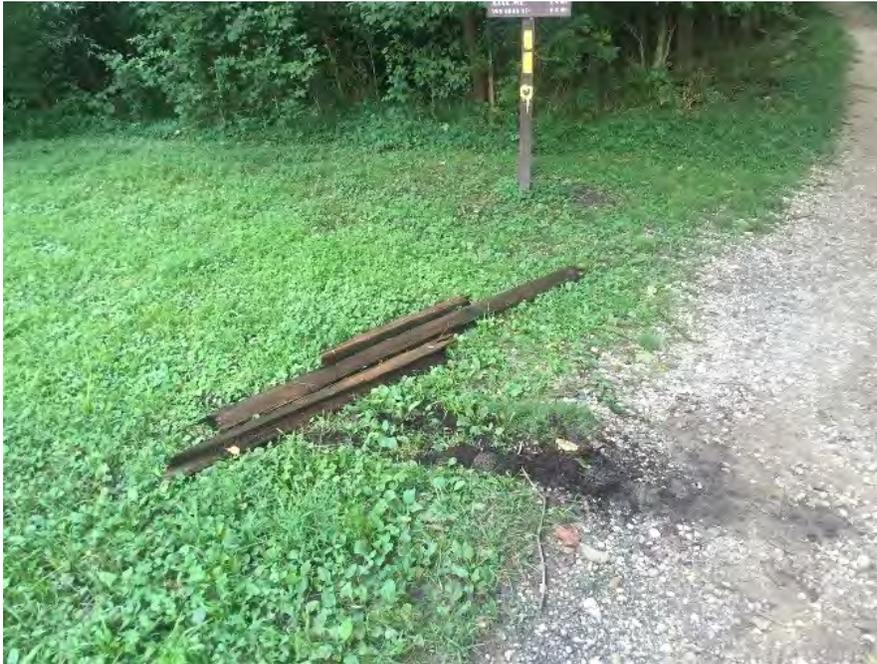
A pedestrian path was located under the steel truss span until the entire structure was fenced off in 2016 when deemed hazardous because of potential falling bridge elements (Figure 1.7).

Figure 1.7: Fallen rail tie beneath the bridge (August 2, 2016)

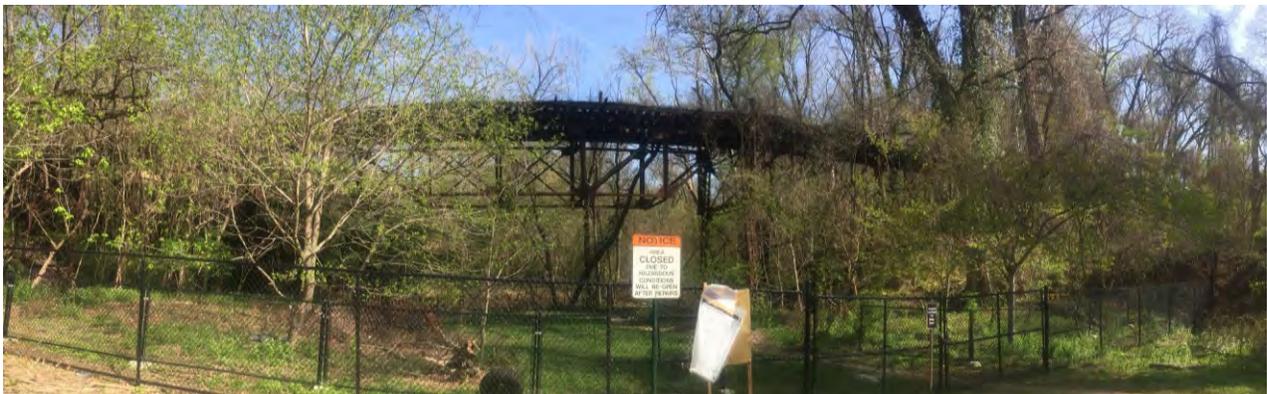
- The timber rail ties on the top of the bridge are loose and have begun to fall from the bridge.
- Vegetation, including bamboo, ivy and some large trees has grown up close to each side of the bridge making physical access impossible. One tree has fallen and is leaning on the suspended truss.
- There is a large depression in the ground to the north west of the bridge that would make siting access equipment difficult, even if the bamboo were cleared.

Figure 3.2: Bridge Overgrowth

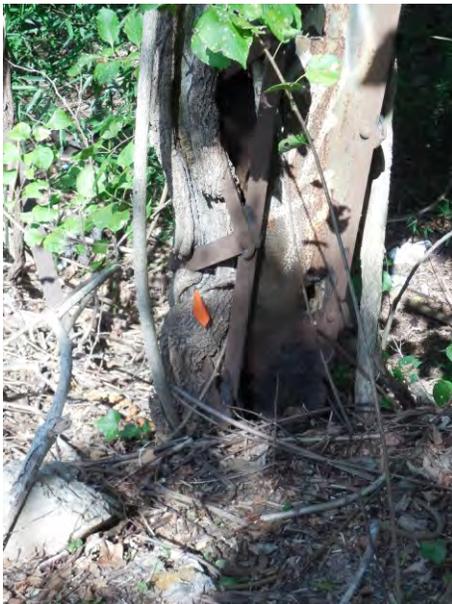
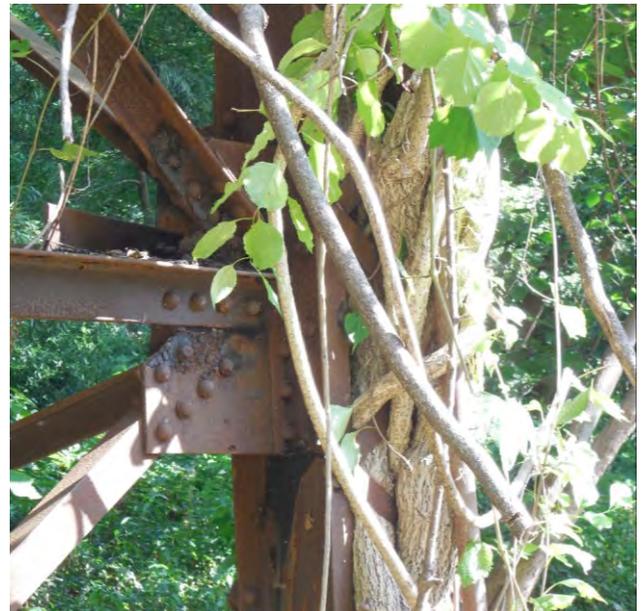
The lack of regular maintenance of the trestle has allowed significant vegetation growth in and around the structure. Vegetation is intertwined with structural components, especially on the west section of the bridge structure (Figure 5.1).

Figure 5.1: Vegetation Growth Gridline 5 – South

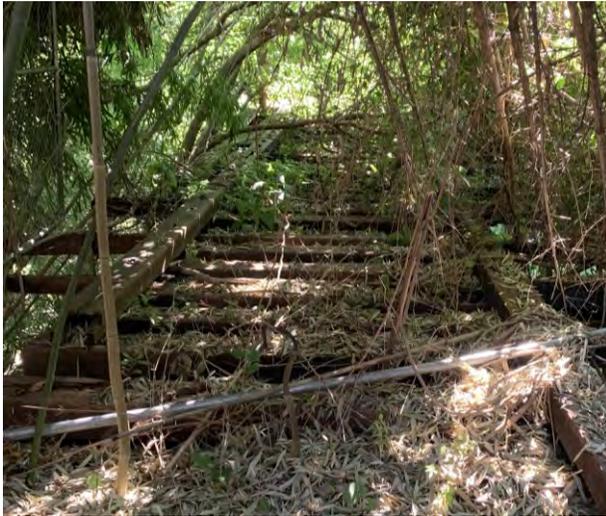
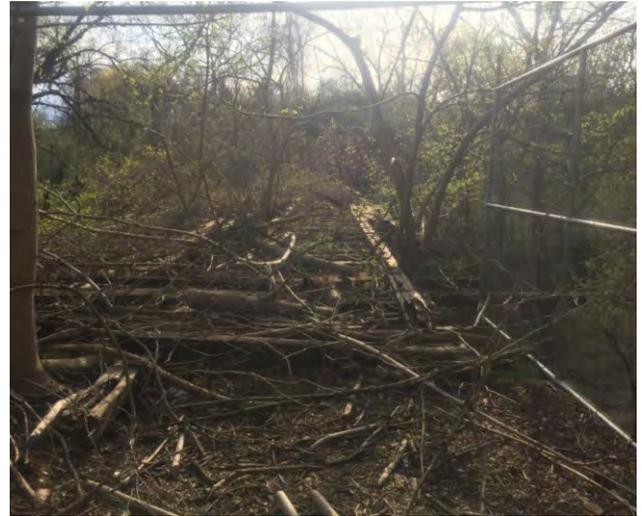
The original heavy timber rail ties (measured on site as 9 inch wide by 7 inch deep) are significantly deteriorated and are not salvageable in their present state. Several wooden members were observed at the base of the structure, having fallen from the top of the bridge. A timber walkway was also originally present on each side of the tracks which is now in partial state of collapse. The steel tracks that the ties would have originally supported have been removed from the bridge. The railings along each edge of the bridge, visible in Figure 1.2, have been removed at some time in the past.

Figure 5.2: Timber Rail Ties (From West Abutment and East Abutment)

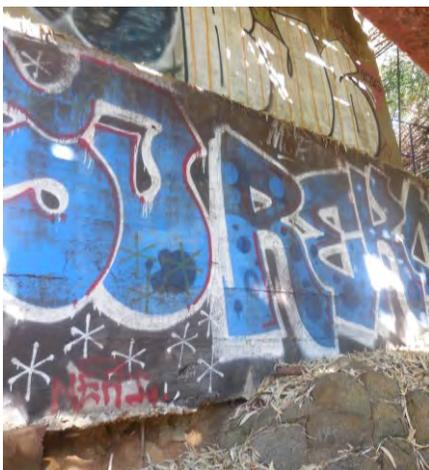
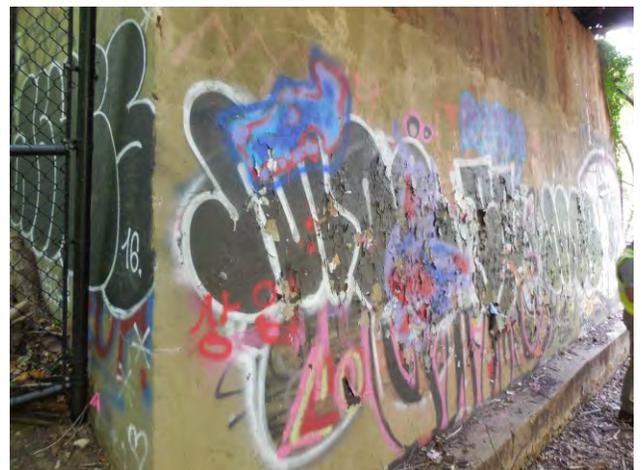
The far east and west sides of the structure are supported by concrete abutments. These structures serve as both retaining walls and gravity support of steel beams along the top of the trestle. Abutments are in overall satisfactory condition. Several cracks and small concrete spalls are present throughout. Cracks start at top of the abutment under steel beams and extends vertically up to full height with other cracks extending horizontally. Cracks are up to 1/16" wide with minor moisture stain and efflorescence. East abutment has exposed footing for 90% of length with minor spalls and honeycombing. West abutment has the footing exposed and is undermined for approximately 8 ft long (Figure 5.3).

Figure 5.3: West Abutment (Left) and East Abutment (Right)

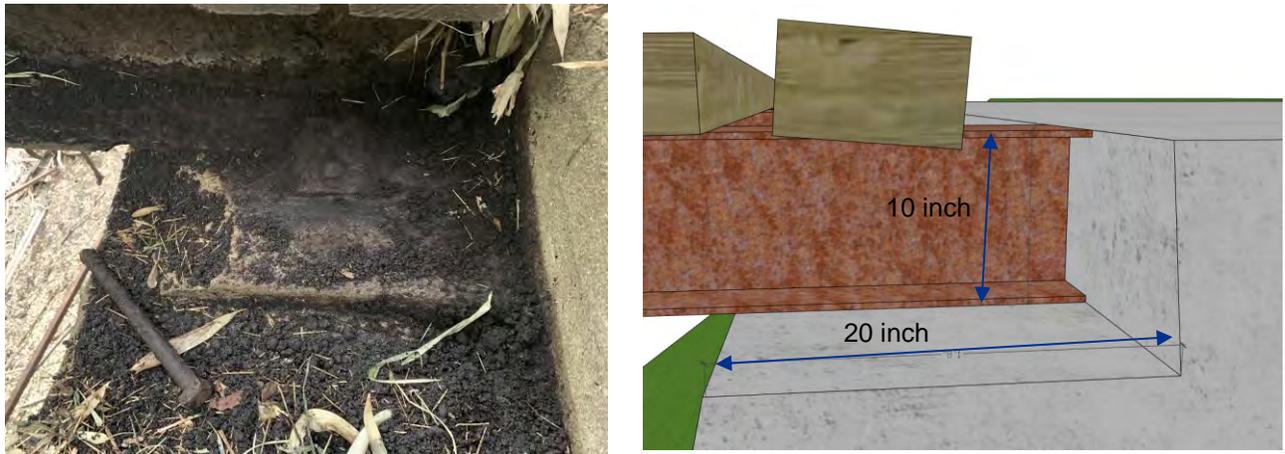
Figure 5.4: Abutment Bearing Shelf

edges which is intended to allow it to slide freely in the longitudinal. It is no longer able to slide since the stringer is up tight against the back of the abutment.

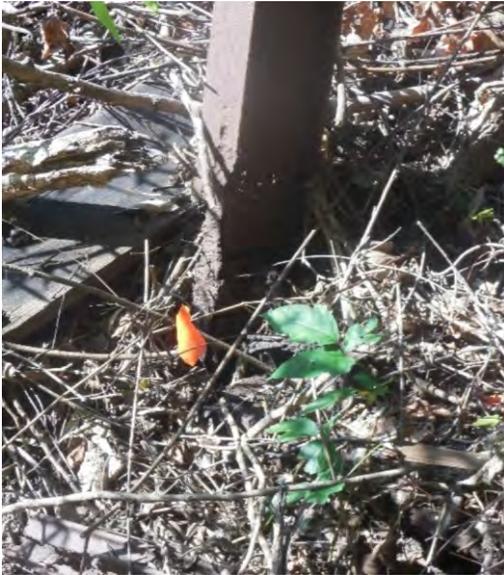
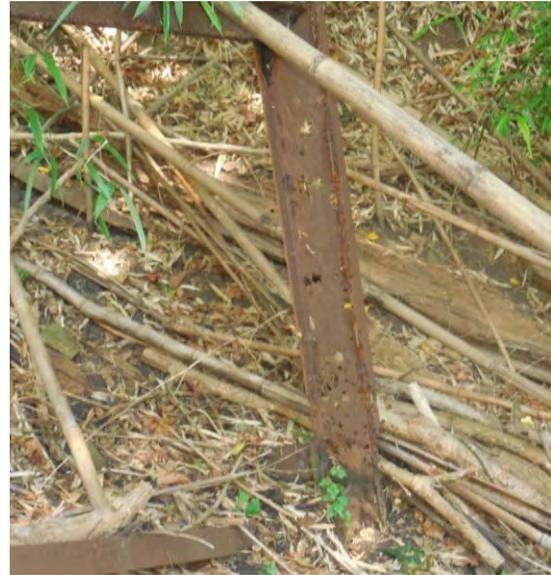
Figure 5.5: Column Base Gridline 3 North and South

Of most concern is the base of Gridline 3 north and south (Figure 5.5) and Gridline 5 north and south (Figure 5.6). At each of these locations there is very little steel section remaining. The load these members should be carrying is assumed to be re-distributed through bracing (which, as discussed below, is also in poor condition) to other members, and by built up vegetation. It is likely that the members which are buried, and not visible, have similar levels of deterioration.

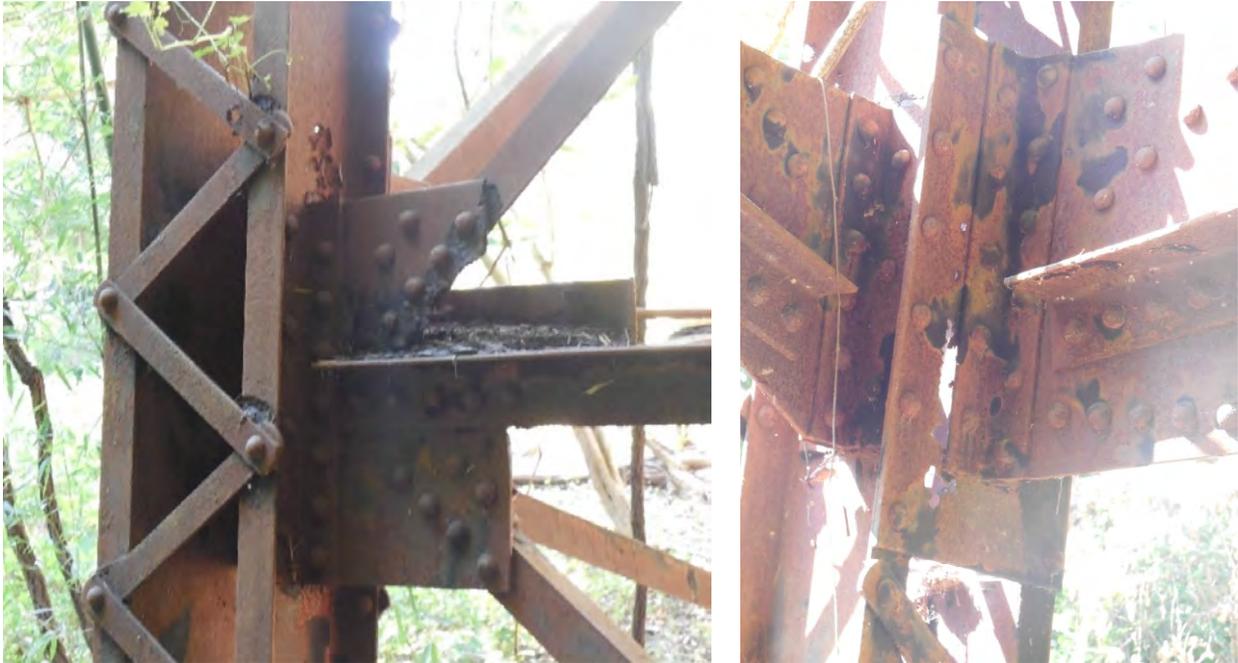
Figure 5.7: Column Connection to Bracing Members

Many of the column connections to bracing members are no longer effective (Figure 5.7).

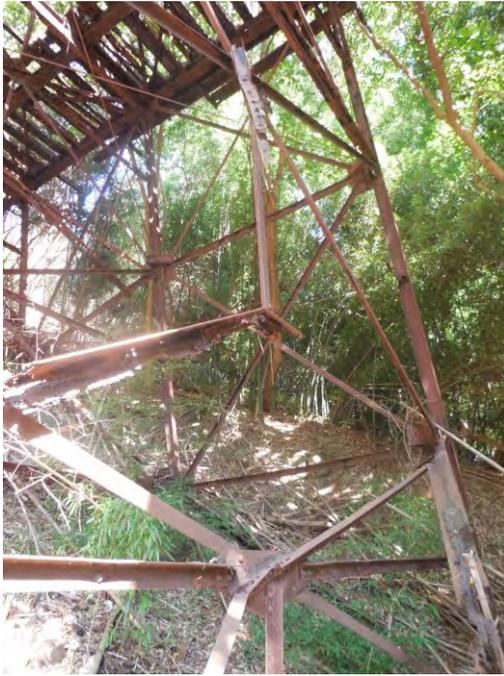
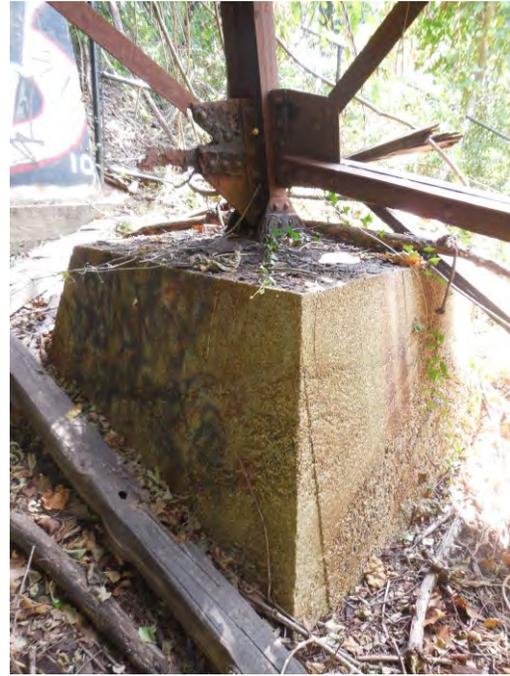
Figure 5.8: Trestle Bracing Members

There is also some 0.7 inch diameter steel rods that provide in-plan bracing at the tops of the trestles (level 0), and first level down (level -2). Although the rods are typically in good condition, many of the gusset connections to the trestle vertical legs has corroded through allowing the rods to hang free.

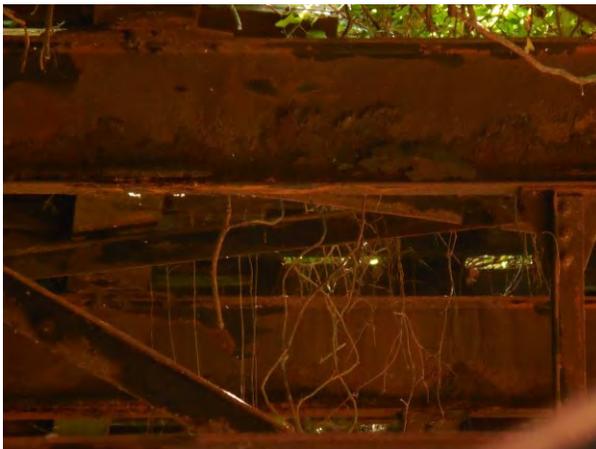
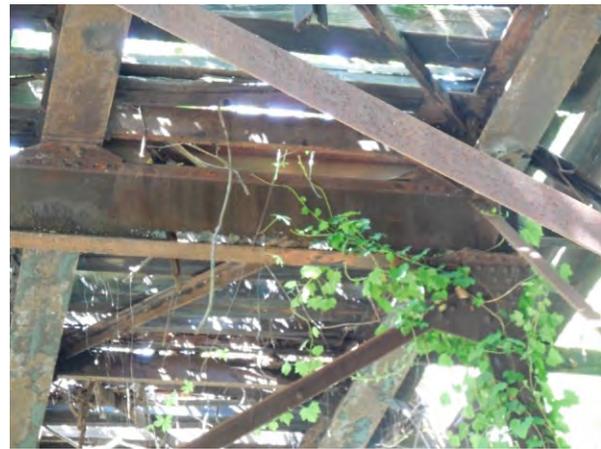
A steel grillage that directly supports the timber rail ties sits on top of 15 inch deep I-Section girders that span transversely between the tops of the trestle legs. The parts of the 15 inch deep girders that are visible show significant deterioration to the webs and at some locations the webs are completely corroded through. Some top flanges also show significant corrosion.

Figure 5.9: Corrosion to 15-inch Deep Cross Girder

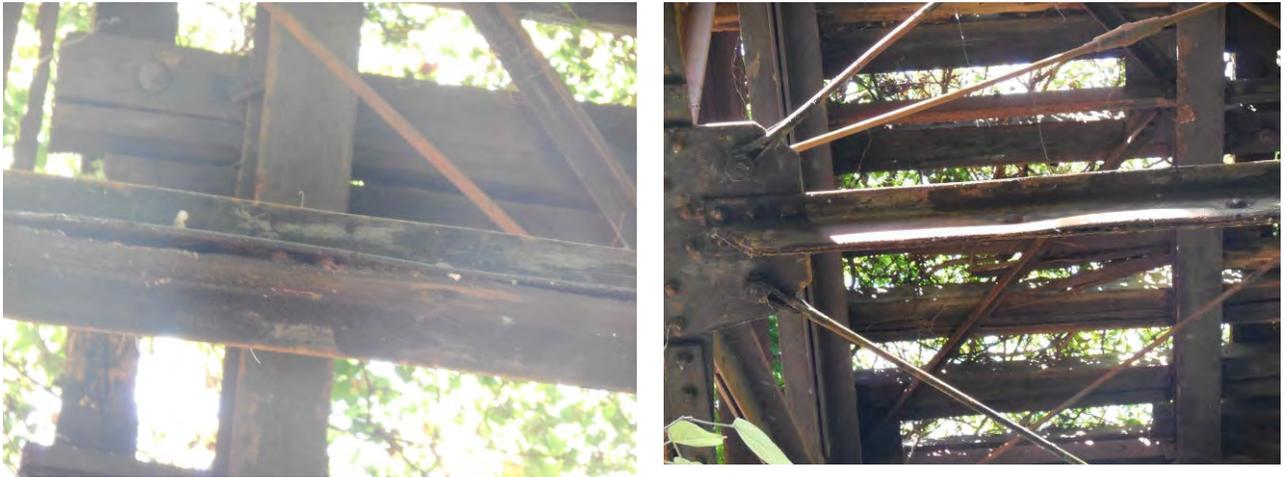
The double angles that connect the lower chords of the north and south trusses show signs of corrosion between the webs of the connected angles where expansion has pushed the steel apart between riveted connections (Figure 5.11). This is where moisture has been trapped in the space between the angles.

Figure 5.11: Rusting between Double Angles
