## Memorandum

Project #: 38559.01

Re: 2017 High Crash Intersections MLK Jr. Avenue and Good Hope  
Road Summary and Next Steps

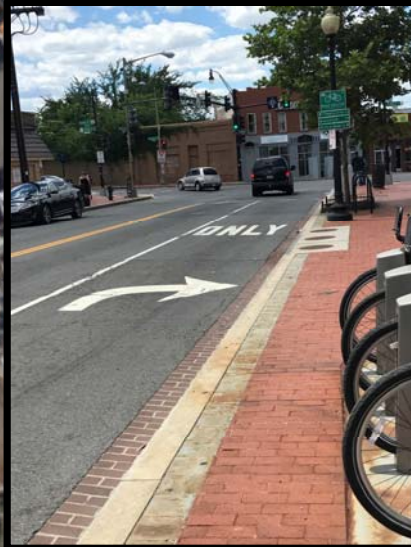
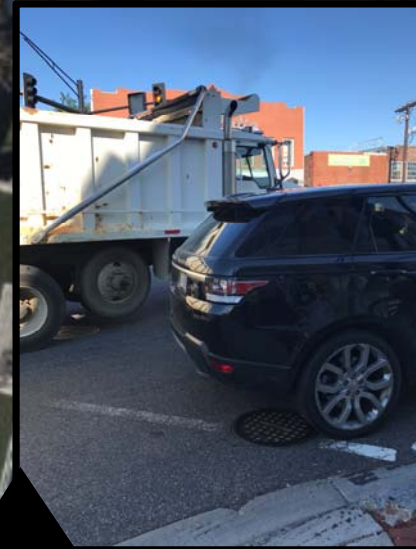
Figure 2. Good Hope Road Observations

**O1.** Difficult to see far-right signal head on westbound Good Hope Road approach. No Turn on Red sign on mast arm is also not visible.  
**O2.** Roadway markings are missing from left lane of the westbound Good Hope Road approach.

**O3.** Tight turning radii is difficult for heavy vehicles and buses to maneuver and turn simultaneously.  
**P3.** Double right turn from westbound Good Hope Road runs with pedestrian signal.

Difficult to see far-right signal head on westbound Good Hope Road approach. No Right Turn on Red sign on mast arm is also not visible from the approach.	Install "No Turn on Red Except From Right Lane" sign on lampposts upstream of the westbound Good Hope Road approach.

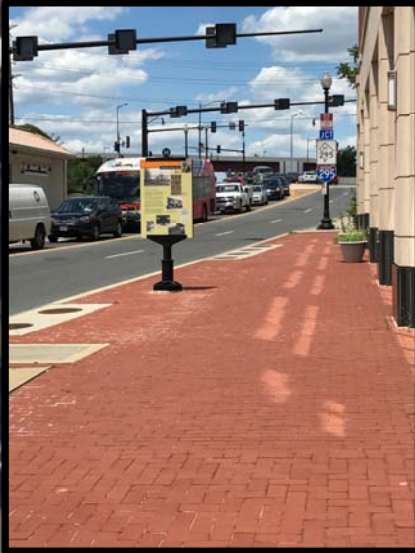
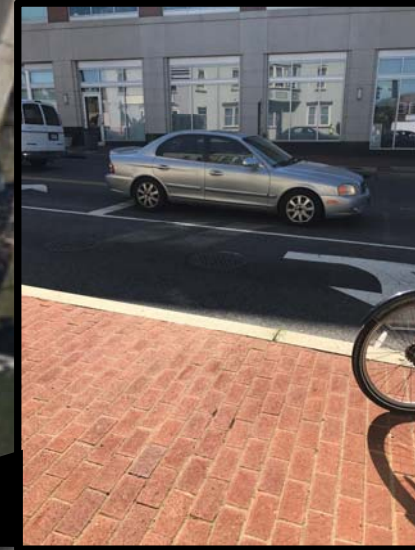
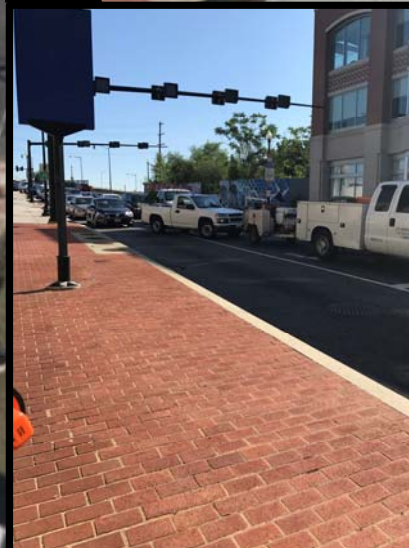
Figure 3. MLK Jr. Avenue Observations

**V1. Vehicles tend to stop past the stop bars on all approaches.**

**V4. Heavy left-turn turning traffic from the southbound MLK Jr. Avenue approach. Vehicles were observed to be frequently speeding while turning from intersection.**

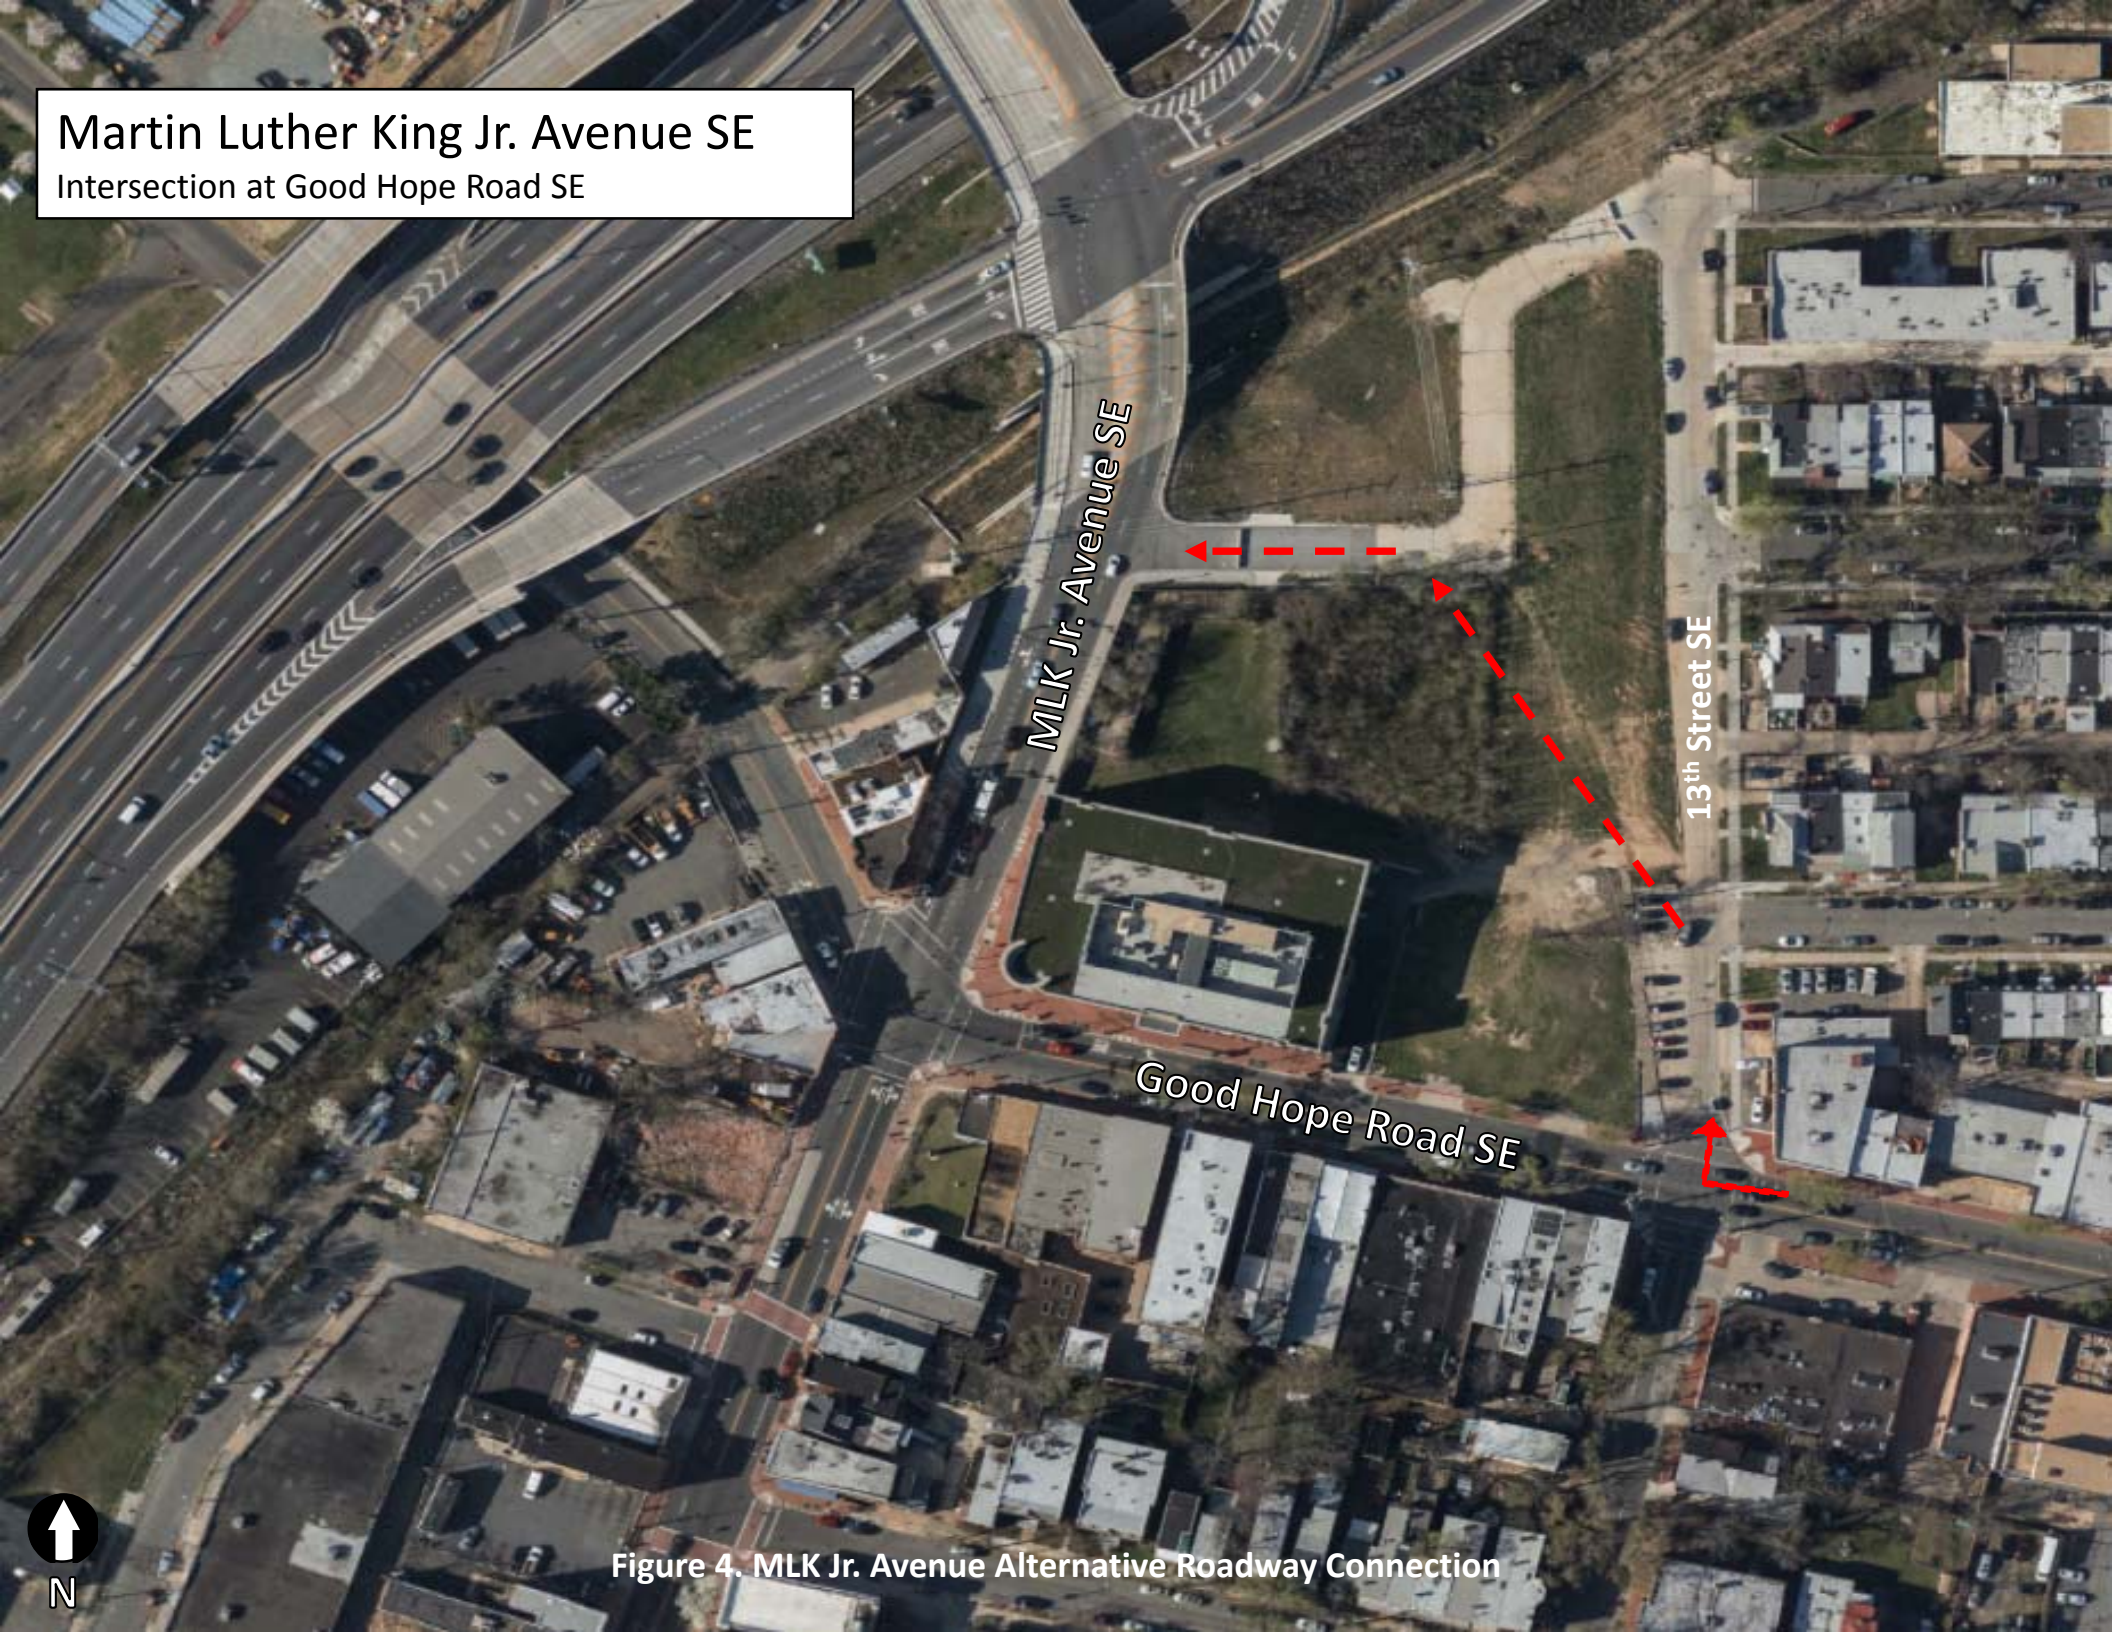
Figure 4. MLK Jr. Avenue Alternative Roadway Connection

The second issue is related to the heavy left-turn traffic from the southbound MLK Jr. Avenue approach. Many vehicles make this movement at elevated speeds to reach the green-arrow indication. Many left-turning vehicles also stop past the stop bar and block westbound right turn maneuvers. Because of the tight intersection geometry, near-miss collisions were observed with other turning movements from Good Hope Road. Additionally, the geometry makes it difficult to have concurrent left-turns from MLK Jr. Avenue. Many pedestrians and bicyclists are present at this approach, and vehicle speeds and congestion exacerbate pedestrian conflicts. See Figure 3 for a detailed indication of the noted issues on MLK Jr. Avenue. There were discussions regarding an alternative route to access the 11<sup>th</sup> Street bridge and alleviate some noted issues. See Figure 4 for an illustration of the potential new 11<sup>th</sup> Street bridge location.

<b>Issue</b>	<b>Next Step</b>
Tight turning radii is difficult for heavy vehicles and buses to maneuver and turn simultaneously.	Investigate a new connection to the 11 <sup>th</sup> Street bridge via 13th SE to potentially alleviate the right-turn traffic from Good Hope Road.
Existing variable message signs, at the intersection and north of the intersection on MLK Jr. Avenue, are not activated.	Remove overhead lane control mast arms on southbound MLK Jr. Avenue and at the intersection that are not in use.
