# DISTRICT DEPARTMENT OF TRANSPORTATION

# LONG BRIDGE STUDY Existing Conditions Bridge Assessment Report

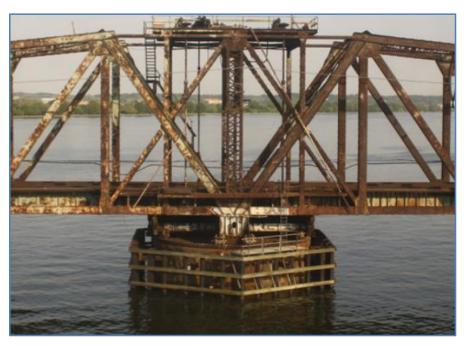
Figure 11 – 1904 Swing Truss Middle Pier

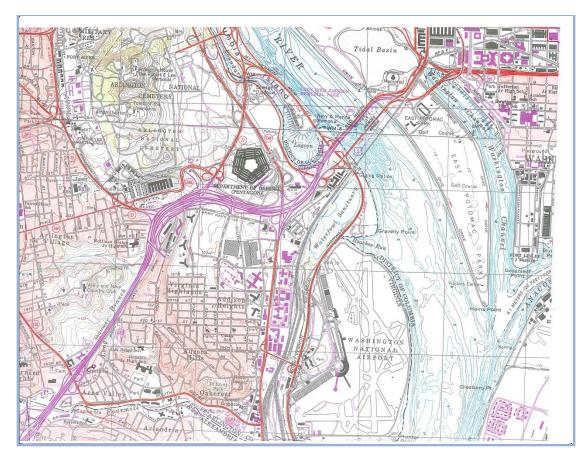
Figure 15 – USGS Hydrology Map

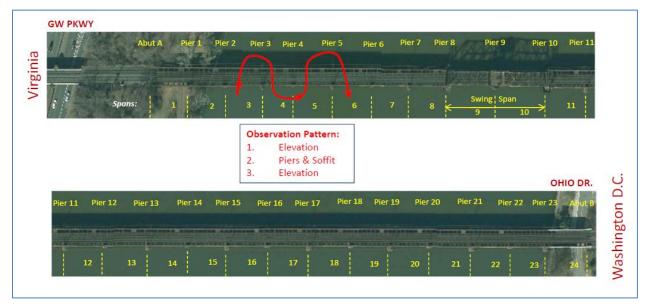
Figure 16 – Boat Survey Route

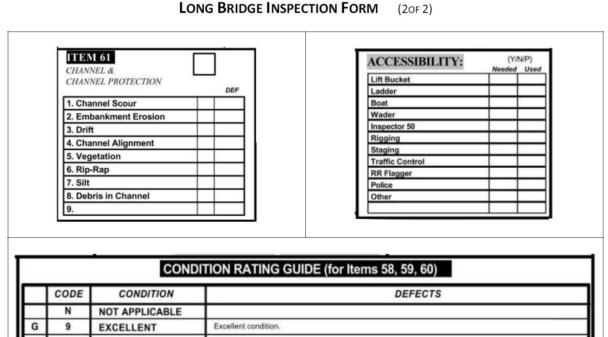
### \*Adapted from Massachusetts Bay Transportation Authority Railroad Operations

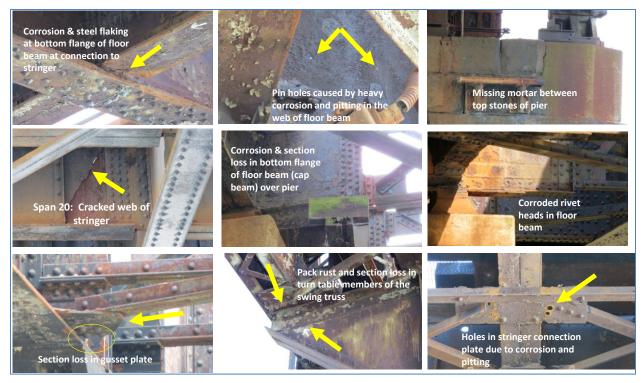
Figure 18 – Typical Deficiencies Noted During Visual Survey
