MEMORANDUM

То:	Emily Dalphy
	District Department of Transportation (DDOT)
From:	Daniel Markham, P.E. Tracy Lower, P.E. Kimley-Horn and Associates, Inc.
Date:	September 7, 2017
Subject:	High Crash Site Review Summary Memo Southern Avenue SE and Wheeler Road SE

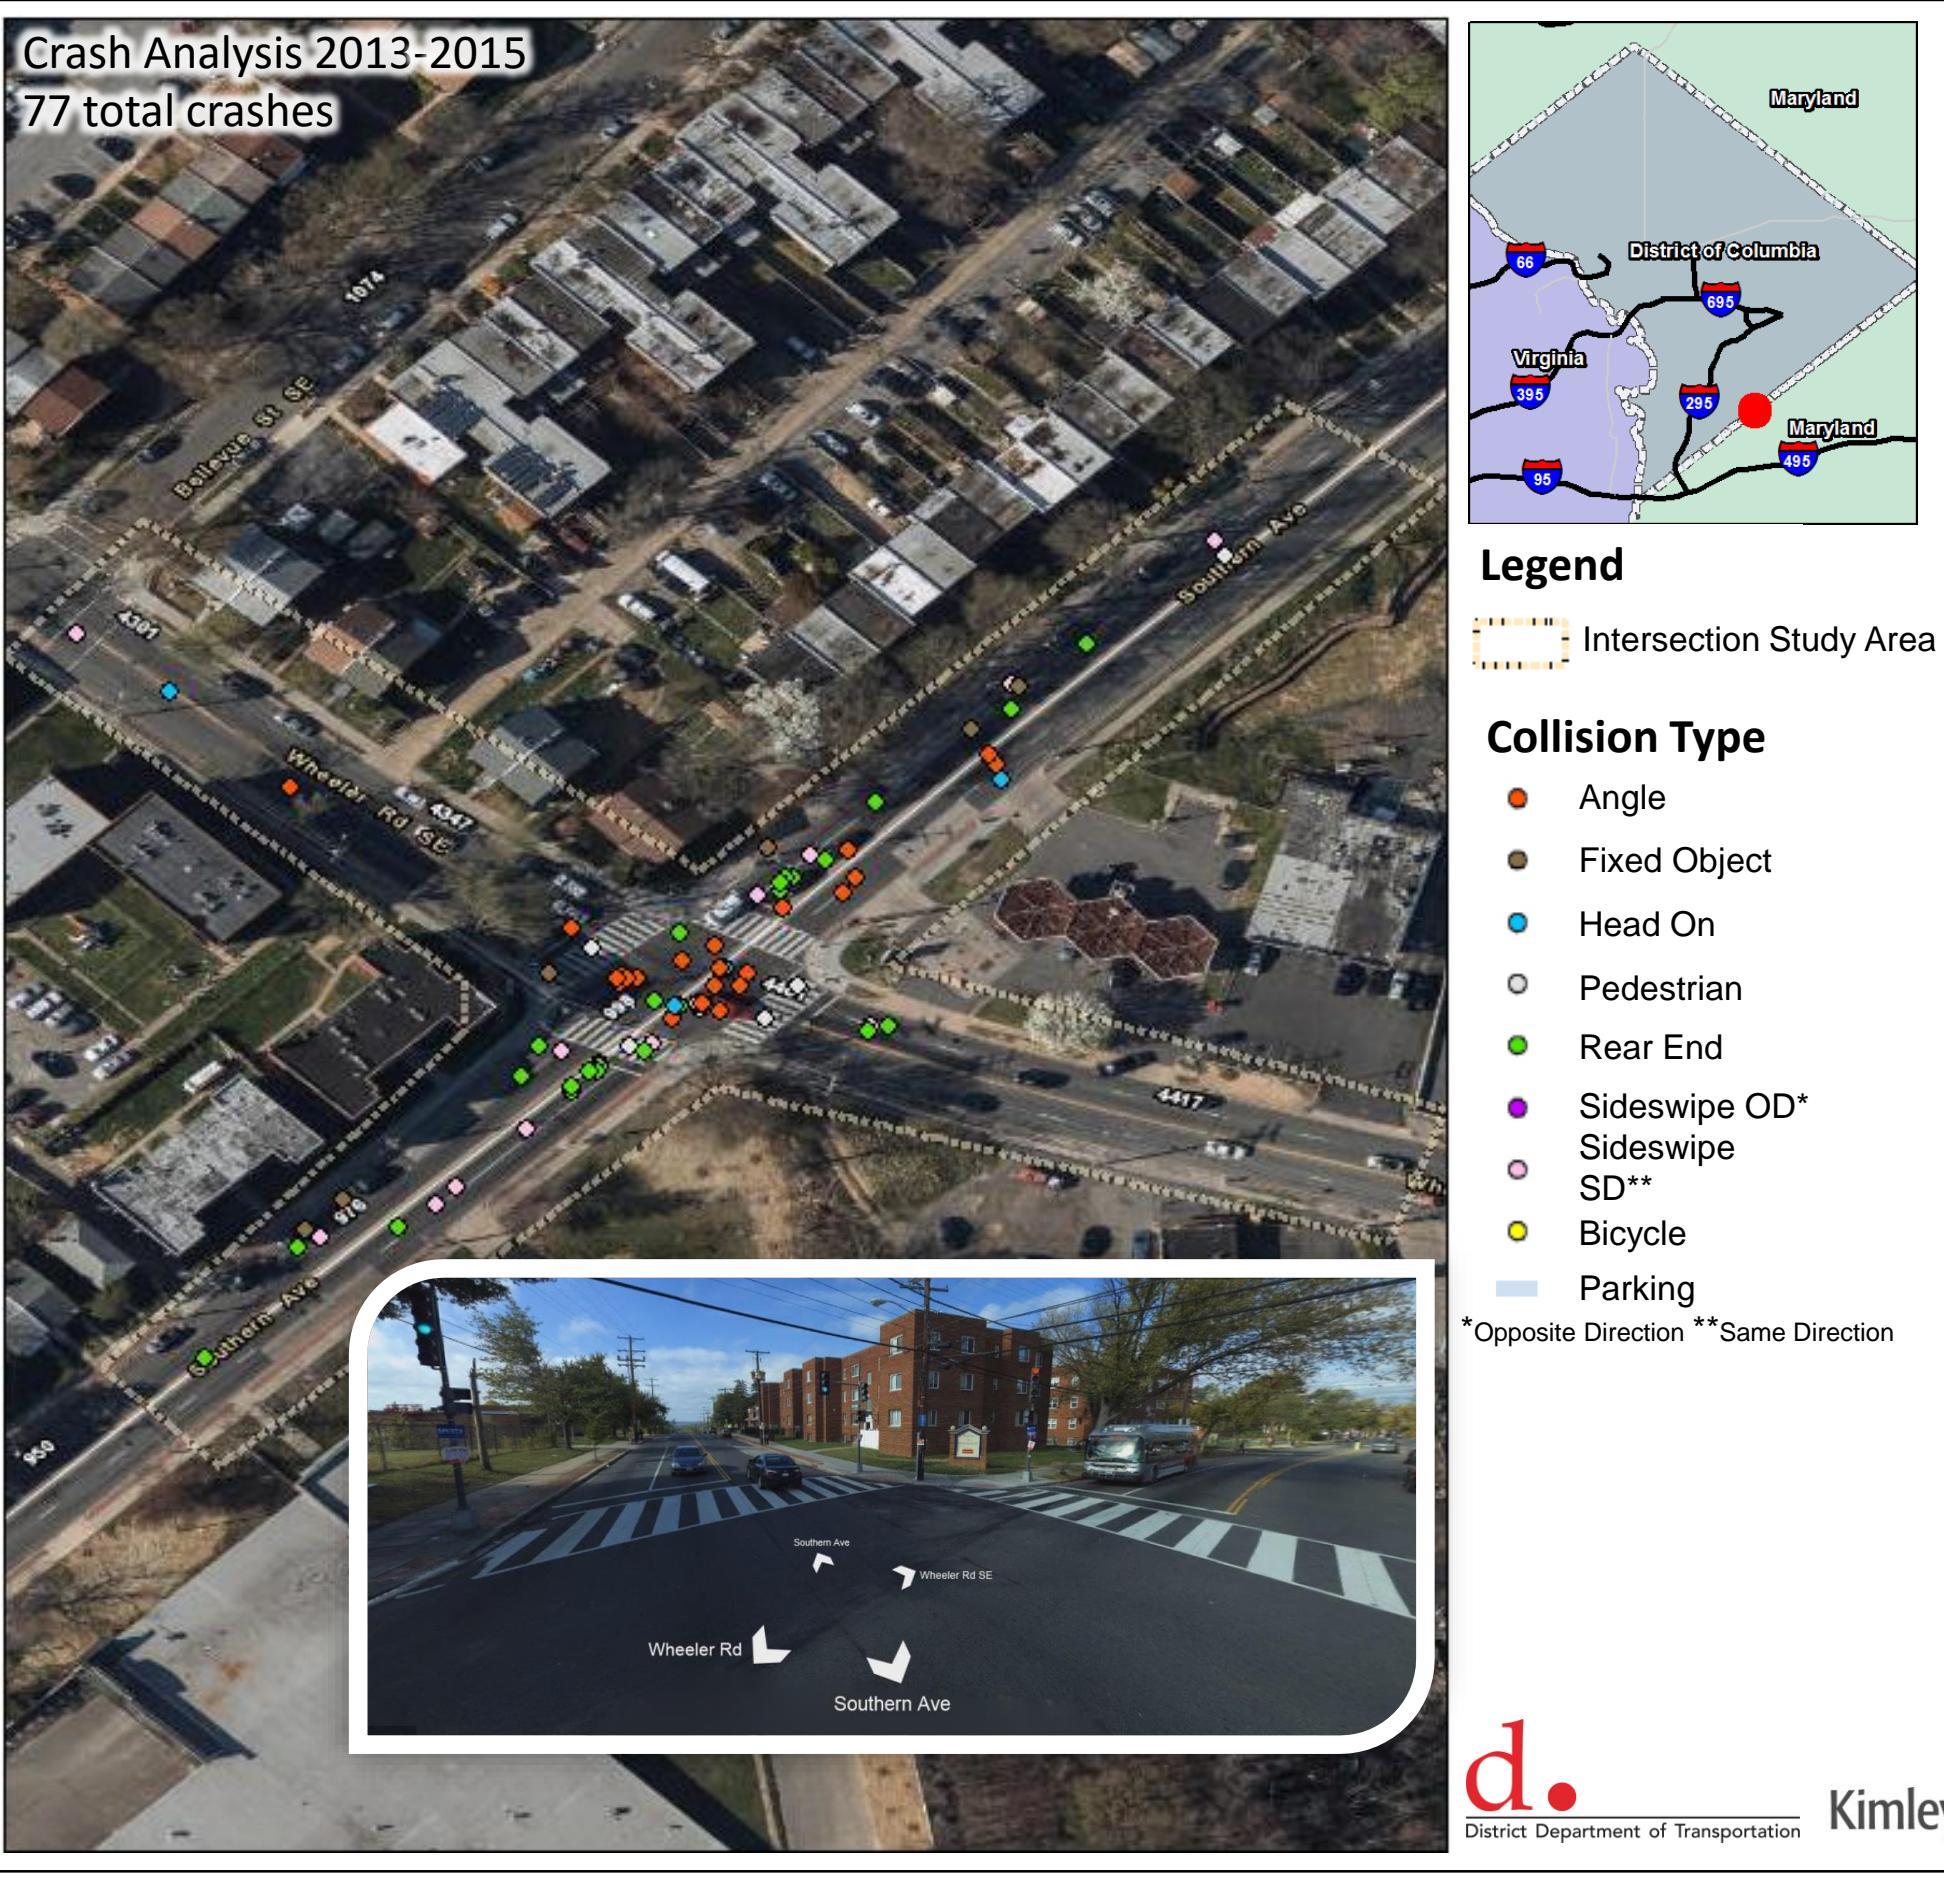
Figure 2: Crash Analysis Summary Figure – Southern Avenue SE and Wheeler Road SE

documented as PDO crashes, 15 (20%) involving at least one reported injury, and 14 (18%) unreported or unknown crash severity. There was one fatal crash recorded at the intersection. The fatal crash occurred on the southwestern approach on Southern Avenue within 100 feet of the intersection due to a speeding and erratic driver. The predominant crash type was rear end collisions, accounting for 26 (34%) of the crashes. Other common crash types include angle, side swipe, and fixed object collisions. Five crashes involved a pedestrian and zero crashes involved bicycles. There is no street parking available at the study intersection; however, illegal parking contributed to seven crashes. **Figure 2** summarizes the crash locations and corresponding crash statistics. From the crash data, some of the key issues identified include:

- Rear end and sideswipe same direction crashes were concentrated on Southern Avenue approaches
- Off peak period crashes accounted for the highest number of crashes (57%), and fewer crashes occurred in the AM peak period (9%) than the PM peak period (34%), defined as 6:00-10:00 AM and 3:00-7:00 PM, respectively
- Three crashes within the intersection were attributed to vehicles running a red light

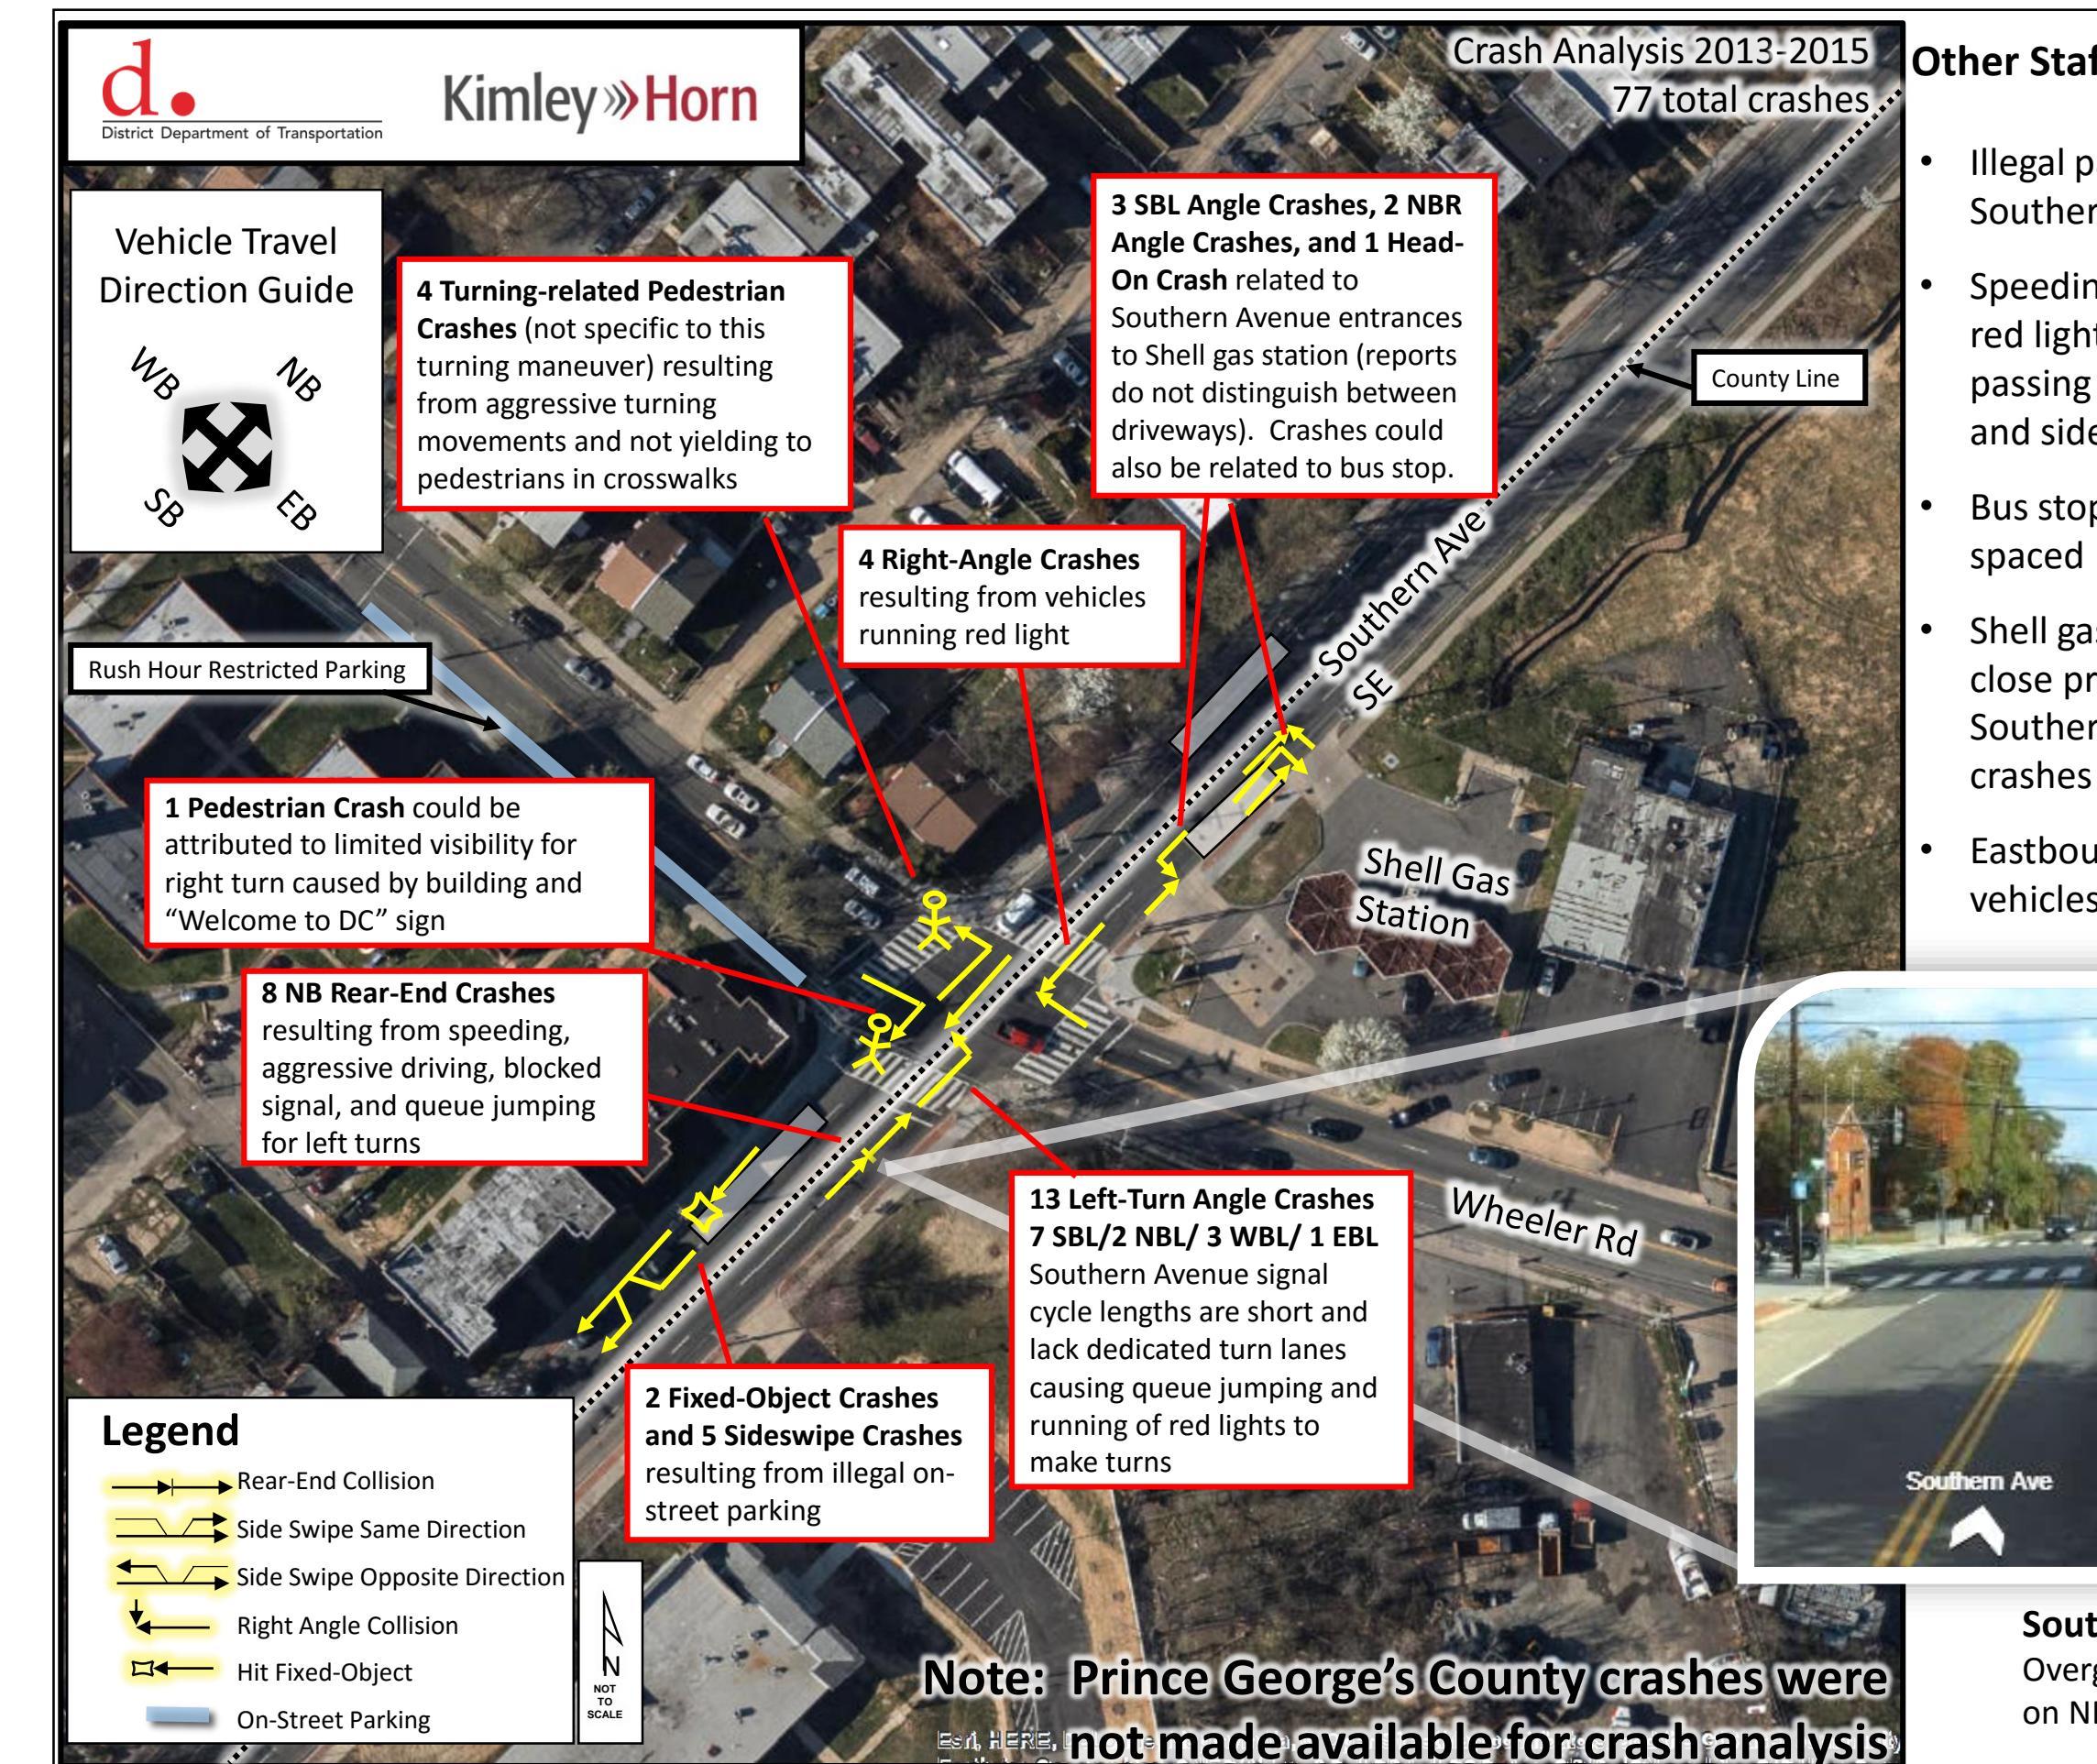
Figure 3: Summary of Field Observations and Associated Crash Types – Southern Avenue SE and Wheeler Road SE

Other Staff Observations During Site Field Review on 6/28/2017

Illegal parking causes weaving issues on Southern Avenue

Speeding and aggressive driving results in red light running, queue jumping, and passing movements that contribute to angle and sideswipe crashes

Bus stops on Southern Avenue are closely

Shell gas station has 5 entrances all within close proximity of the intersection. Southern Ave entrances have caused 6

Eastbound right turn for bus conflicts with vehicles on northbound Southern Avenue

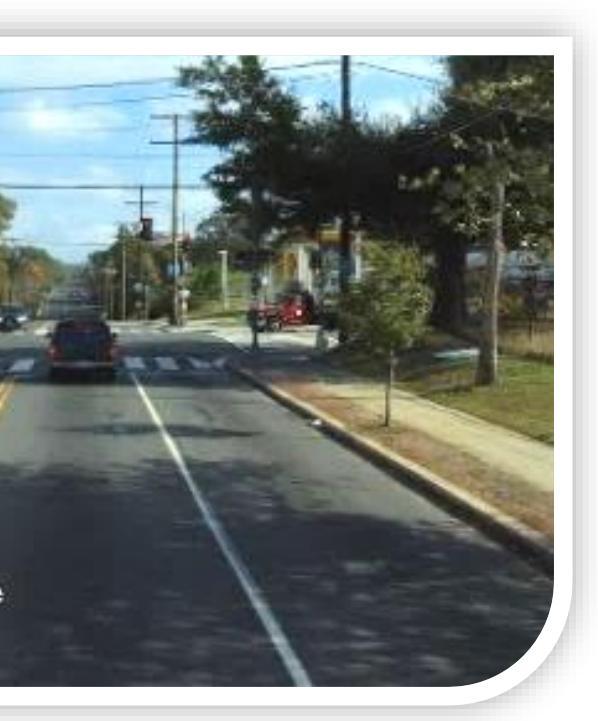
Southern Ave NB Approach Overgrown trees block view of signals on NB approach

- "No Parking" and "Yield to Pedestrian" signage
- Pavement markings
- Retroreflective backplates
- Tree trimming
- Parking enforcement

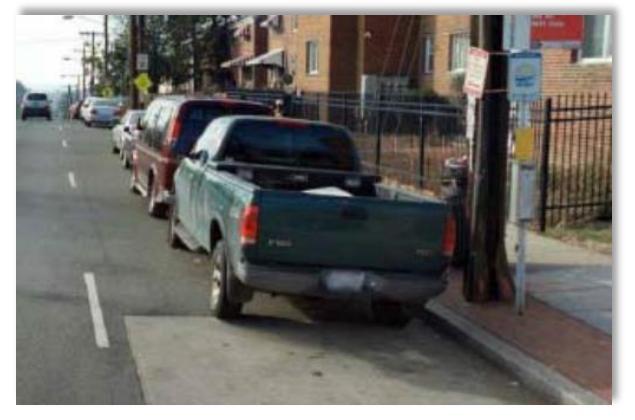
Illegal parking on Southern Ave SE recommended to be addressed with additional signage and parking enforcement

Figure 4 illustrates the short-term improvements for the intersection. To address enforcement issues with parking and failure to yield to pedestrians, it is recommended that additional no parking signs be installed on Southern Avenue SE and that "Yield to Pedestrians" signs be installed at each approach. It is also recommended that periodic parking enforcement occur by the Department of Public Works (DPW) at this location to monitor and address illegal parking activity. To address signal visibility, it is recommended that retroreflective backplates be installed on traffic signal heads and that trees be trimmed. To reinforce the allowable vehicular movements in each travel lane, it is recommended that through-right and through-left pavement markings be installed along all approaches to
