District Department of Transportation

High Crash Intersection Site Visits

Summary and Next Steps

January 2016

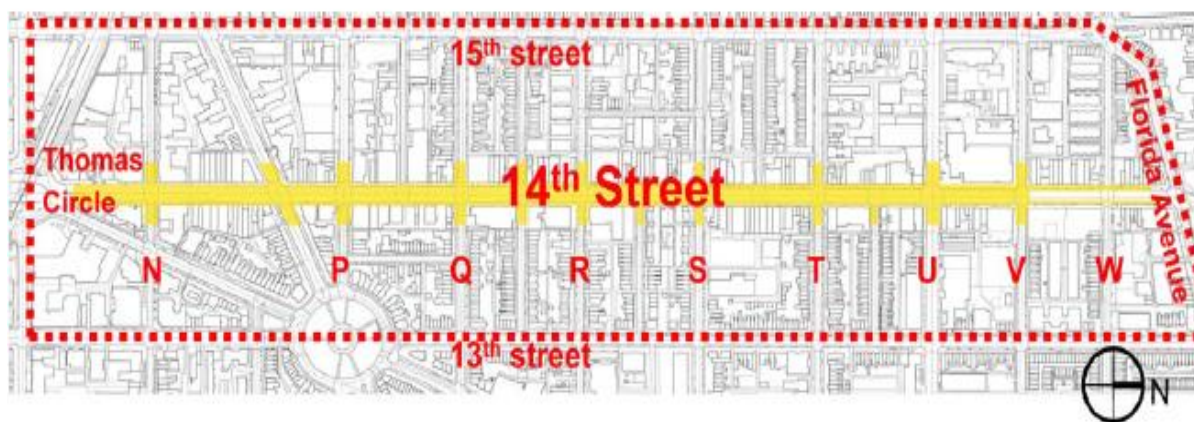
Figure 7: 14th Street NW Streetscape Project Boundaries

Figure 7 is an overview of the project boundaries and Figure 8 is an image of the proposed signs and marking plan, which depicts the following changes:

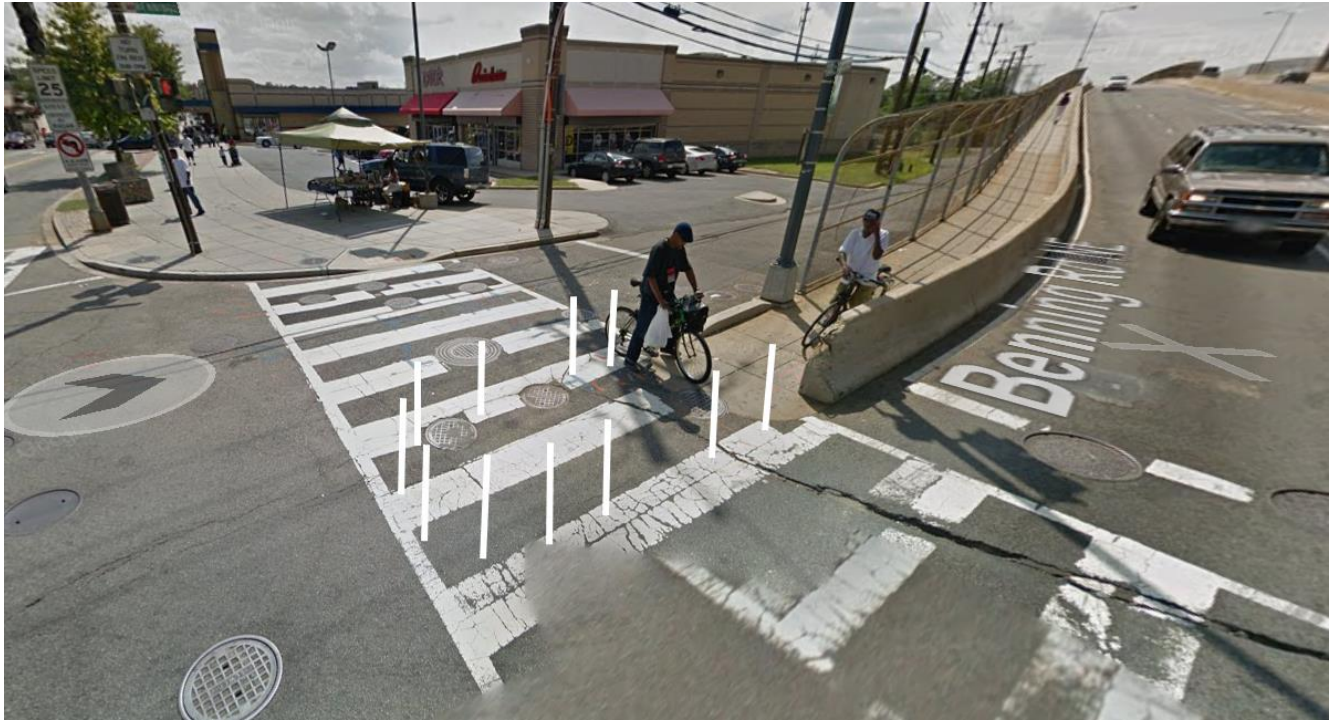
Figure 13: Mock-up of Potential Interim "Pedestrian Refuge" on West Side Crossing of Benning Road.
