# DC Experience with the HAWK-Hybrid Pedestrian Signal and Rectangular Rapid Flashing Beacons

DC Department of Transportation

# How a HAWK-Hybrid Pedestrian Signal Works:

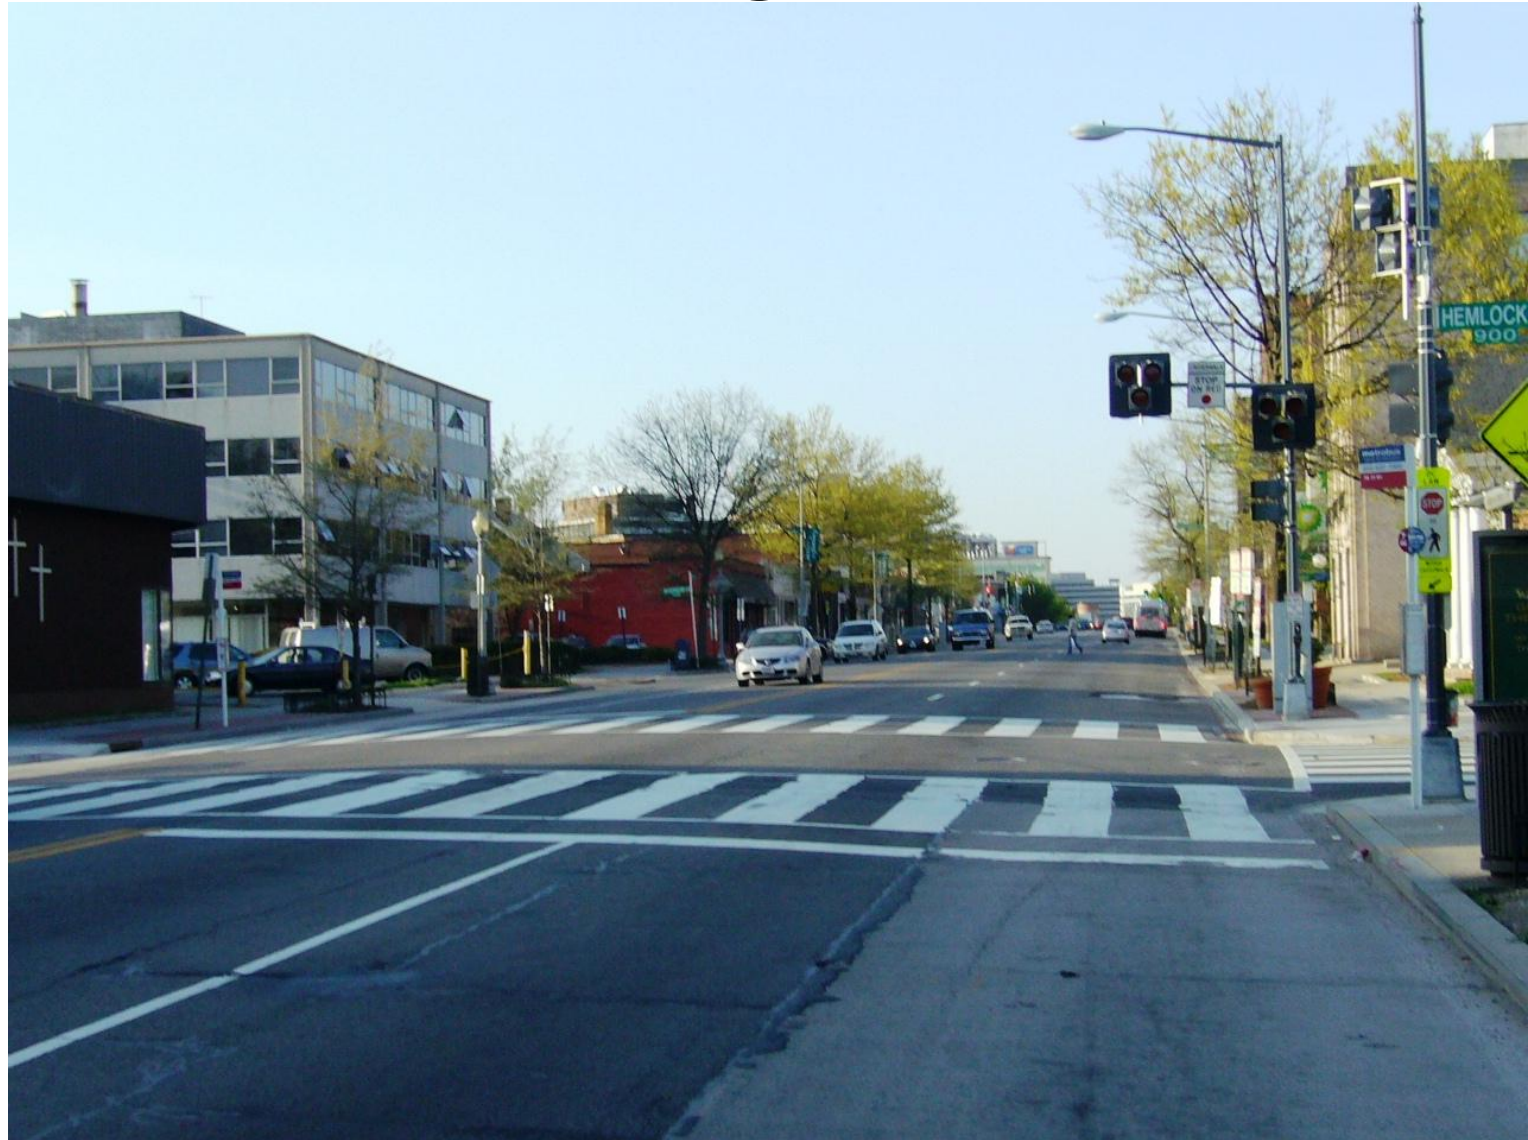
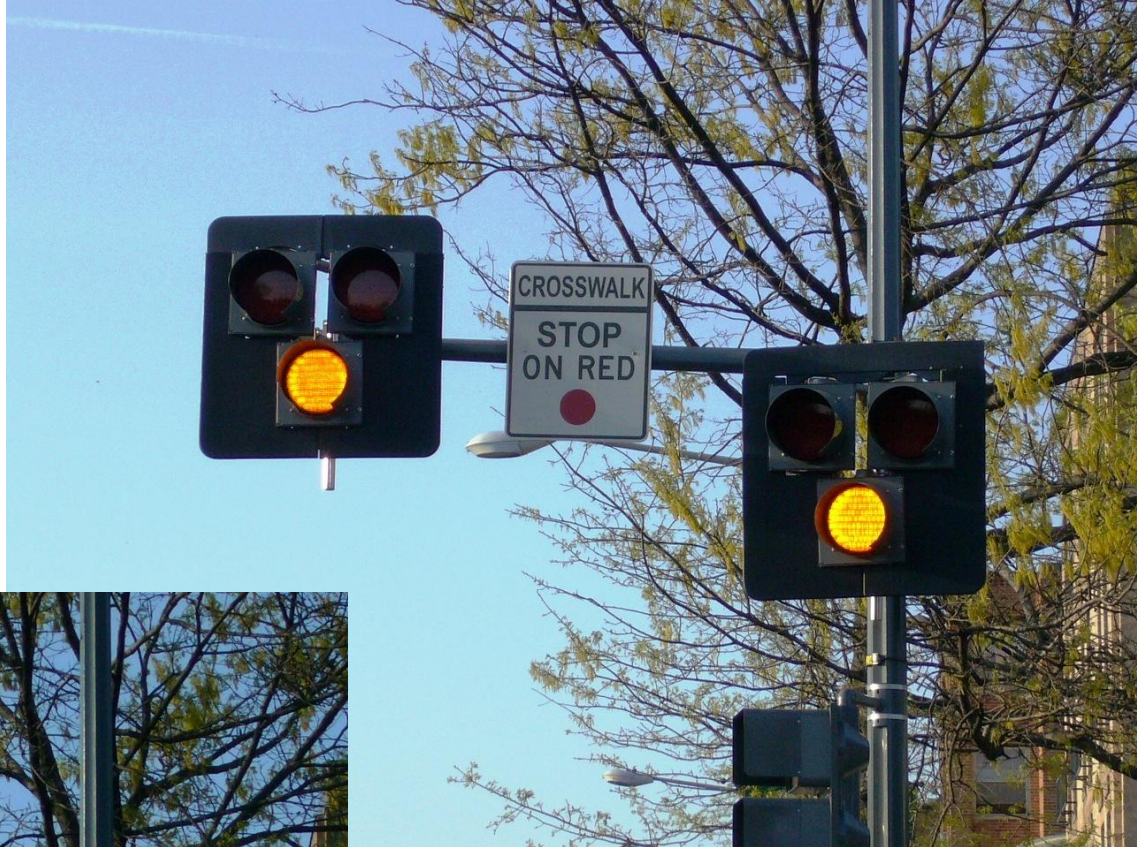
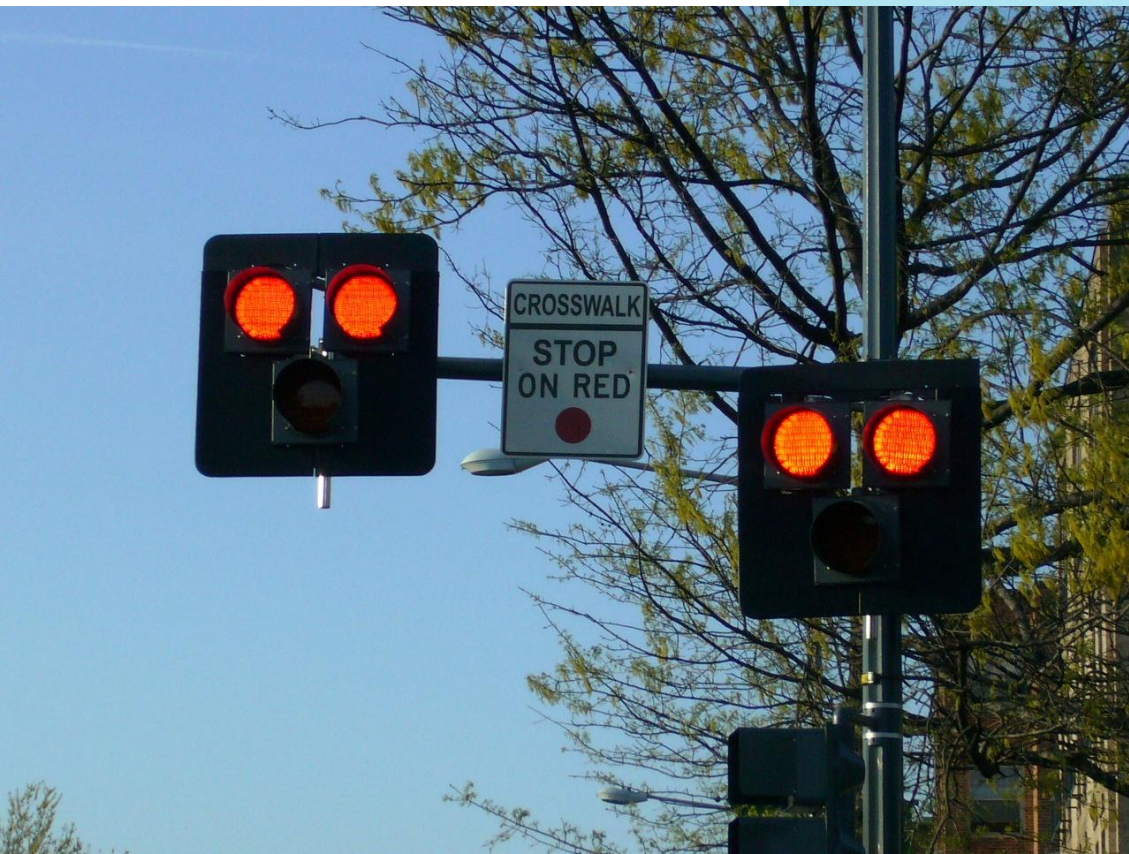
# Location: Georgia Ave. & Hemlock St. NW Washington, DC

- In August 2009, DDOT installed a HAWK signal at a “T” intersection on a major arterial street, Georgia Ave. NW.
- The land use context is a mixed use commercial/residential node along a commercial corridor.
- Intersection was uncontrolled with high vizibility marked crosswalks on all legs.
- The intersection is approximately 750 ft. from adjacent signalized intersections.
- Community members, especially the elderly, had complained for years that it was difficult and unsafe to cross Georgia Ave. at this location.

# HAWK GENERAL FIELD OBSERVATIONS:

- Field observations were conducted on typical weekdays for both A.M. and P.M. periods.
- Overall, 97.1% of drivers stopped for pedestrians using the HAWK signals.
- A number of drivers exhibited aggressive driving characteristics, such as hesitating or slowing down briefly for crossing pedestrians to clear the driver's travel path, and then proceeding to drive across the intersection on the flashing red without stopping.
- While waiting to turn onto Georgia Avenue, motorists from Hemlock Street generally yielded to pedestrians using the crosswalk.

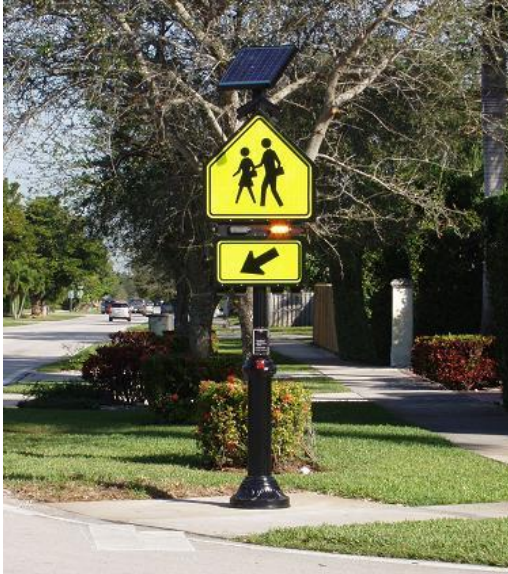
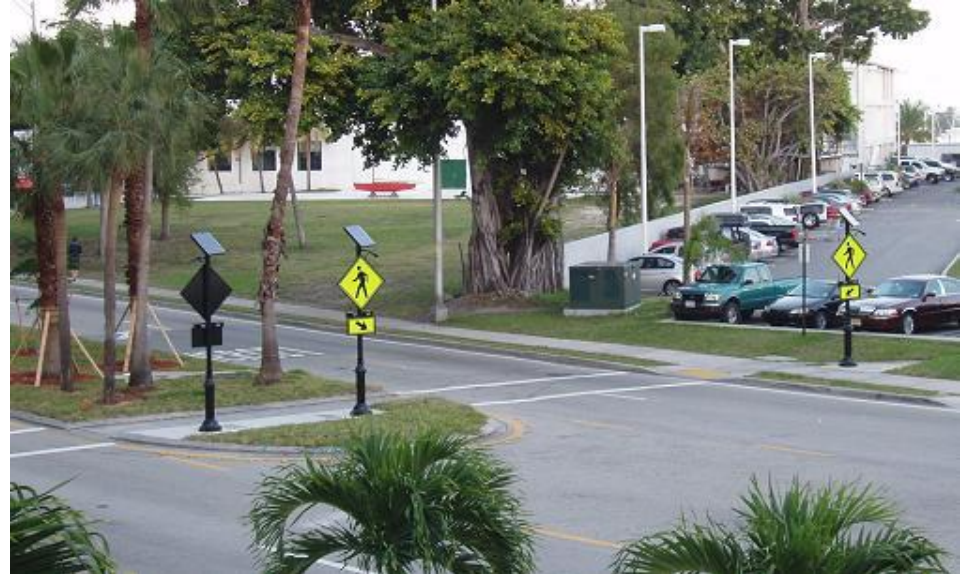
# Rectangular Rapid Flashing Beacons Summary

- DDOT staff monitored the development of the RRFB since 2005 and decided to test an installation at an uncontrolled crossing on a four lane arterial street. (Photos from Florida)

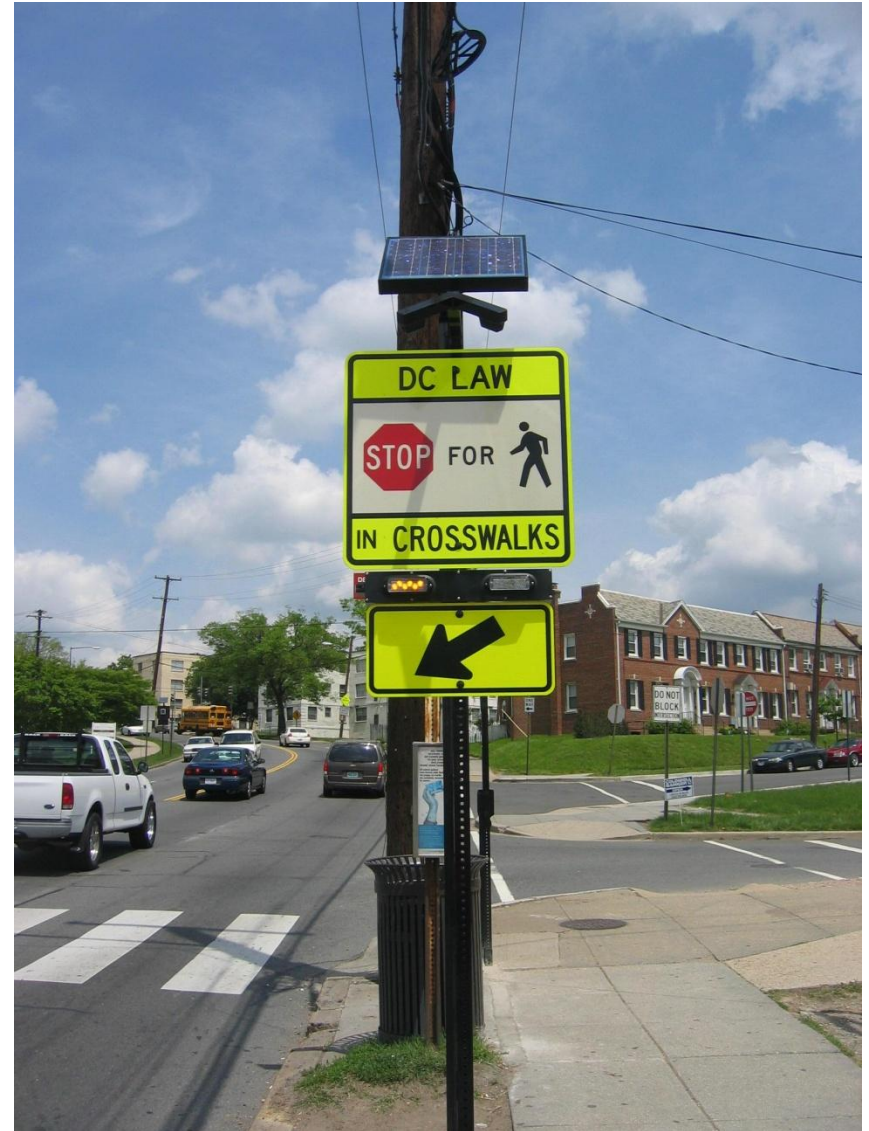
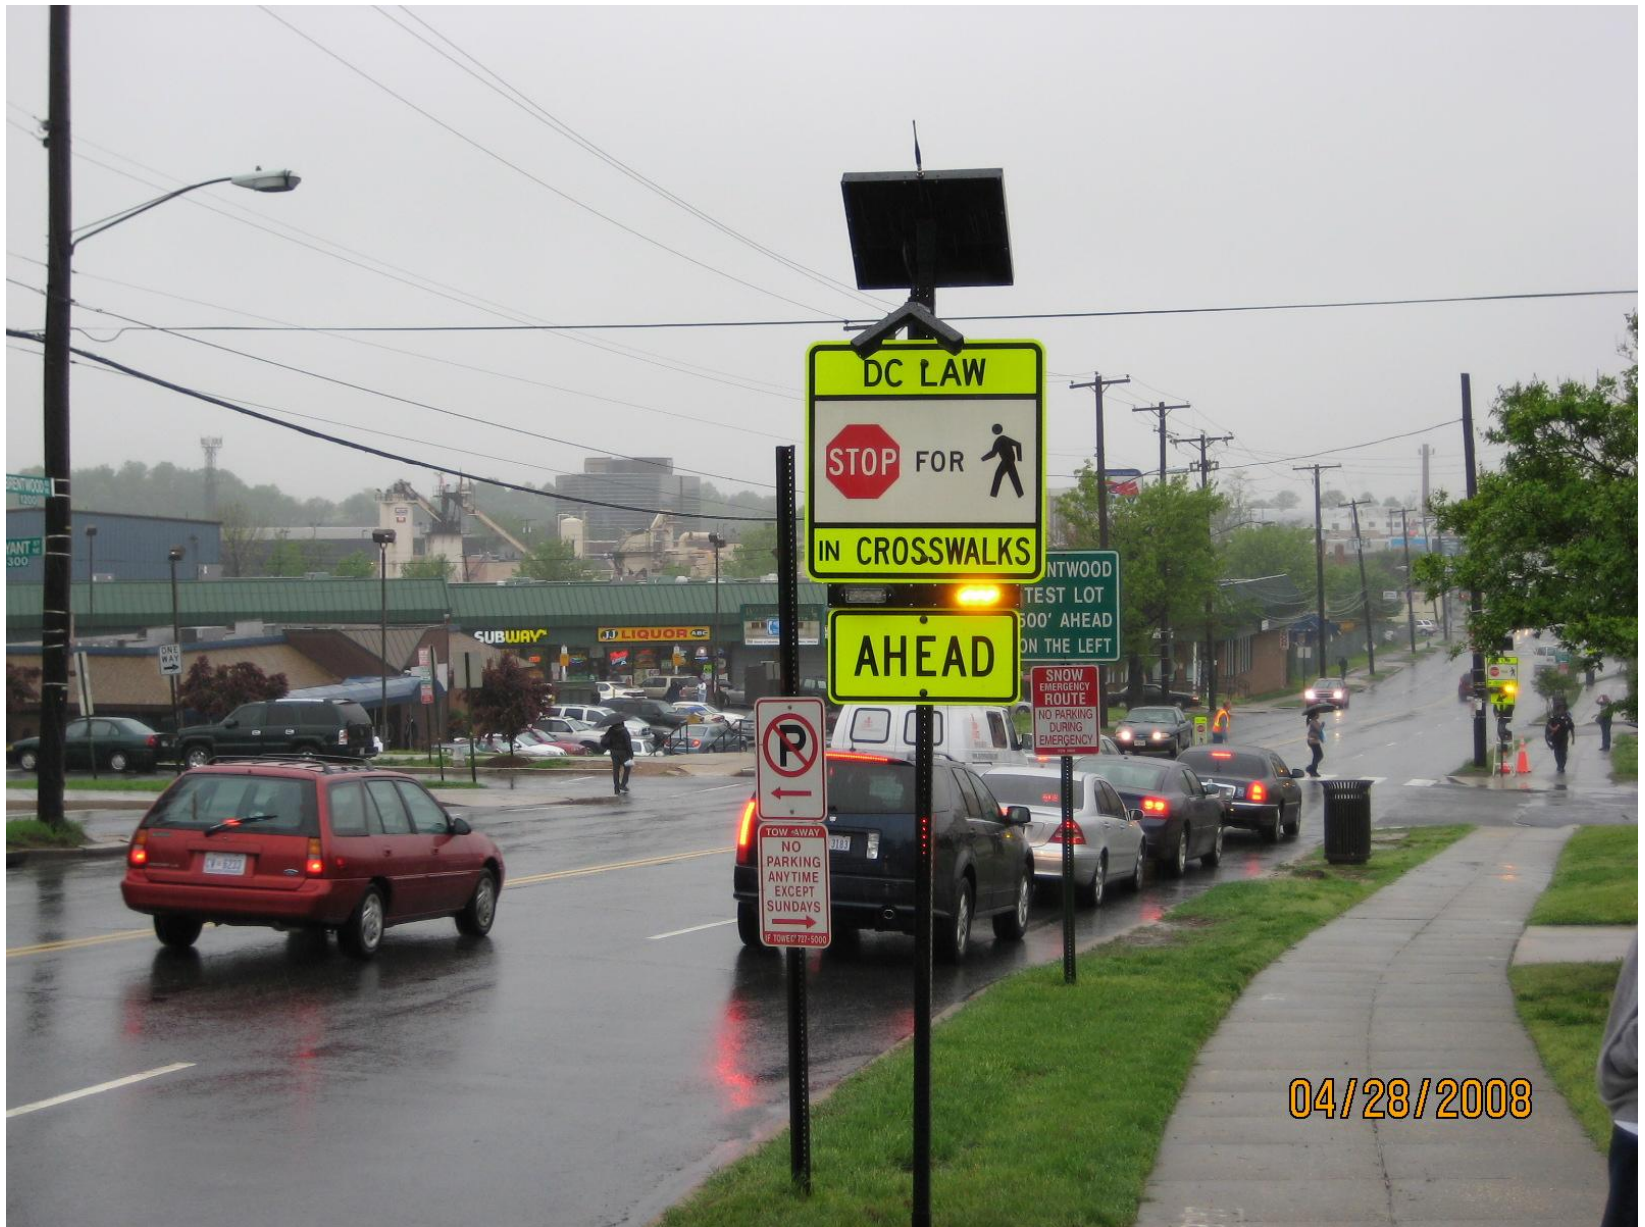
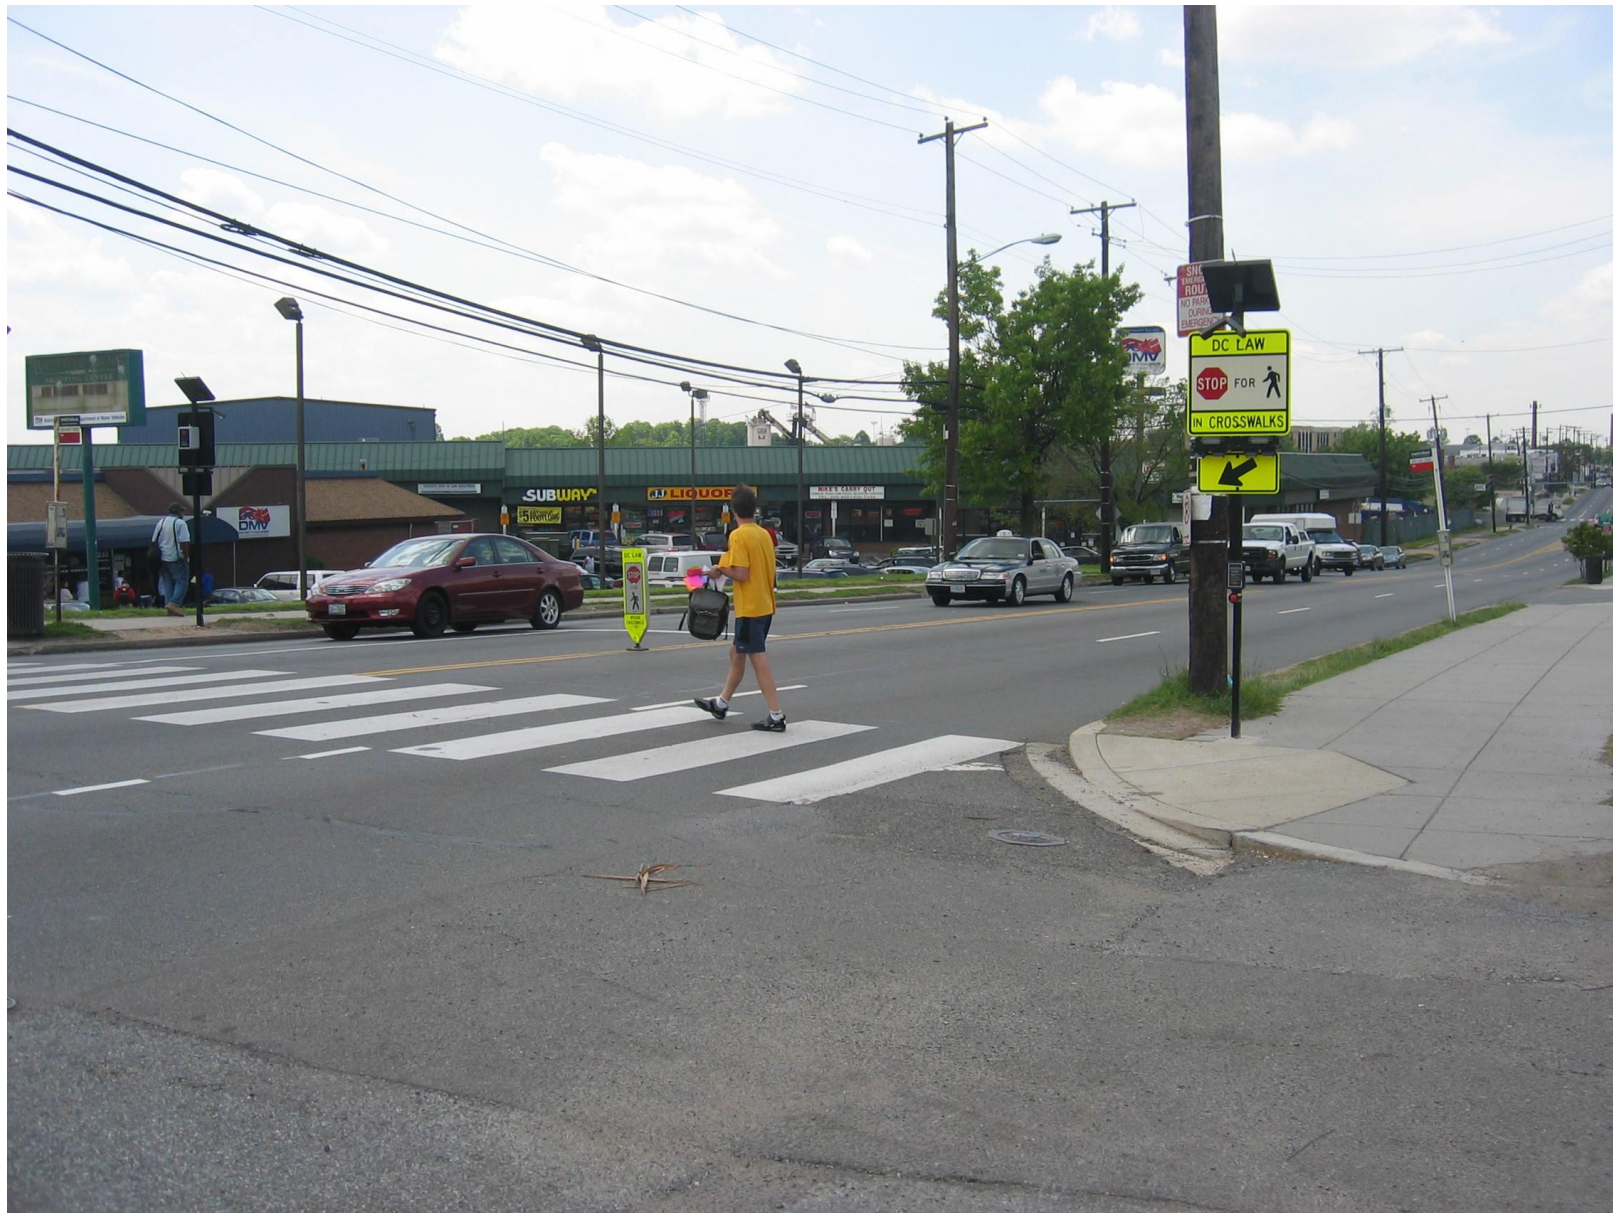
# DC's Rectangular Rapid Flashing Beacon

- The beacons were paired with a unique “Stop for Pedestrians” sign in an effort to provide drivers with a stronger regulatory message.

- DDOT installed a RRFB at an uncontrolled marked crosswalk on an 4 lane arterial street with 30,000 VPD ADT and a posted speed of 30 mph (85<sup>th</sup>ile= 44 mph). This is the largest road on which a beacon of this type has been installed.
- Because of the slope and horizontal curvature of the street, an advance beacon was used on the southbound approach, 150' before the crosswalk.
