Potential Transportation Problems 7th Street / 8th Street / Independence Ave / North Carolina Ave SE

Capitol Hill Transportation Study

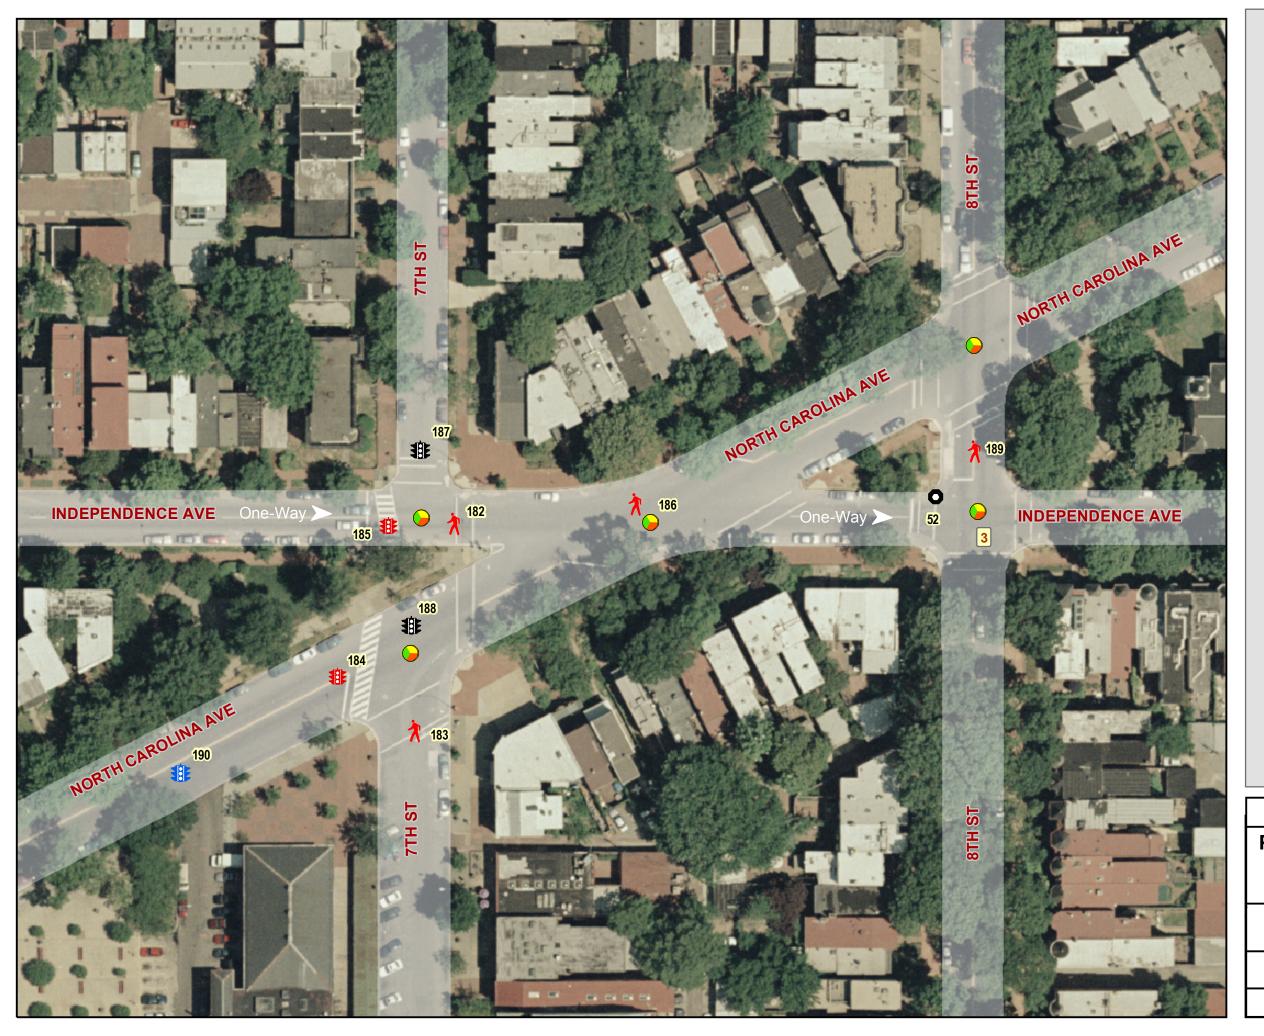
Figure 7-16

- **52** The existence of stop bars are not obvious to motorists and pedestrians.
- **182** Pedestrian signals do not exist, providing pedestrians no way to determine what cycle the signal is on.
- **183** Pedestrian signals do not exist, providing pedestrians no way to determine what cycle the signal is on.
- **184** Through traffic on NC has flashing yellow instead of green light.
- **185** Through traffic on Independence has flashing yellow instead of green light.
- **186** No crosswalks along Independence Ave. between these blocks
- **187** Intersection is not fully signalized (7th has stop signs mid-intersection).
- **188** Intersection is not fully signalized (7th has stop signs mid-intersection).
- **189** No pedestrian signals.
- **190** Traffic along North Carolina Avenue between 6th and 8th Street SE does not have sufficient green time to clear the intersections.
