District Department of Transportation Bicycle Facility Evaluation

Washington, District of Columbia

Final Report

April 2012

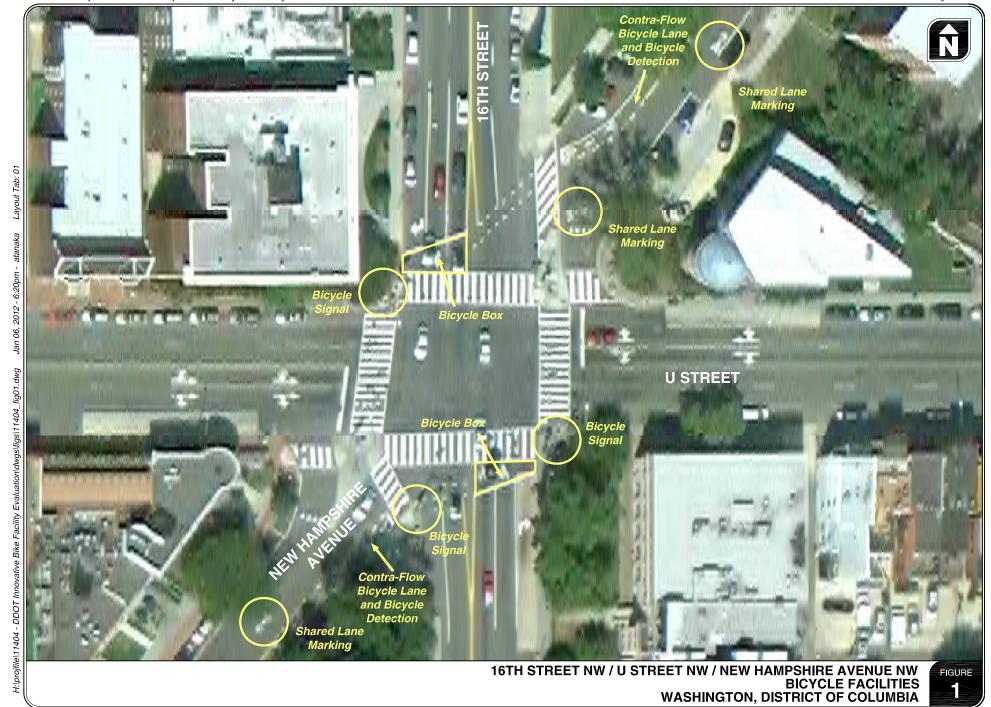
- *Bicycle signals* were installed on the northwest and southeast corners of the intersection (as shown in Figure 1 and Figure 2C). Bicyclists receive their own signal phase to allow bicyclists to travel from the New Hampshire Avenue contra-flow bicycle lanes to the 16th Street bicycle boxes without having to cross the intersection using the pedestrian crosswalks. No motor vehicle movements run concurrently with the bicycle signal phase.

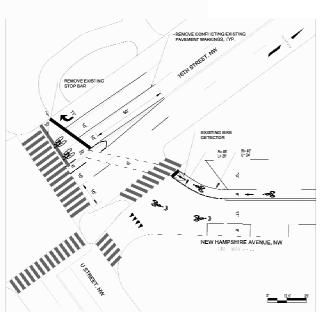
FIGURE 2A

PAVEMENT MARKING DETAILS

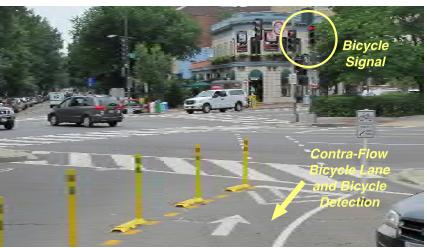
2C

SOUTHBOUND APPROACH ON NEW HAMPSHIRE AVENUE
