Pedestrian Bridge and Connecting Trail Over Arizona Avenue, NW

Public Meeting #2

Purpose and Project Area

The purpose of the project is to rehabilitate the existing pedestrian bridge over Arizona Avenue NW and to improve the connecting trail to provide greater community connectivity to the Palisades Recreation Center. The project is needed because the existing pedestrian bridge is nearing the end of its service life.

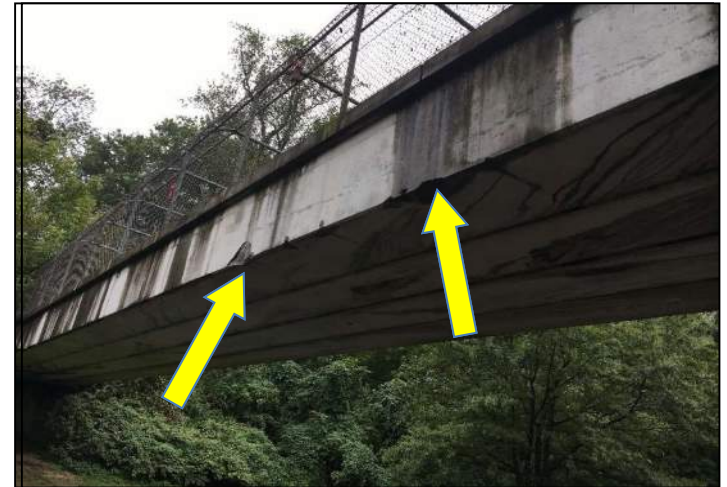
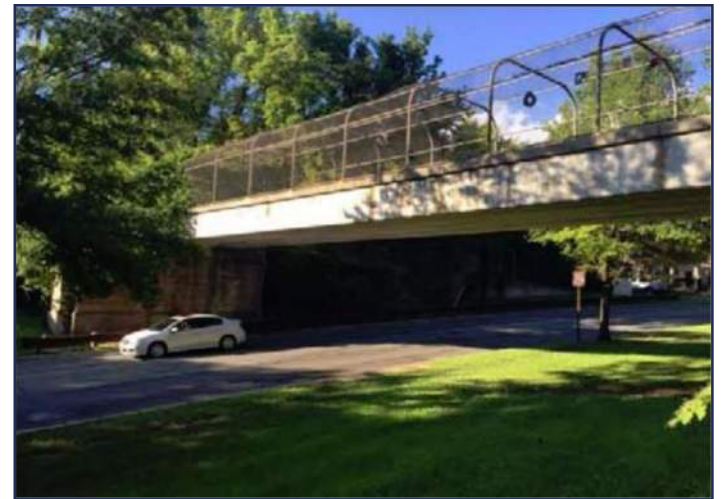
Existing Pedestrian Bridge

- Constructed in Early 1980's
- Vertical Clearance
 - Existing Minimum = 14'-2"
 - AASHTO/DDOT Standard Minimum = 17'-6"
- Structural Condition
 - Recent Inspection (2018)
= 5 (Fair Condition) (0 to 9 scale)
 - Prestressed Concrete Box Beams

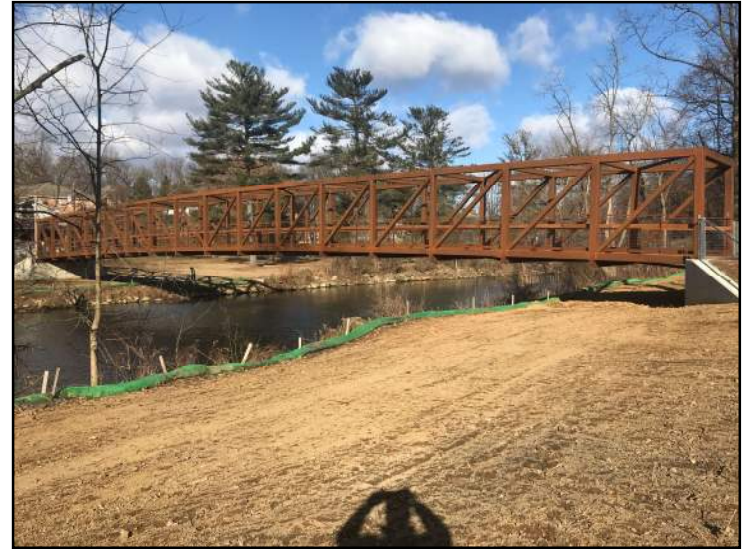
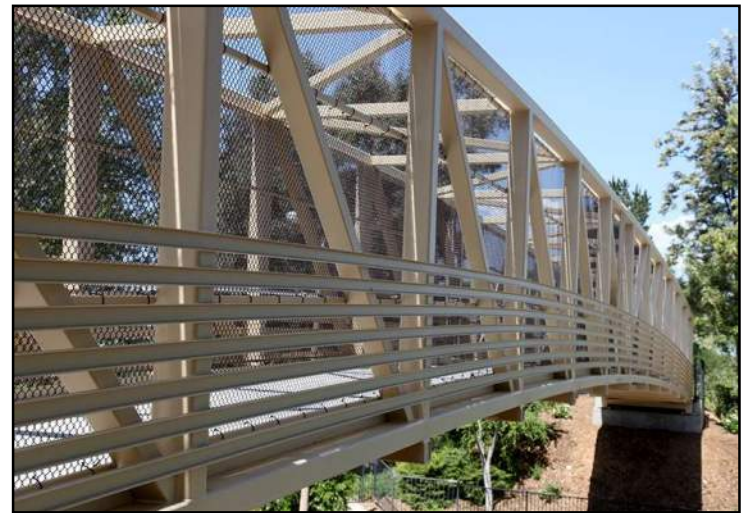
Pedestrian Bridge

- Main Span over Arizona Avenue
 - Prefabricated Steel "Box" Truss
 - Safety Handrails at 42"
 - Mesh Panels
 - Concrete Deck
 - Minimal Arch

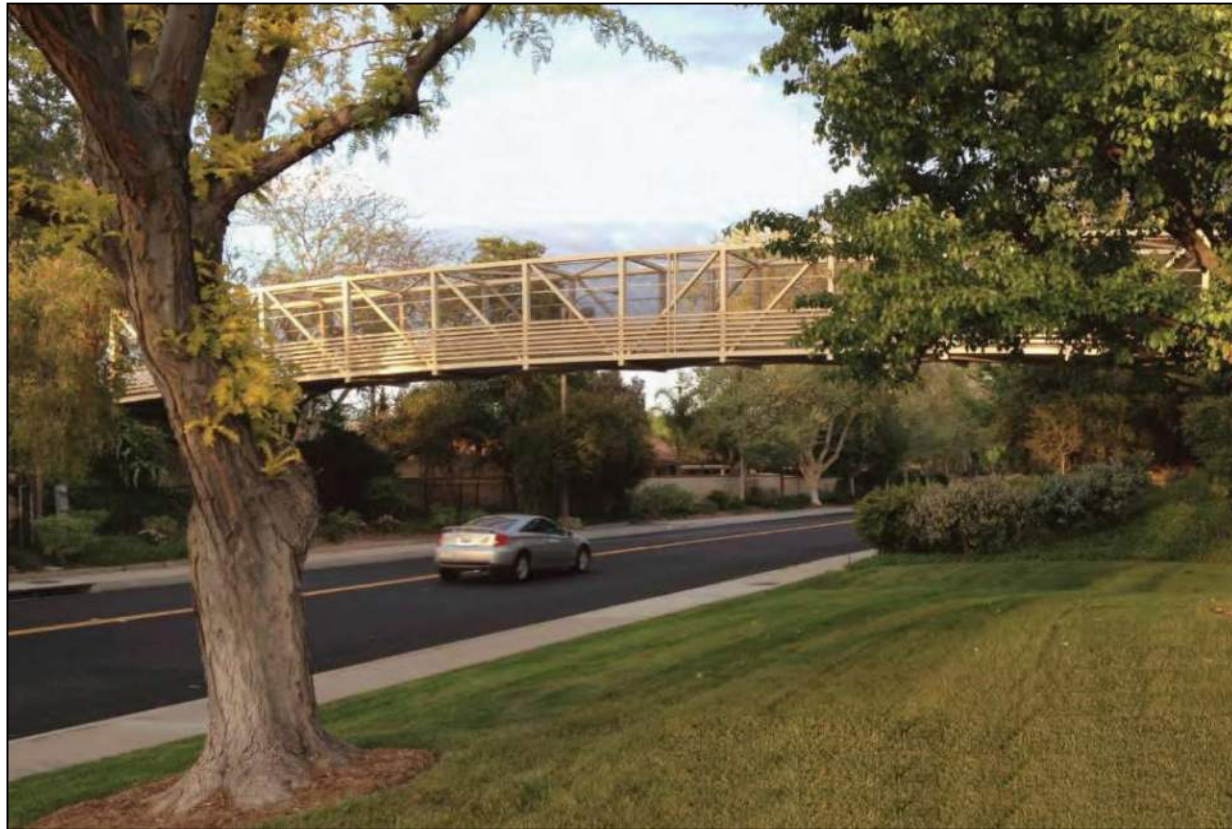
Prefabricated Steel Trusses

- Parallel Chord “Box” Truss Example

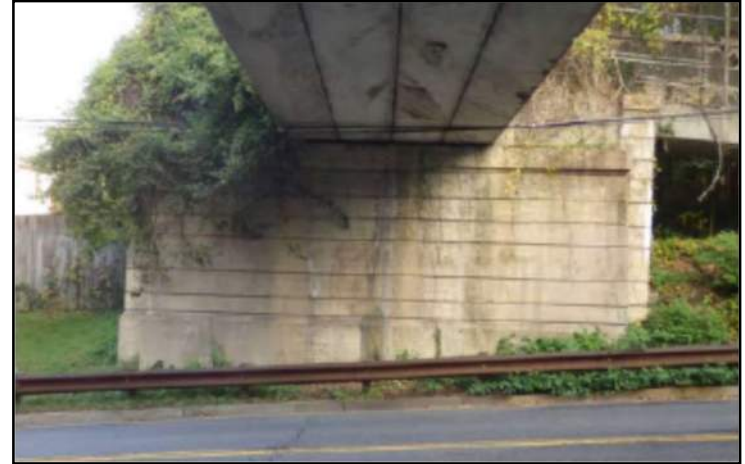
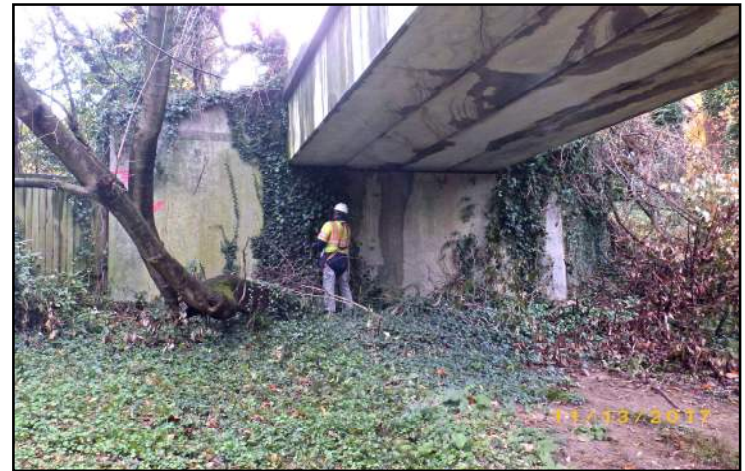
Pedestrian Bridge

- Abutments
 - Modifications
 - Modify/Extend Abutment Using Lightweight Backfill
 - Evaluate Existing Foundations
 - Repair Existing Defects
 - Spalls and cracks

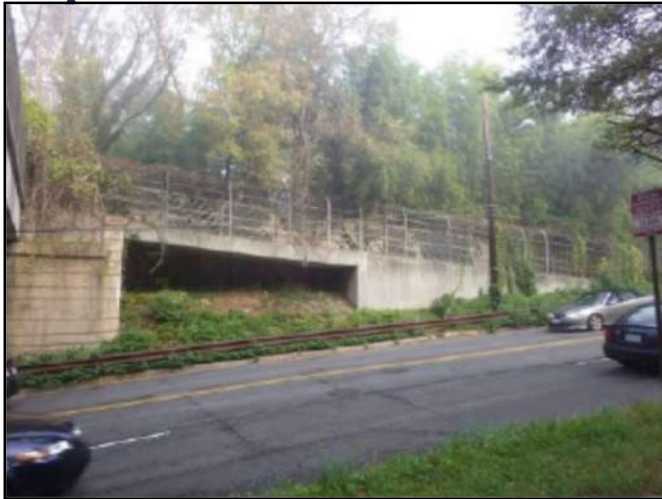
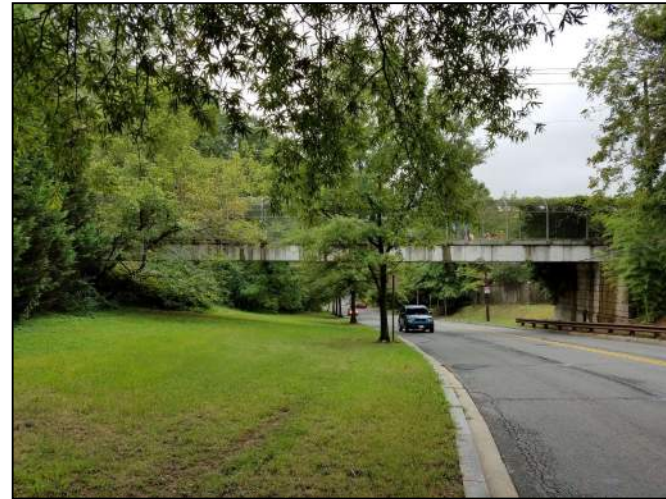
Pedestrian Bridge

- Pedestrian Access Ramp
 - Replace Existing West Ramp Structure
 - Design Follows Accessibility Guidelines
 - Raised Trail Profile = Longer Ramp
 - Evaluated New Ramp on East Side of Arizona Ave.

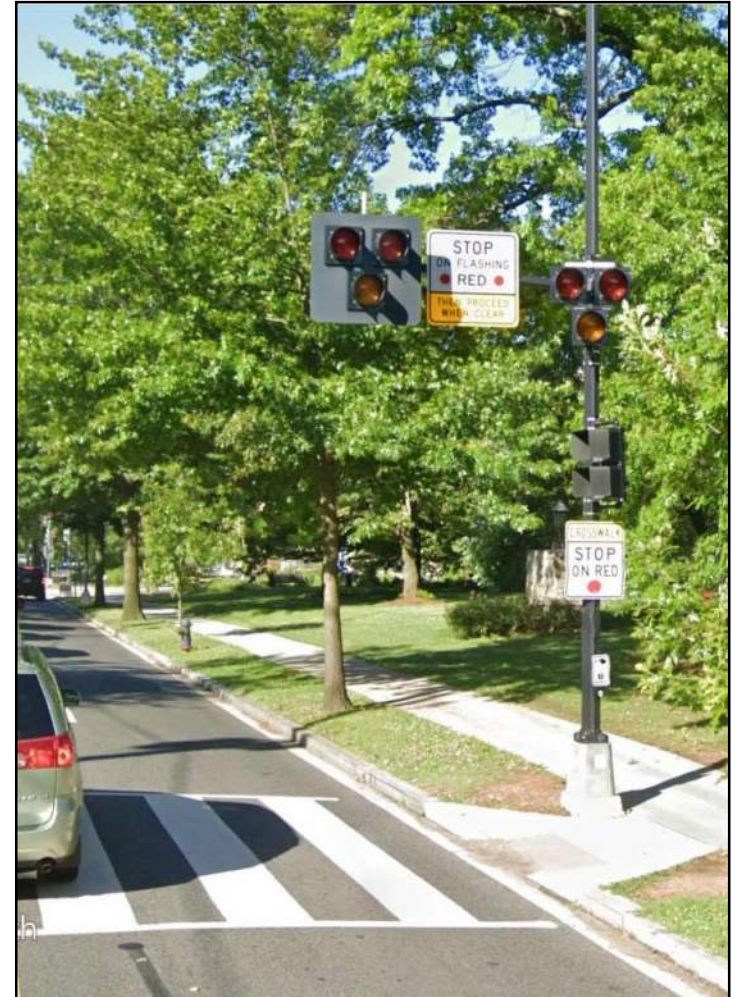
Traffic Study Results

- A fully signalized intersection of Arizona Avenue NW and Sherier Place NW does not meet the signal warrants.
- HAWK pedestrian signal meets DDOT requirements.
- Provide improved pavement markings and HAWK pedestrian signal at intersection of Arizona Avenue, NW and Sherier Place, NW.

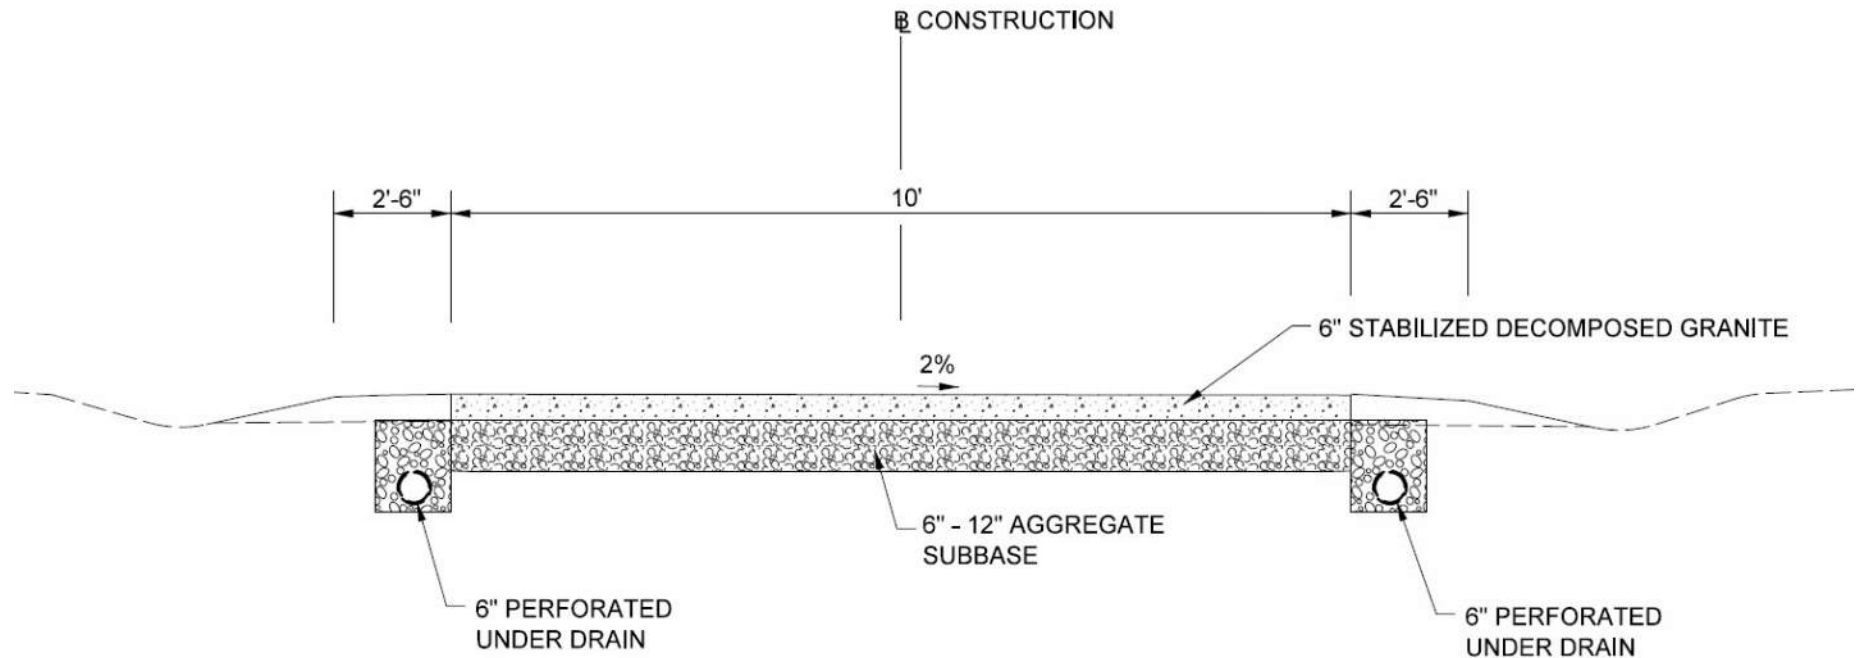
TYPICAL SECTION

Trail Typical Section

PALISADES TRAIL
N.T.S.

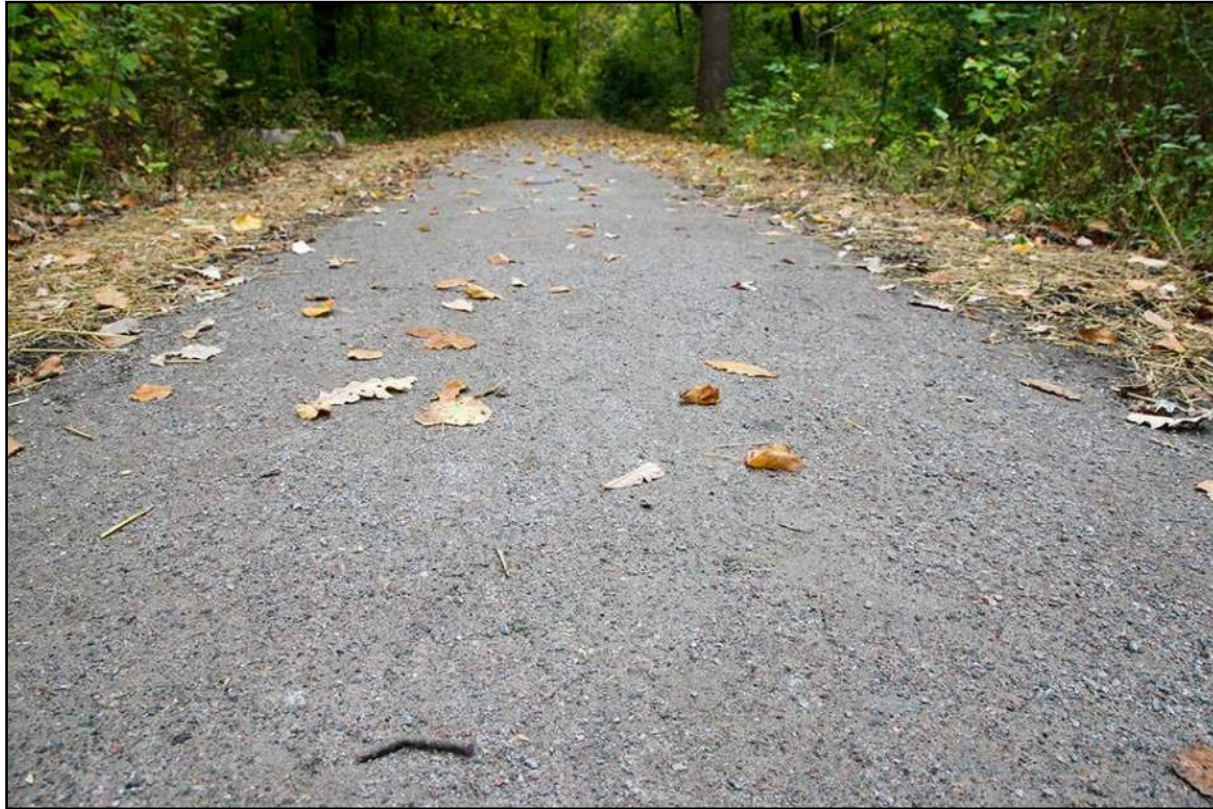
Trail Surface

*STABILIZED DECOMPOSED GRANITE
(Vendor Photo)*

- **Trail Limits** – Galena Pl. to Sherier/Nebraska Ave.
- **Replace Pedestrian Bridge (Steel Box Truss) & West Access Ramp**
- **Recommending to install HAWK Pedestrian Crosswalk Signal**
- **Install Sidewalk Improvements** on Arizona Avenue, Carolina Place and Sherier Place
- **Use Stabilized Decomposed Granite Trail Surface**
