Memorandum

From: Dan Lovas, P.E. Alvaro Calle, EIT Re: 2017 High Crash Intersections 3<sup>rd</sup> Street NW and D Street NW Summary and Next Steps

## 3<sup>rd</sup> Street NW and D Street NW

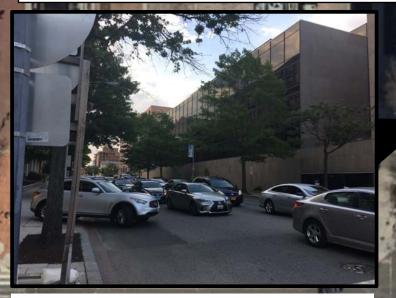
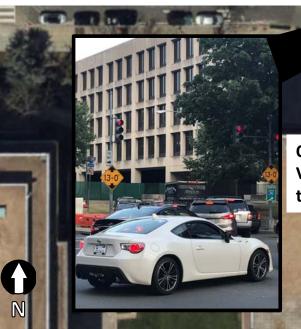
Figure 2. 3<sup>rd</sup> Street NW Observations

V4. Vehicles exiting the parking garage on southbound 3<sup>rd</sup> Street add to vehicle queuing and additional blockages.

O4. Major regional congestion on I-395. V6. Heavy left-turn southbound 3<sup>rd</sup> Street traffic.

The main issue that was noted by all participants was the heavy vehicle congestion and aggressive driving on the southbound approach of the intersection. The access to I-395 is the main contributing factor to the congestion, as the Capital Crossing project construction has rerouted additional I-395 traffic to this intersection. The vehicle queues were observed to extend for blocks north of the intersection. There are no lane configuration markings or signage at this approach, which has resulted in a defacto double left-turn lane condition entering the single receiving lane of the I-395 tunnel. This results in box blocking and a complete gridlock of traffic at the intersection during the weekday evening peak period. Many pedestrians and bicyclists are forced to maneuver around the vehicles. See Figure 2 for a detailed indication of the noted issues.

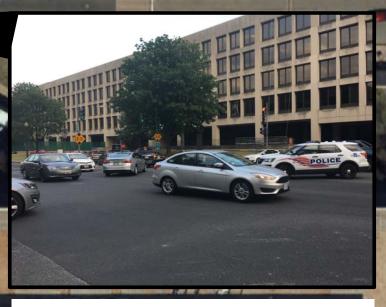
Figure 3. 3<sup>rd</sup> Street and D Street NW Observations

P4. Pedestrian platooning was observed. Majority crossing during the "Do Not Walk" indication. P1. No bisycle facilities present at intersection

**B1.** No bicycle facilities present at intersection.

V5. Vehicles were observed blocking the intersection box.

V3. Law enforcement vehicles tend to park on the channelized right turn lane.

O5. Visibility can be poor on northbound 3<sup>rd</sup> Street approach.

**O3.** Debris and damage near crosswalks.

Traffic safety issues on other approaches are primarily related to the proximity of the on-street parking to the travel lanes and the poor maintenance of the pedestrian facilities. For instance, law enforcement vehicles are parked on the channelized right-turn lane on D-Street NW, which makes right turns difficult for all vehicles. Additionally, the crash history shows most crashes occurred on 3<sup>rd</sup> Street NW south of the intersection. Collisions related to entering and exiting US Department of Labor traffic with parked vehicles and fixed-objects have been recorded at this location. Second, the pedestrian facilities were observed to have grade issues and debris blocking the crosswalk on the southeast and southwest corner of the intersection, respectively. At the west leg of the intersection, pedestrians crossing north/south have a 7-second Walk time and a 14-second Flash Don't Walk time. Pedestrians do not clear the intersection in their allotted time and are affected by the conflicting I-395 entering traffic. See Figure 3 for a detailed indication of the noted issues.

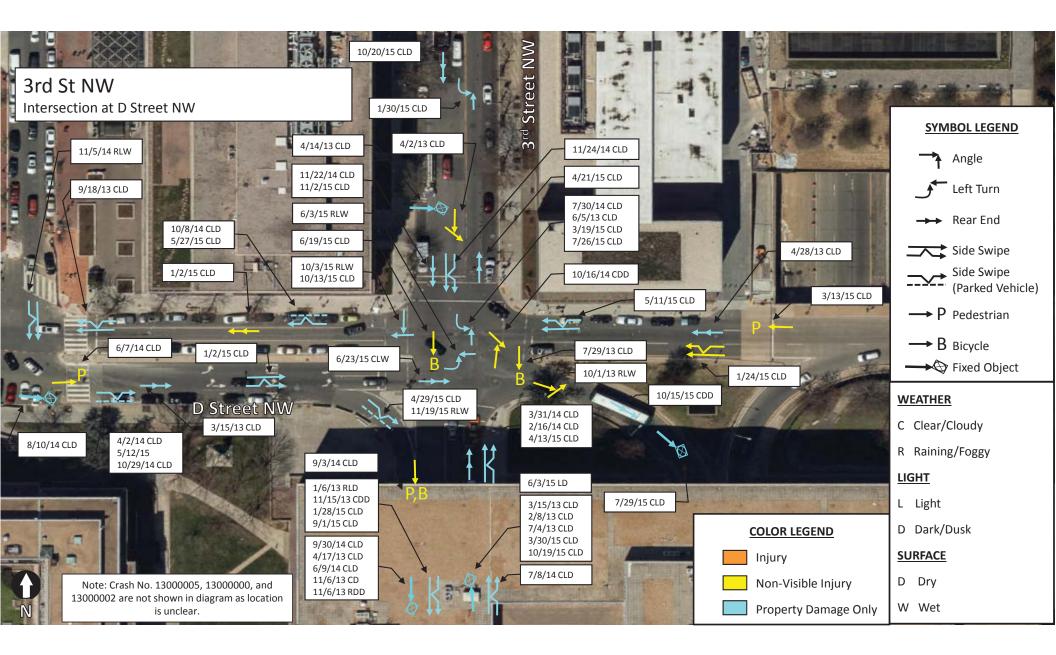
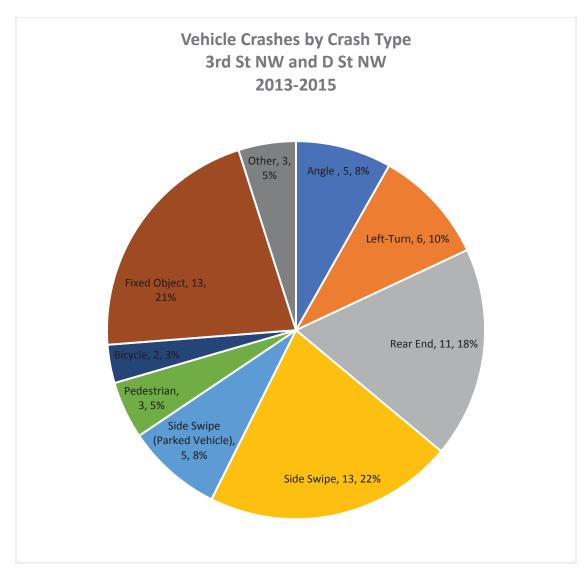
Appendix B – Crash Diagram

**61 Total Crashes**

From January 2013 to December 2015, 61 total crashes were reported at this intersection. Approximately 30 percent of the crashes were sideswipe collisions with a parked or non-parked vehicle. This crash type is common in locations where drivers quickly change lanes or where on-street parking is allowed. About 21 percent of the crashes were fixed object collisions. The severity of the crashes at this intersection is low, as there were no fatalities and the 10 injury crashes resulted in non-disabling injuries. See Appendix B for a crash diagram and the summary report of the crashes at this intersection.
