**Potential Transportation Problems  
Stanton Park -1**

## Potential Transportation Problems Stanton Park -2

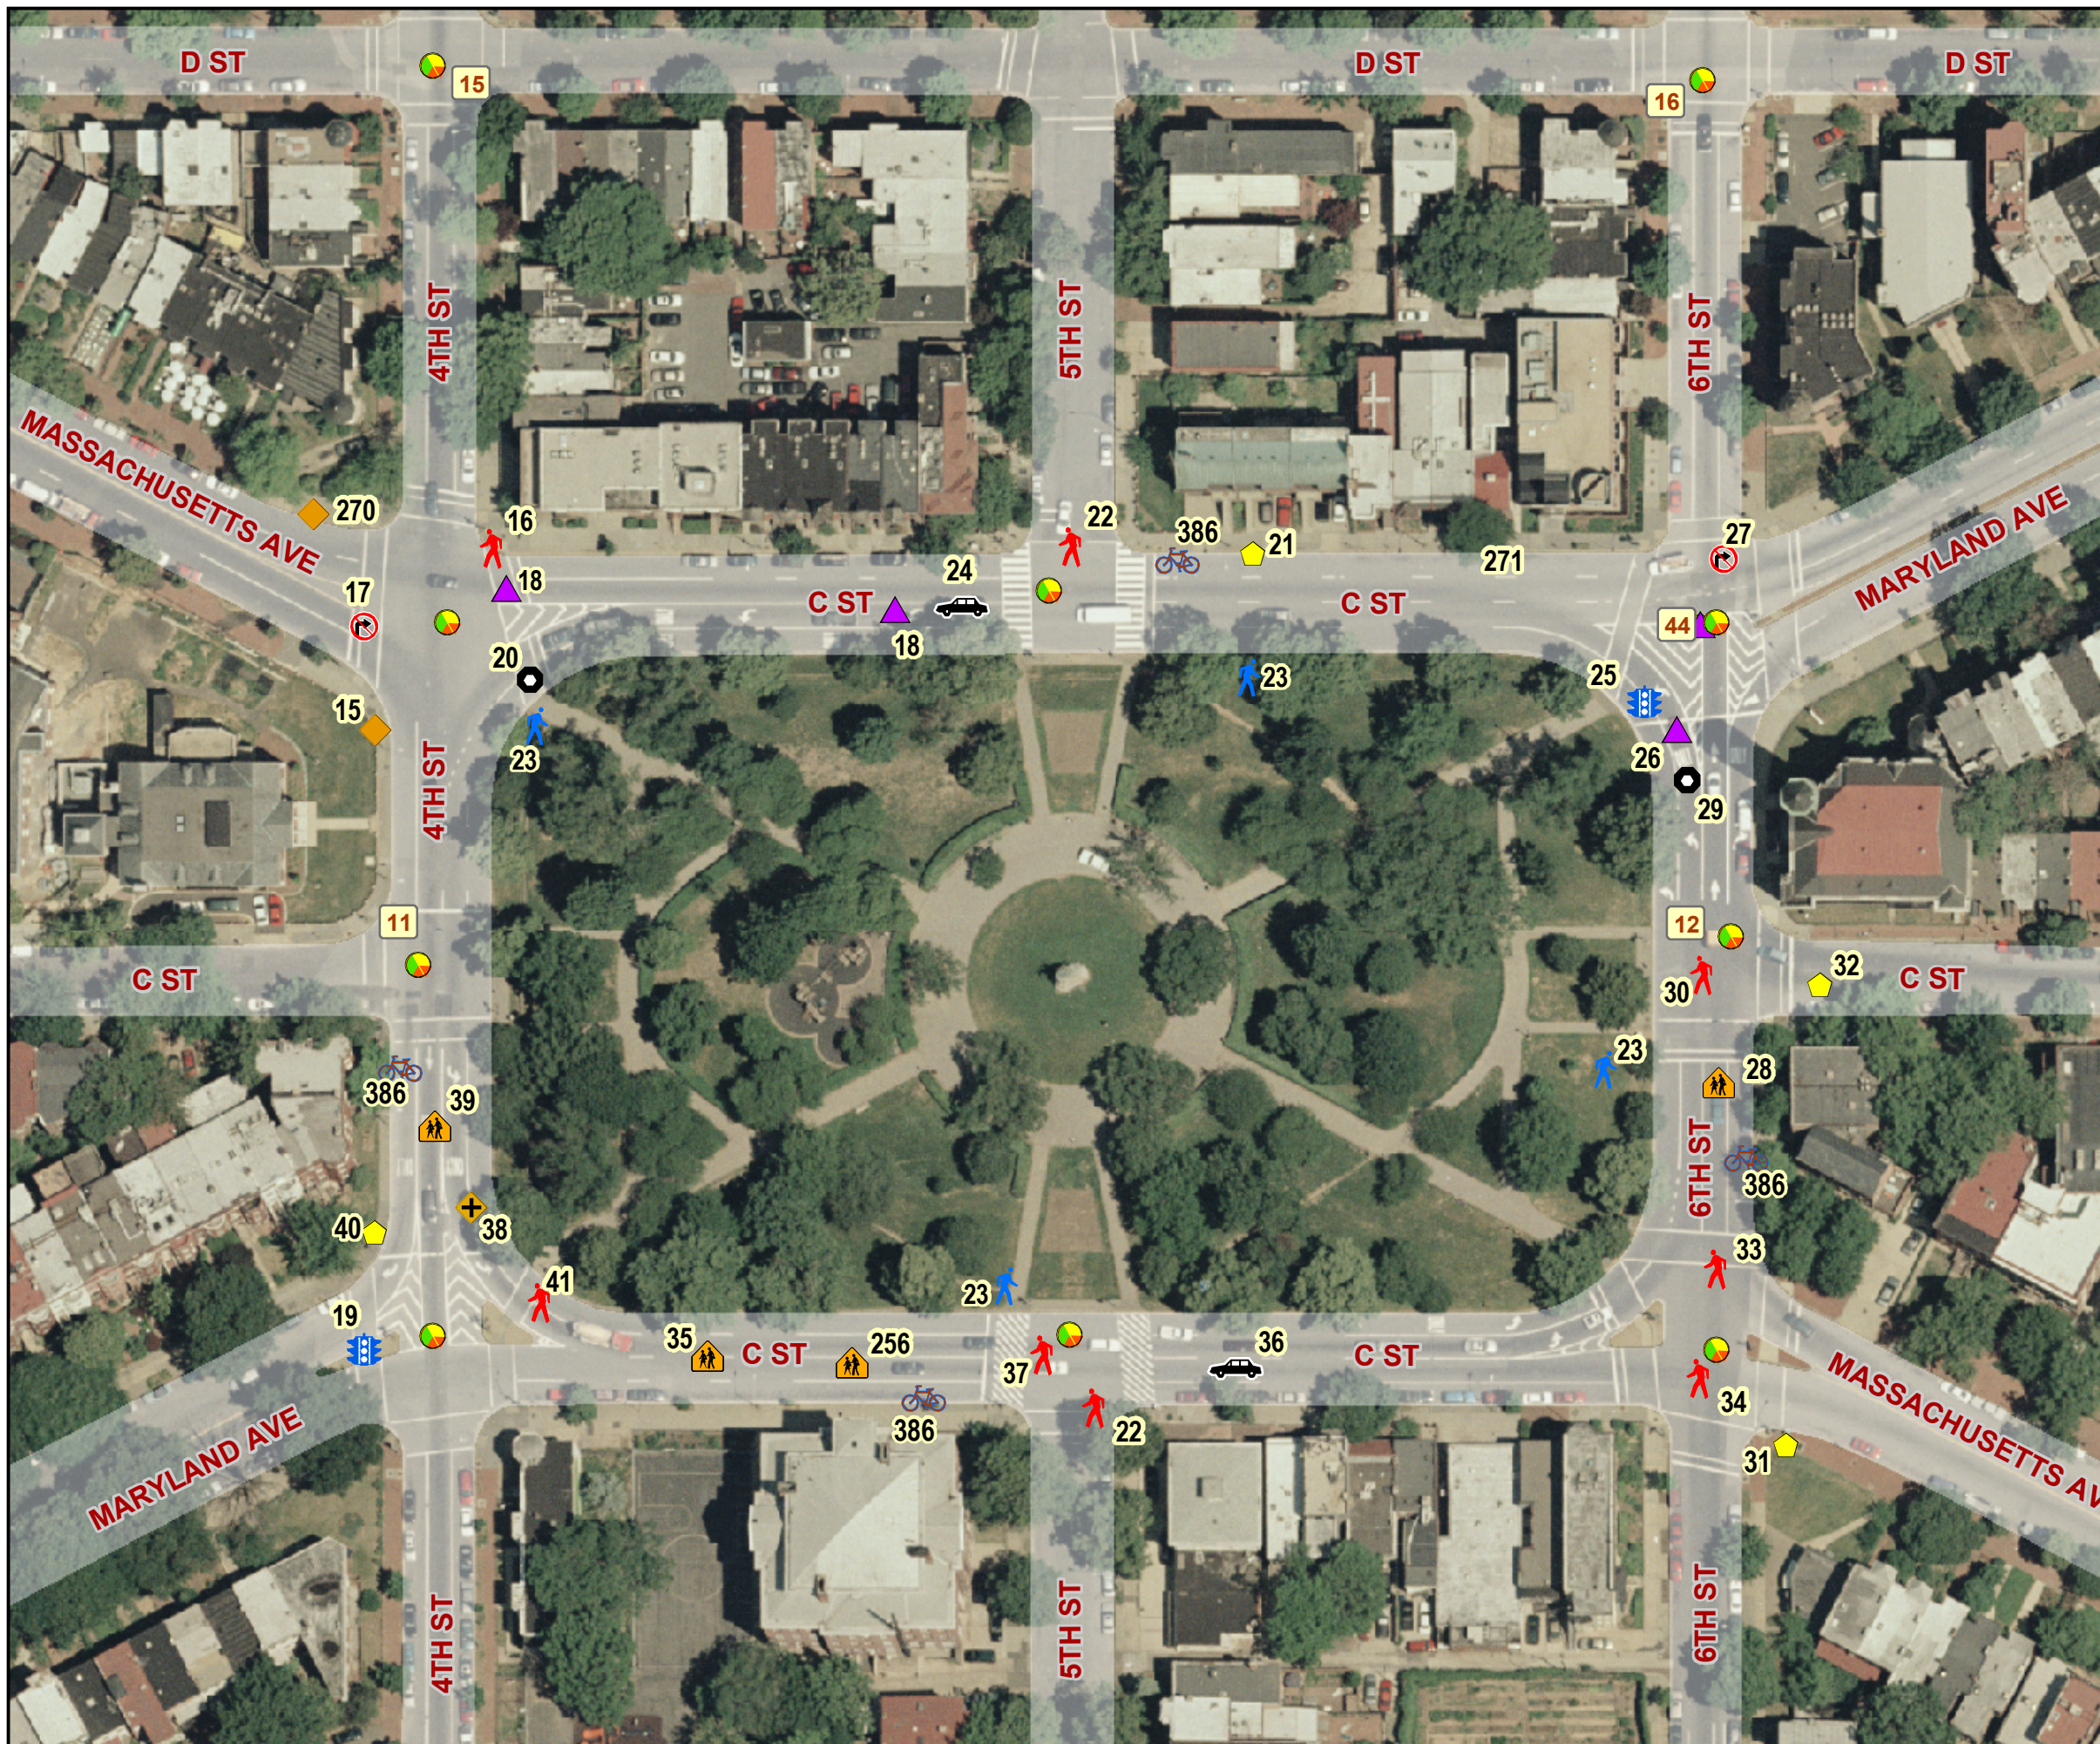
Figure 7-5a

**Traffic Volume Count Location**
- 15** Sign showing 'left on green only' is placed too low for drivers making a left on 4th Street NE from C Street NE to see. Some drivers miss the sign.

- 16** Narrow ADA ramps at the northeast and northwest corner of the intersection of 4th Street NE and C Street NE; no ADA ramps or crosswalk to enter park at NW corner.

- 17** Traffic does not yield to pedestrians.
- 18** Vehicles weaving.
- 19** Signal timing strands pedestrian on narrow island.
- 20** Stop bars not painted.

- 21** Curb cuts along North side of C St.
- 22** Pedestrian signal heads are not countdown.
- 23** No sidewalk along the perimeter of the park. Note: Pedestrians have formed a path along the perimeter of the park.

- 24** Cars drive above the speed limit on C Street NE between 4th Street NE and 6th Street NE on the north side of Stanton Park.
- 25** Vehicles run red light traveling northbound on 6th Street NE making a left turn on C Street NE, and also vehicles traveling westbound on Maryland Ave NE.

- 26** Northbound vehicles on 6th Street NE queue on two lanes but most of these vehicles want to turn right onto Massachusetts Avenue northbound, creating a dangerous weave.

- 27** Traffic does not yield to pedestrians.
- 28** Sign shows speed limit to be 15 mph when children are present.
- 29** Vehicles traveling northbound on 6th Street NE and making a left turn on C Street NE do not stop at the stop bar.

- 30** Crosswalk only at south side, no ADA ramp on park side.

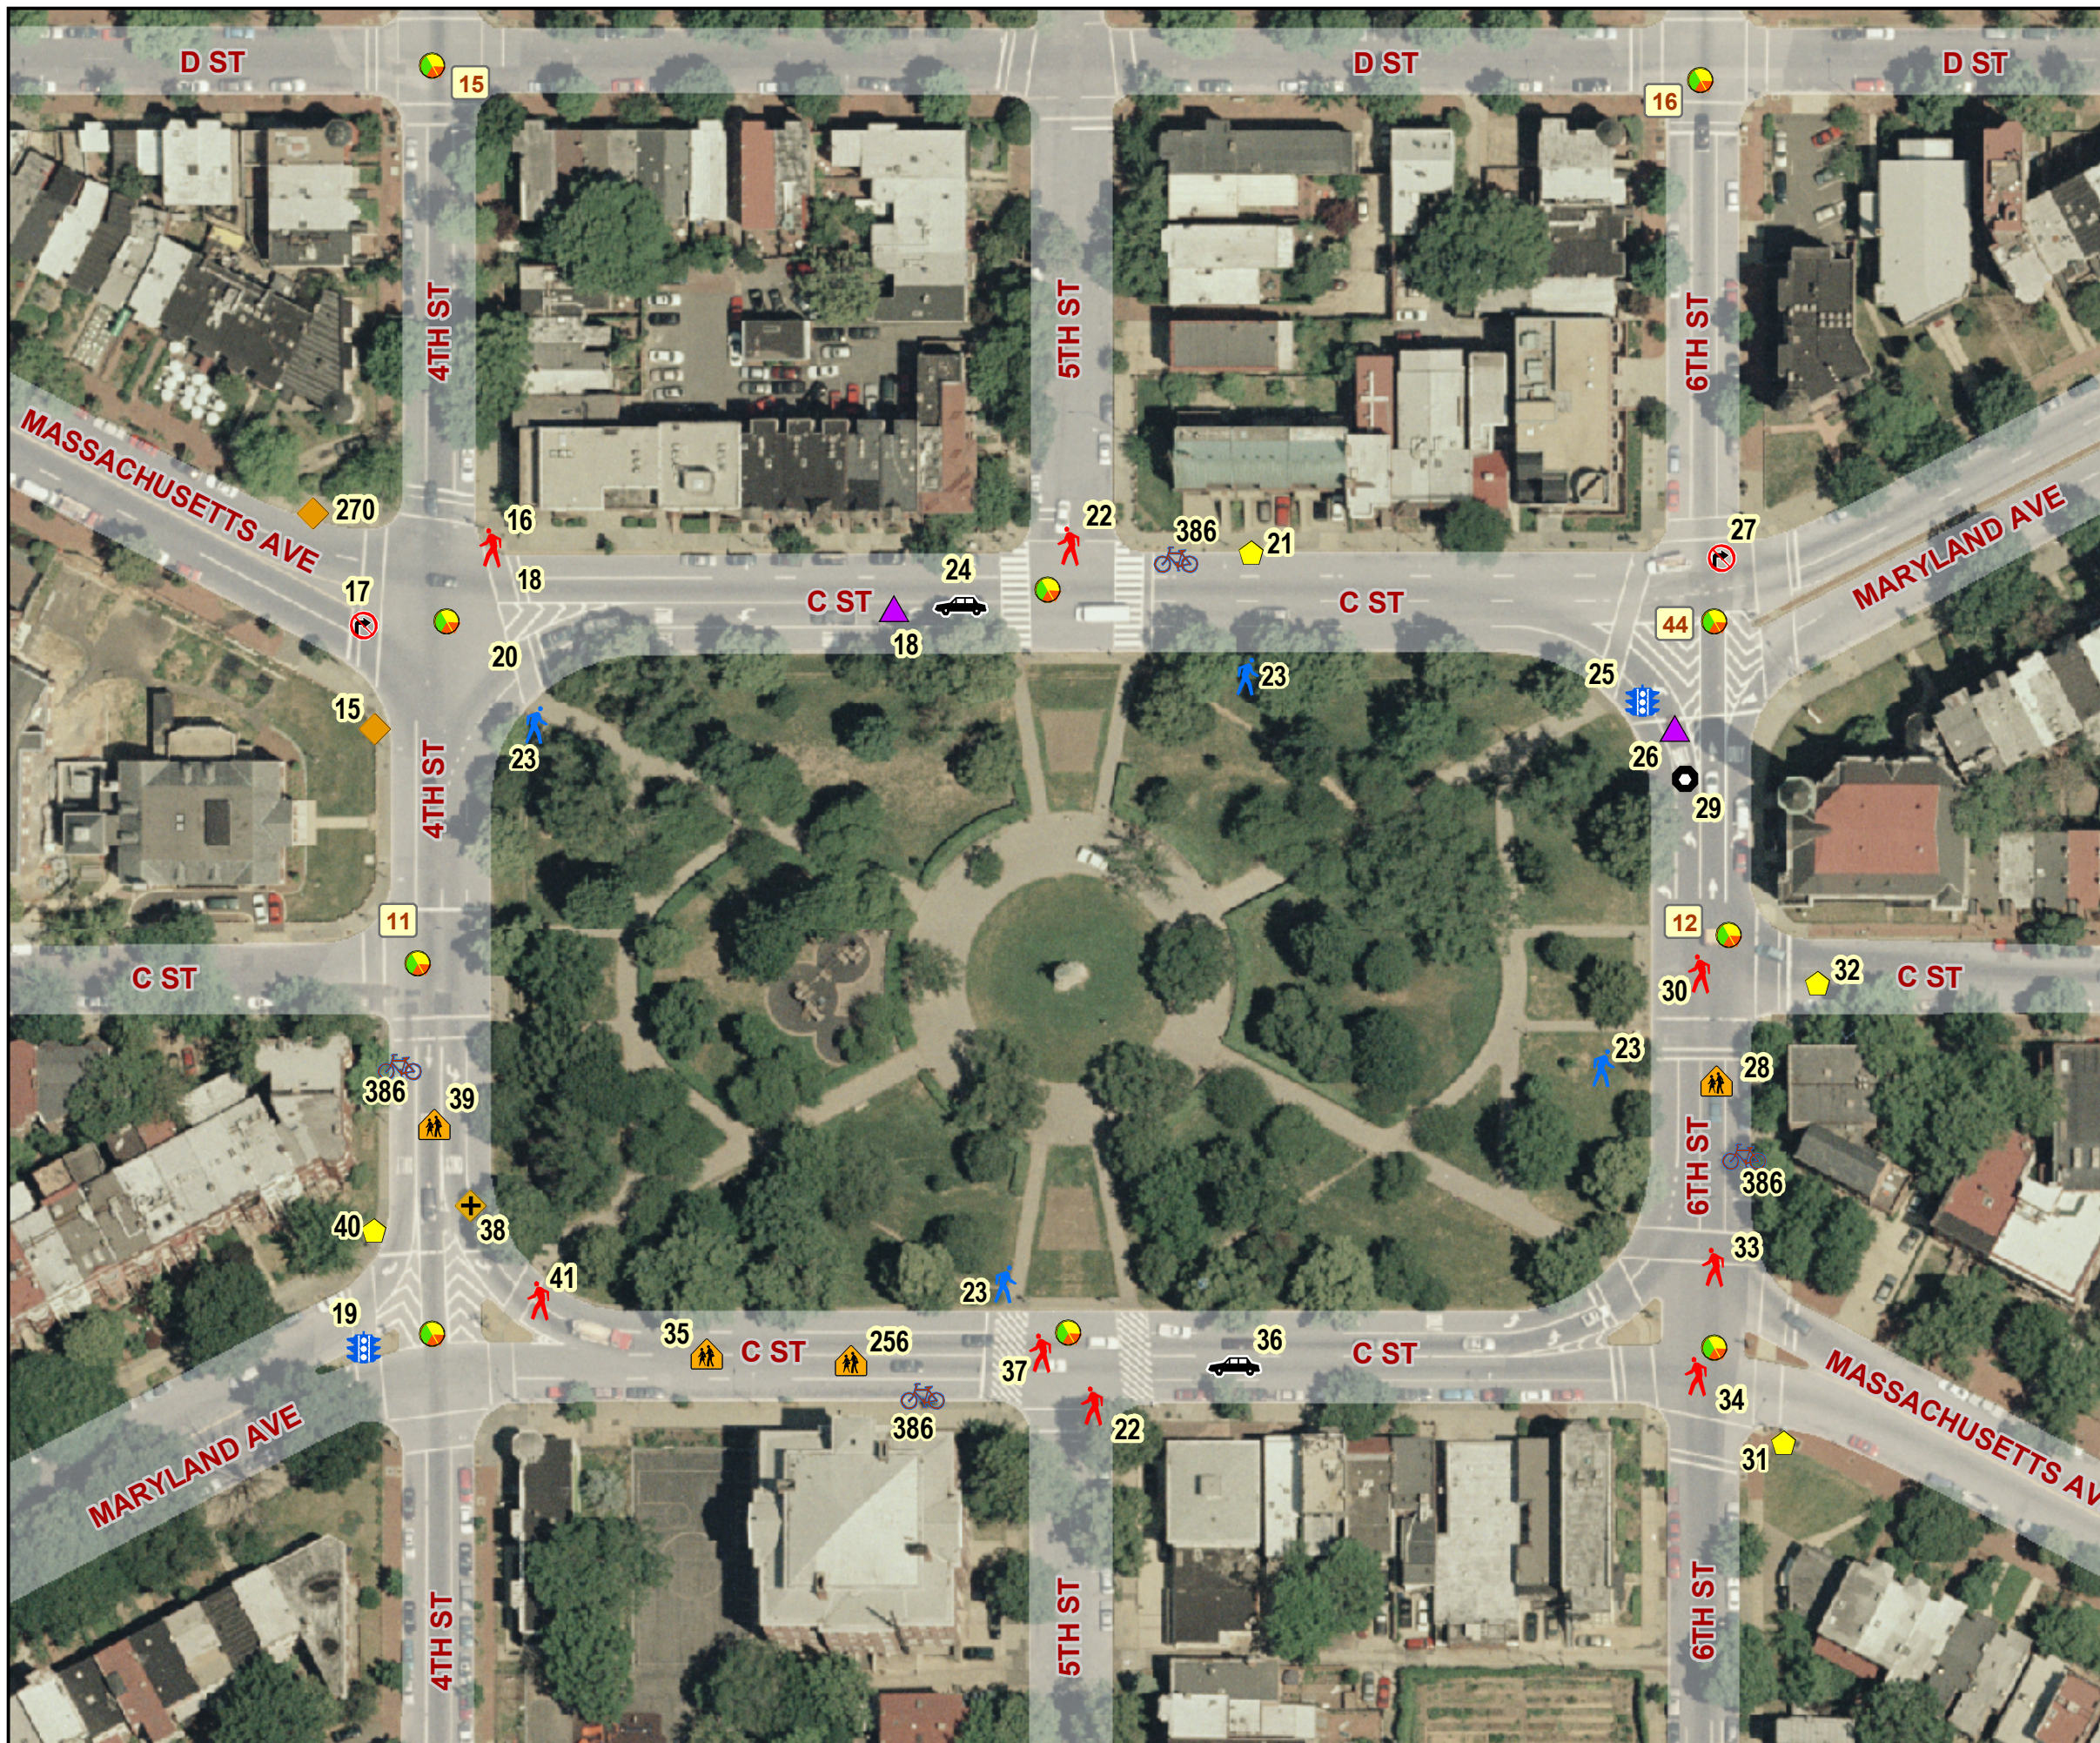
Figure 7-5b

**Traffic Volume Count Location**
- 31** Damaged sidewalk.
- 32** C Street traffic backs up: Two lanes form at C St. WB approaching 6th St. where there is only one designated travel and bike lane.

- 33** Pedestrians crossing 6th Street NE into Stanton Park from Massachusetts Avenue NE are at risk from drivers who run the red light making right turn from Massachusetts Avenue NE onto 6th Street NE.

- 34** Insufficient pedestrian crossing time.
- 35** There is no sign indicating speed limit 15 mph when flashing along C Street NE between 4th Street NE and 5th Street NE on the south side of Stanton Park.

- 36** Cars drive above the speed limit between 4th Street NE and 6th Street NE along C Street NE on the south side of Stanton Park.
- 37** Faded crosswalk paint.

- 38** Problem with signal timing allowing vehicles traveling south on 4th Street to turn left onto C Street toward Peabody Elementary School, while conflicting Maryland Avenue traffic still have a green light.

- 39** There is no speed limit sign for school zone along 4th St. between Massachusetts Avenue and Maryland Ave.
- 40** Sidewalk not ADA compliant at west side of 4th.

- 41** Poor visibility at pedestrian crossing into park from SW corner.
- 256** Speed limit sign for school zone on Maryland Avenue at 5th Street does not have a flashing beacon.

- 270** "Do Not Enter" sign on NW corner should not exist at location.
- 345** Enforcement of residential parking laws.
- 386** Need Bike lanes around the parks.
