Potential Transportation Problems

7th Street / 8th Street / Constitution Ave / Massachusetts Ave NE

Capitol Hill Transportation Study

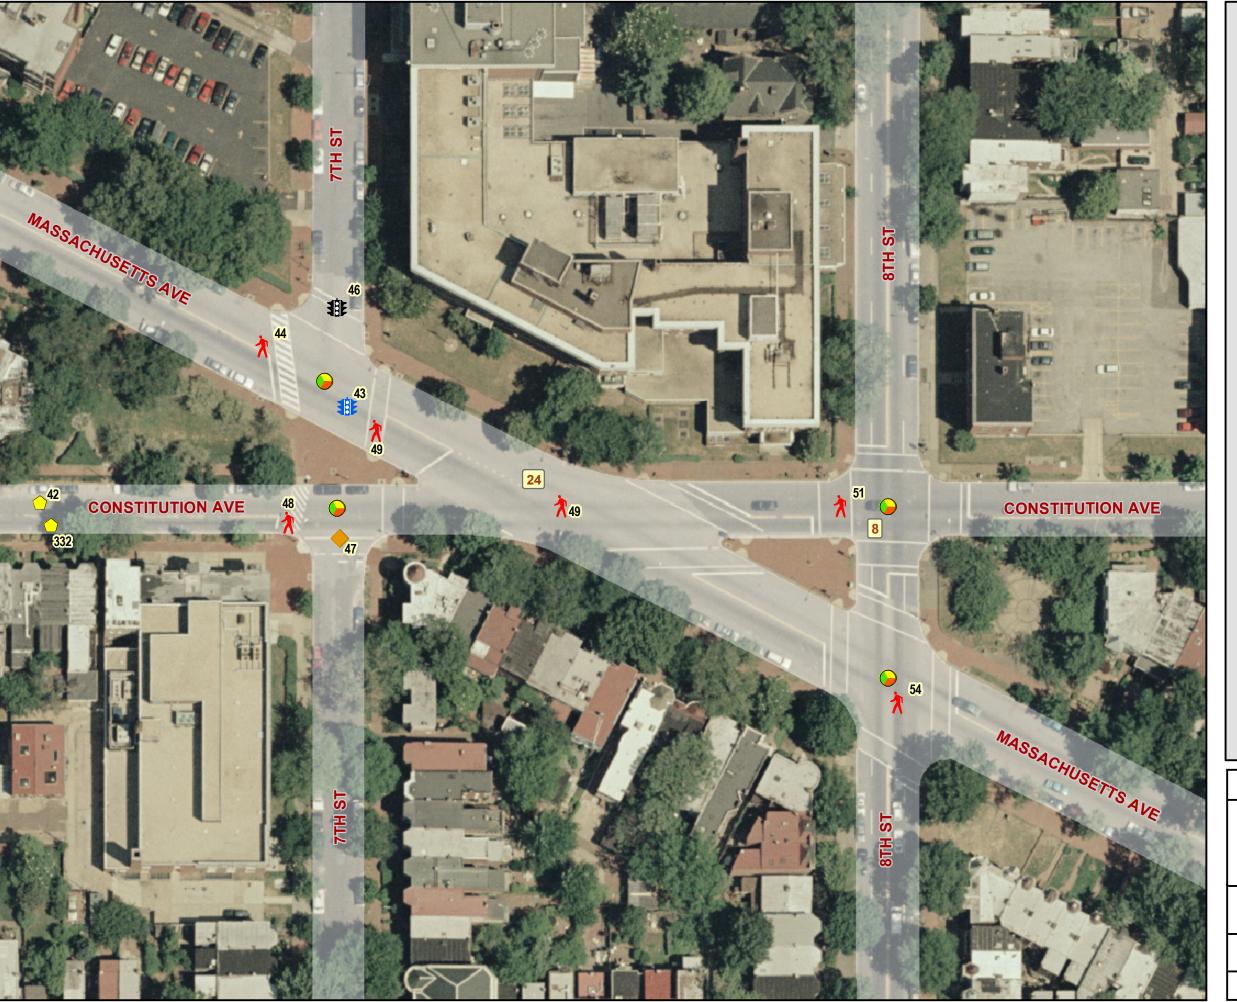
Figure 7-7

Signalized Intersection

- 42 The 'Do Not Enter' sign on Constitution Avenue located 300 feet east of the intersection of 7th Street NE and Constitution Avenue is placed on the wrong side; its not visible by the people coming from the alley.

- **43** Traffic signal timing at the intersection of Massachusetts Avenue and 7th Street NE needs to be changed to improve traffic flow.
- **44** Lack of pedestrian signal head on southbound Massachusetts Avenue.

- **46** Intersection is not fully signalized (7th has stop sign)
- 47 Inadequate signing for the southbound approach at the intersection of 7th Street and Constitution Avenue.

- **48** No pedestrian signals at this intersection
- **49** Due to signal phasing, pedestrian cannot safely cross southbound Massachusetts Avenue at any time.

- **51** Pedestrian crossings are confusing.
- **54** No pedestrian signals, pedestrians are unable to see traffic signals.
- 332 Allow parking on both sides of the street.
