2016 High Crash Intersection Site Visits

Summary and Next Steps

February 2017

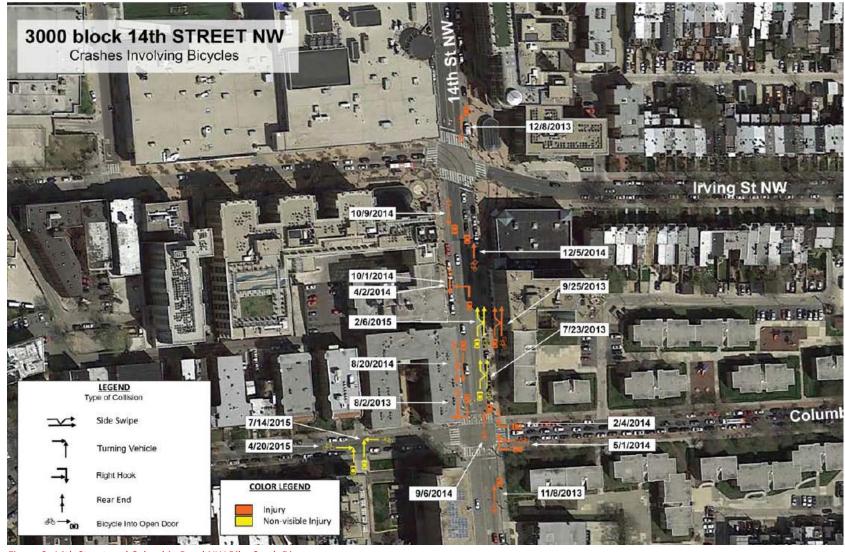
Figure 9. 14th Street and Columbia Road NW Bike Crash Diagram

was a factor in one collision, and alcohol/drugs in three of the crashes. Figure 8 provides the summary report of crashes at this intersection. The seventeen bicycle collisions at 14th Street and Columbia Road makes this intersection the second highest intersection in the city for bicycle crashes. Analysis of sixteen of the seventeen bicycle crash reports revealed that the two most prevalent crash types were dooring-related (31 percent) and sideswipe crashes (25 percent). Figure 8 provides a collision diagram for the bicycle crashes at this intersection.

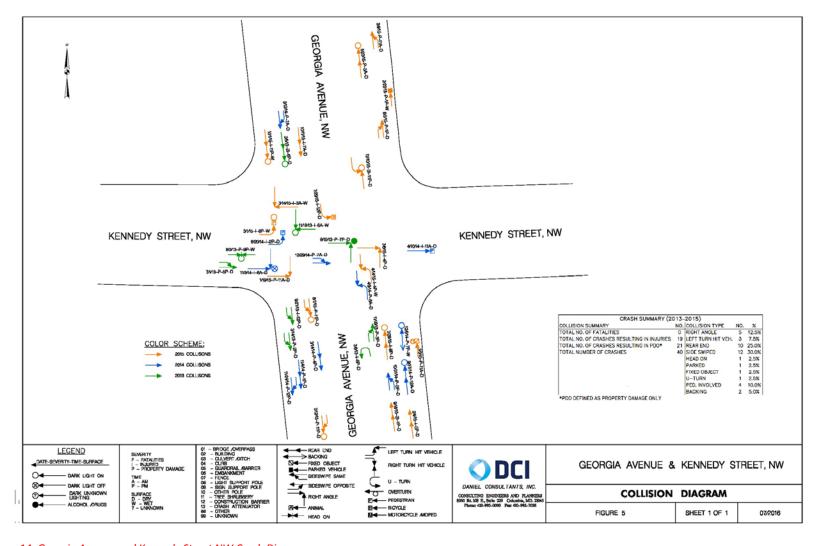
Figure 14. Georgia Avenue and Kennedy Street NW Crash Diagram

report of crashes at this intersection. Figure 14 provides a collision diagram for the crashes at this intersection.

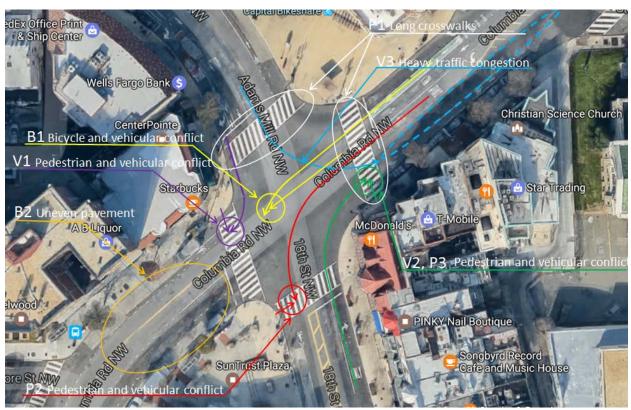
Figure 23. 18th Street and Adams Mill Road NW Site Visit Observations

On Thursday, June 2, 2016, beginning at 4:30 PM, site visit participants identified issues related to all travel modes. Some may only require minor fixes while others could require more substantial capital improvements. Many require further investigation and evaluation by DDOT.

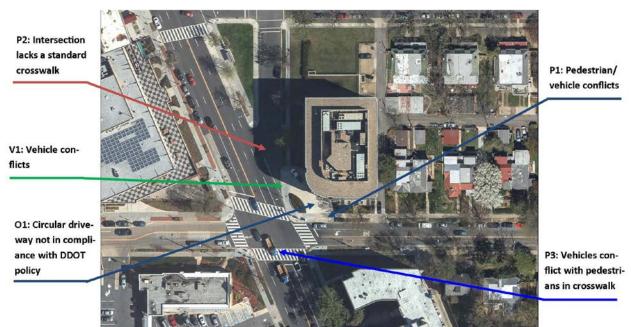
Figure 31. Wisconsin Avenue, Van Ness Street, and 39th Street NW Site Visit Observations

On Wednesday, August 18, 2016 beginning at 8:30am, participants identified issues related to all travel modes. Some may only require minor fixes, while others may require more substantial capital improvements. Many require further investigation and evaluation by DDOT. The timeline for next steps is included in the next section.
