Subject Foundry Branch Trestle Feasibility Study

Project Name Palisades Trail Feasibility Study

Date December 2019

Attachment A - Foundry Branch Trestle Inspection Report

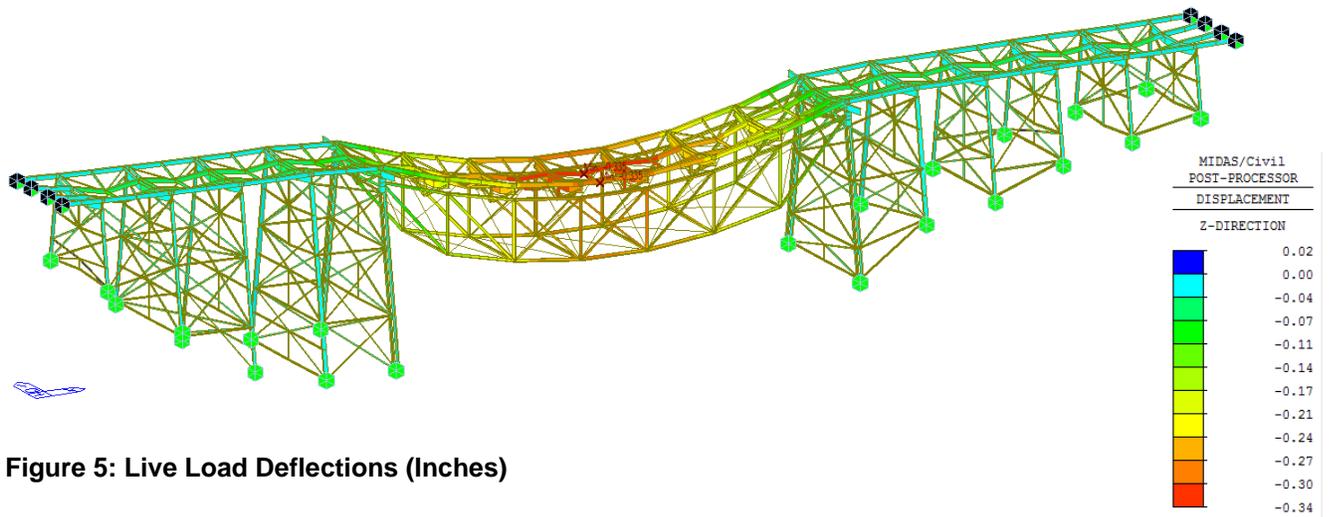
Figure 5: Live Load Deflections (Inches)

The maximum deflection under unfactored pedestrian live loading is 0.34 inches (Figure 5). The maximum allowable deflection is span/360 (AASHTO Guide Spec for the Design of Pedestrian Bridges) or 3.33 inches (100-ft trestle span). Truss deflections are therefore well within that allowed by AASHTO LRFD.

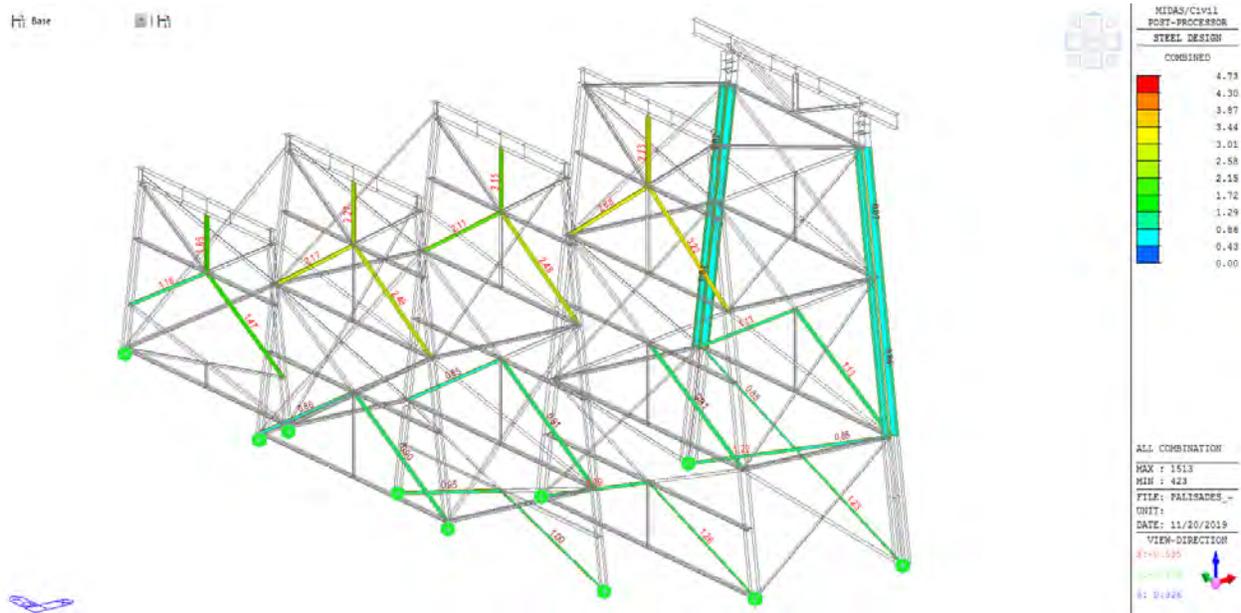
Figure 6: West Approach Results (Utilizations > 0.8 Shown)

- Figure 6 – Bracing members in the plane of the supporting columns at Gridlines 1 to 4 have utilizations greater than 1.0. The maximum utilization is 2.73.

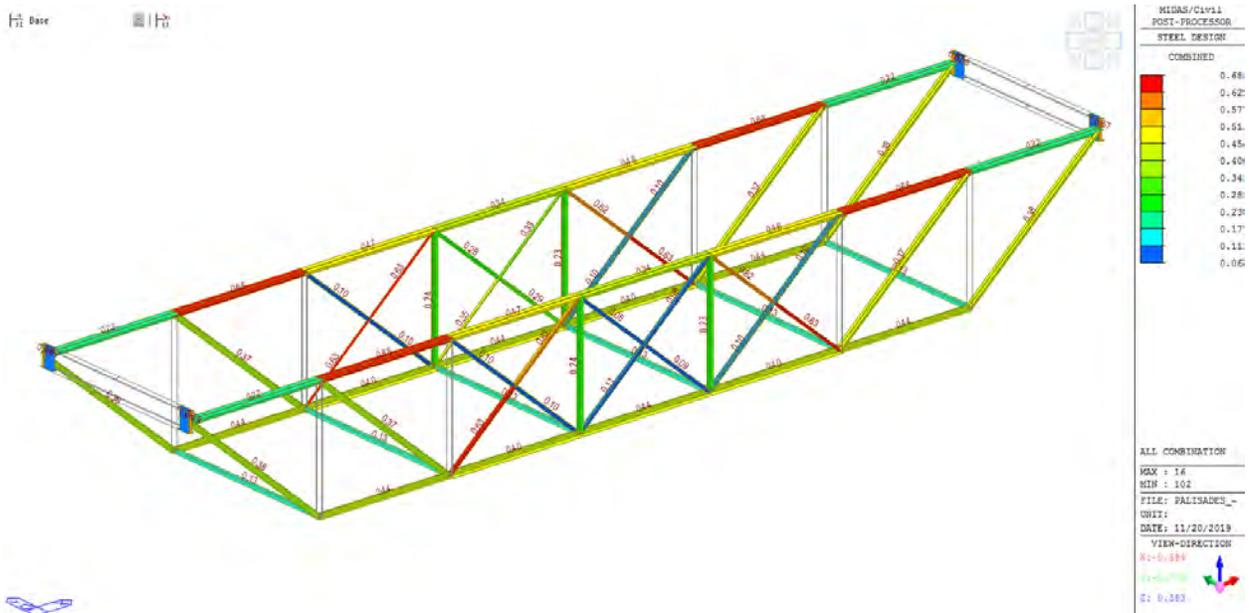
Figure 8: Truss Results (All Utilizations Shown)

- Figure 7 – Bracing members in the plane of the supporting columns at Gridlines 13 to 17 have utilizations greater than 1.0. The maximum utilization is 4.37.
- Figure 8 – The maximum member utilization in the truss is 0.68 in its top chord.
- Figure 9 - The maximum member utilization in the deck is 0.99 at a diagonal bracing member. The 10-inch deep longitudinal deck members typically have utilizations less than 0.7.

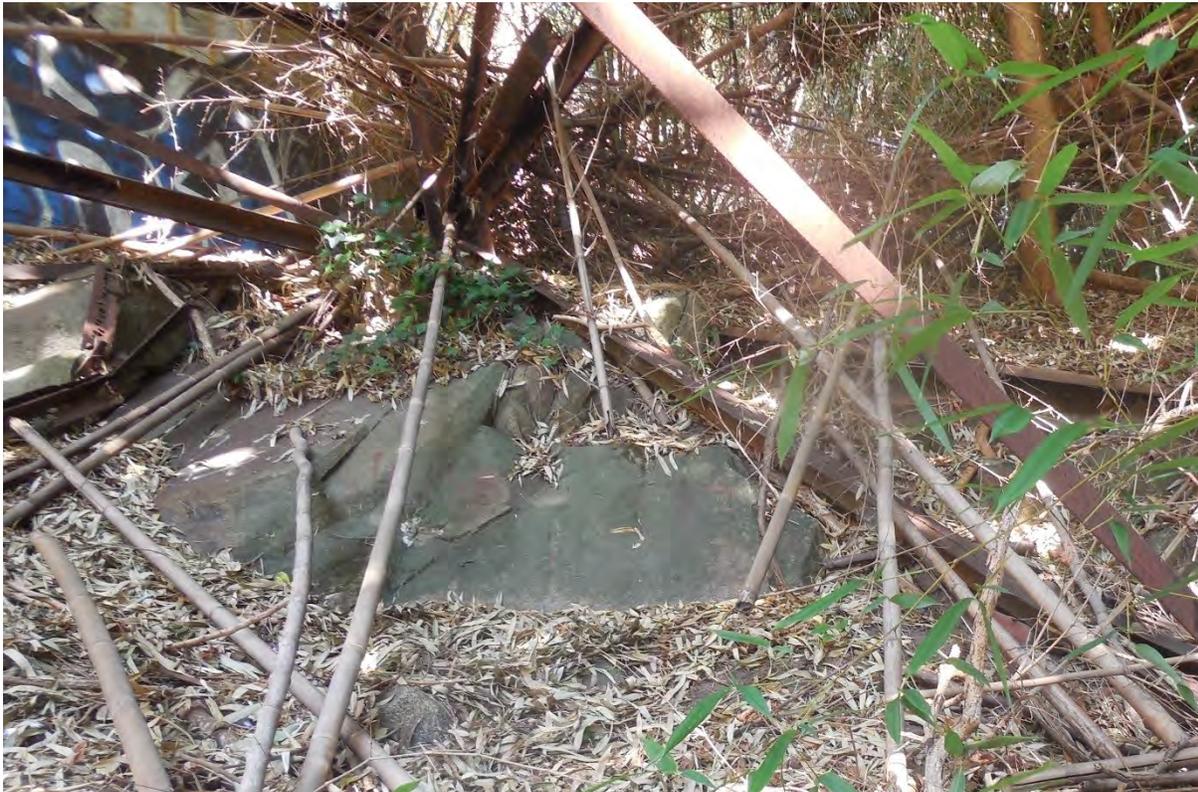
Figure 13: Rock Outcrop at Gridline 2/3

The subsurface conditions are extracted from the historical borings performed in 1981 for the design and construction of a 9' diameter crosstown watermain (see Attachment C). The closest available boring (B-2A) shows a top layer consisting of stiff to very stiff silt and clay fill with a thickness of about 15 feet and with SPT blow counts between 9-18 blows-per-foot (bpf). This fill layer is underlain by a medium dense to very dense sandy layer with blow counts between 11 and >50 bpf. The top of the rock in this boring is approximately 26 ft below the existing ground surface. However, it appears that the top of bedrock elevation at the site varies substantially as based on field observations, the bedrock appears to be outcropping at the ground surface in the area of the existing west abutment (Figure 13).

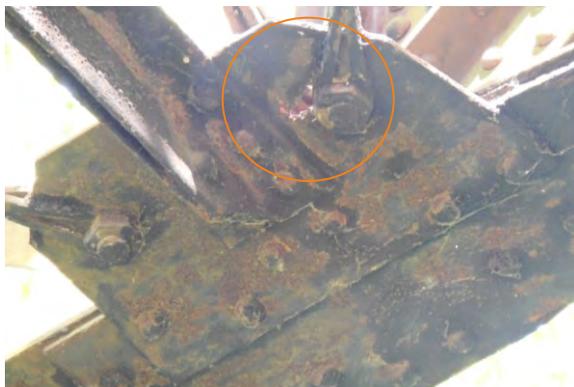
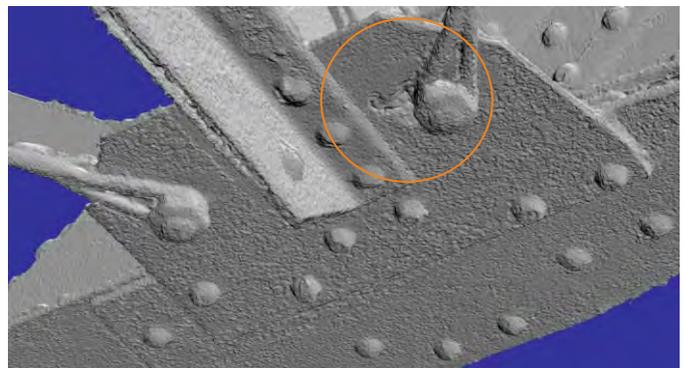
Figure 3.4: View of Gusset Detail from Photo and Model (Gridline 10 – North level -2)

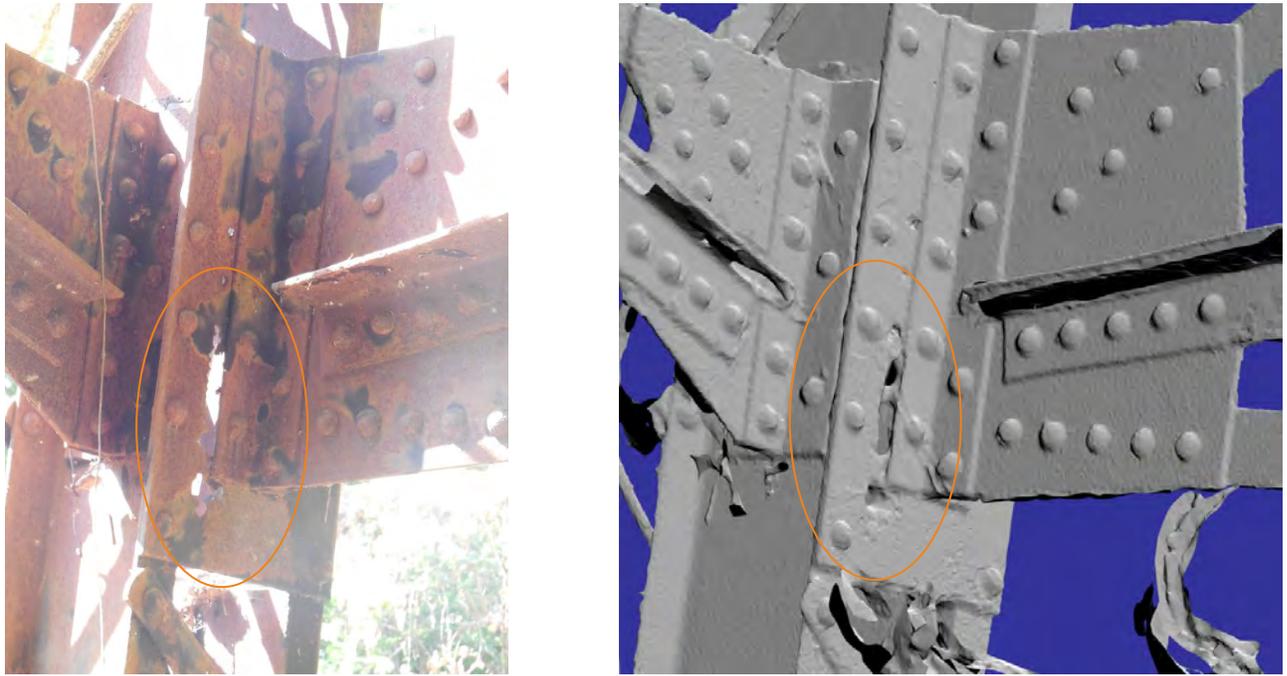
Figure 3.5: View of Gusset Detail from Photo and Model (Gridline 12 – South level -4)

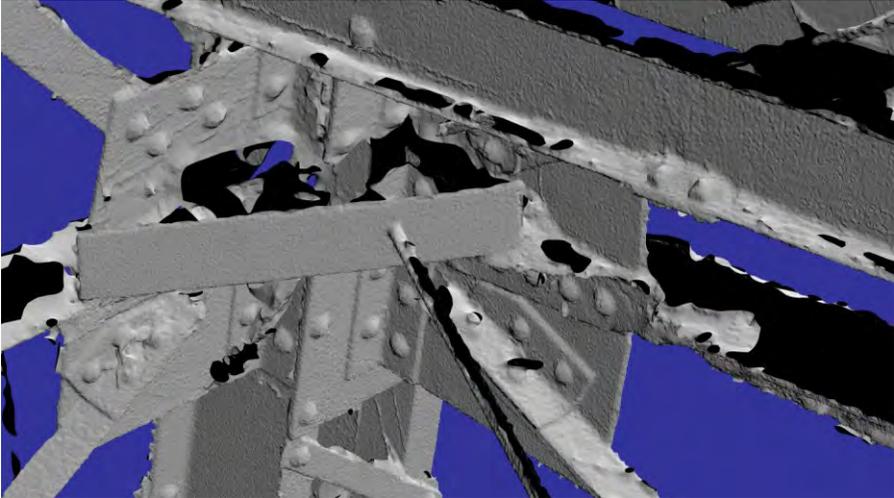
Figure 3.6: Missing Data

The 3D cloud was obtained from data taken at thirty-six survey locations dispersed around the bridge and as high up the approach slopes as possible. The combined data allowed most of the 3D geometry of members to be shown in the resulting reality mesh. Back faces of members from one survey setup are caught at a different setup and combined in the reality mesh. The multiple survey setups are why there is so much data for the 3D cloud as one point in space may be covered multiple times. Areas that do not get covered by the survey are shown in the reality mesh as missing (Figure 3.6). This sometimes led to confusion over areas of the bridge that were corroded through, versus missing data. This was corrected through physical inspection on site and review of photographs.

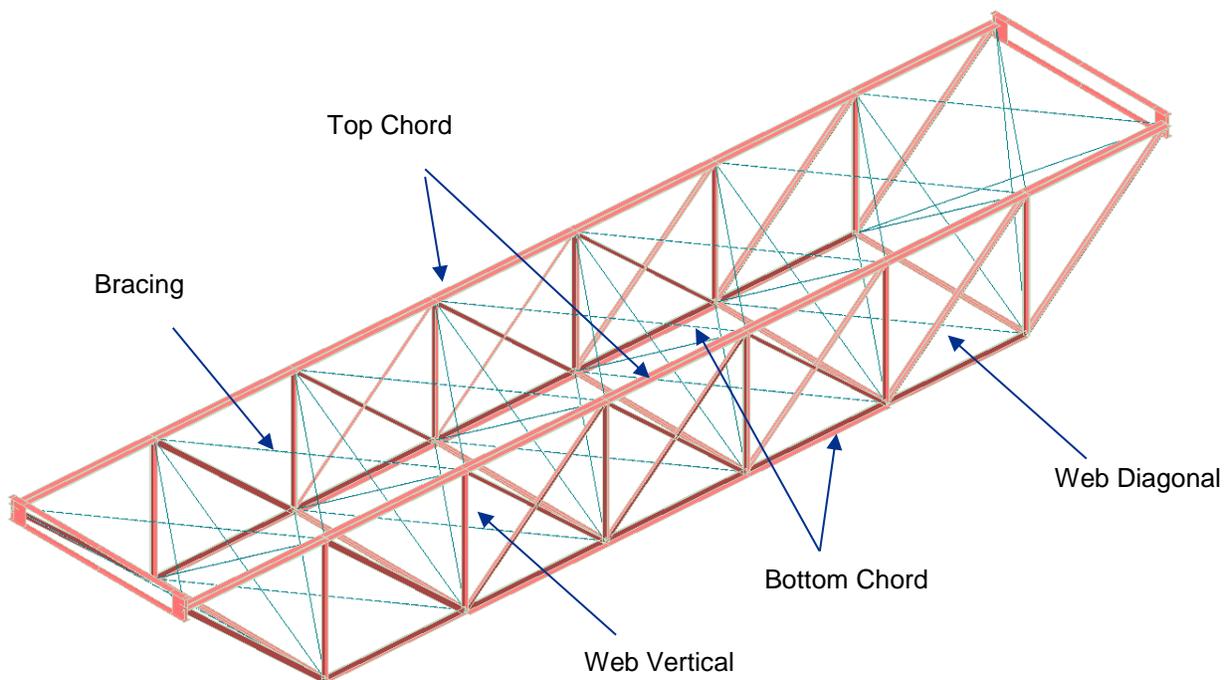
Figure 5.10: Suspended Truss

The truss assembly is composed of double angle chords members and single/double angle or double t web sections. The truss span was inspected through a combination of visual inspection using a telephoto camera lens, and inspection of the 3D reality mesh.

Inspection of the chords did not identify any areas of corrosion greater than surface rusting. In many places the original paint coating is still visible.

Inspection of the web verticals and diagonals did not identify any areas of corrosion greater than surface rusting. In many places the original paint coating is still visible.
