## Memorandum

Project #: 38559.01

Re: 2017 High Crash Intersections MLK Jr. Avenue and Good Hope  
Road Summary and Next Steps

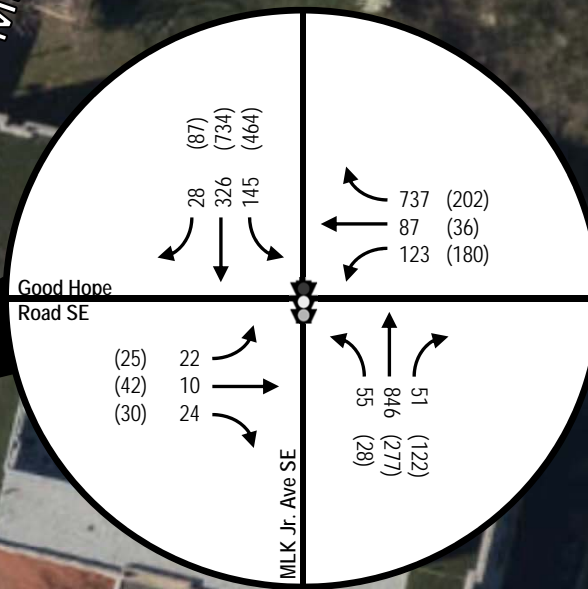
Intersection at Good Hope Road SE

**O1.** Difficult to see far-right signal head on westbound Good Hope Road approach. No Turn on Red sign on mast arm is also not visible.  
**O2.** Roadway markings are missing from left lane of the westbound Good Hope Road approach.

**V4. Heavy left-turn turning traffic from the southbound MLK Jr. Avenue approach. Vehicles were observed to be frequently speeding while turning from intersection.**

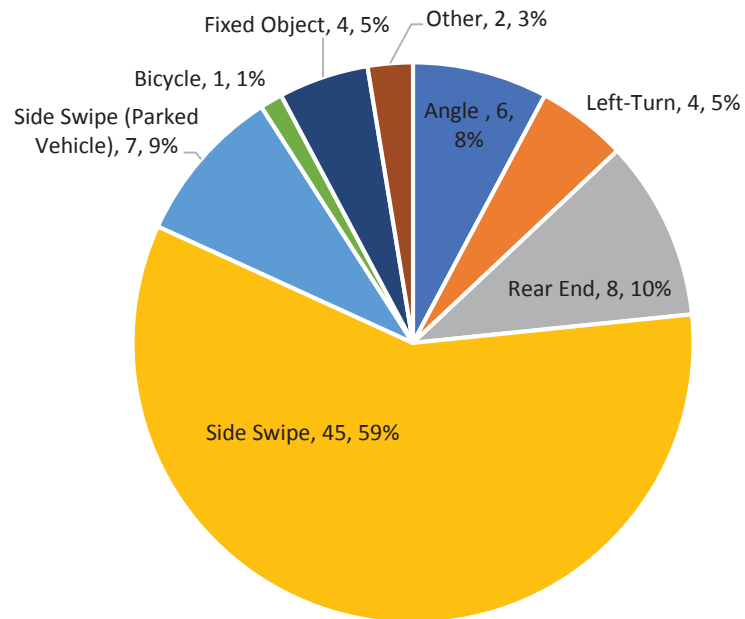
# Vehicle Crashes by Crash Type MLK Jr. Avenue SE and Good Hope Road SE 2013-2015

**77 Total Crashes**
