MEMORANDUM

То:	Emily Dalphy
	District Department of Transportation (DDOT)
From:	Daniel Markham, P.E. Tracy Lower, P.E. Kimley-Horn and Associates, Inc.
Date:	September 7, 2017
Subject:	High Crash Site Review Summary Memo Southern Avenue SE and Wheeler Road SE

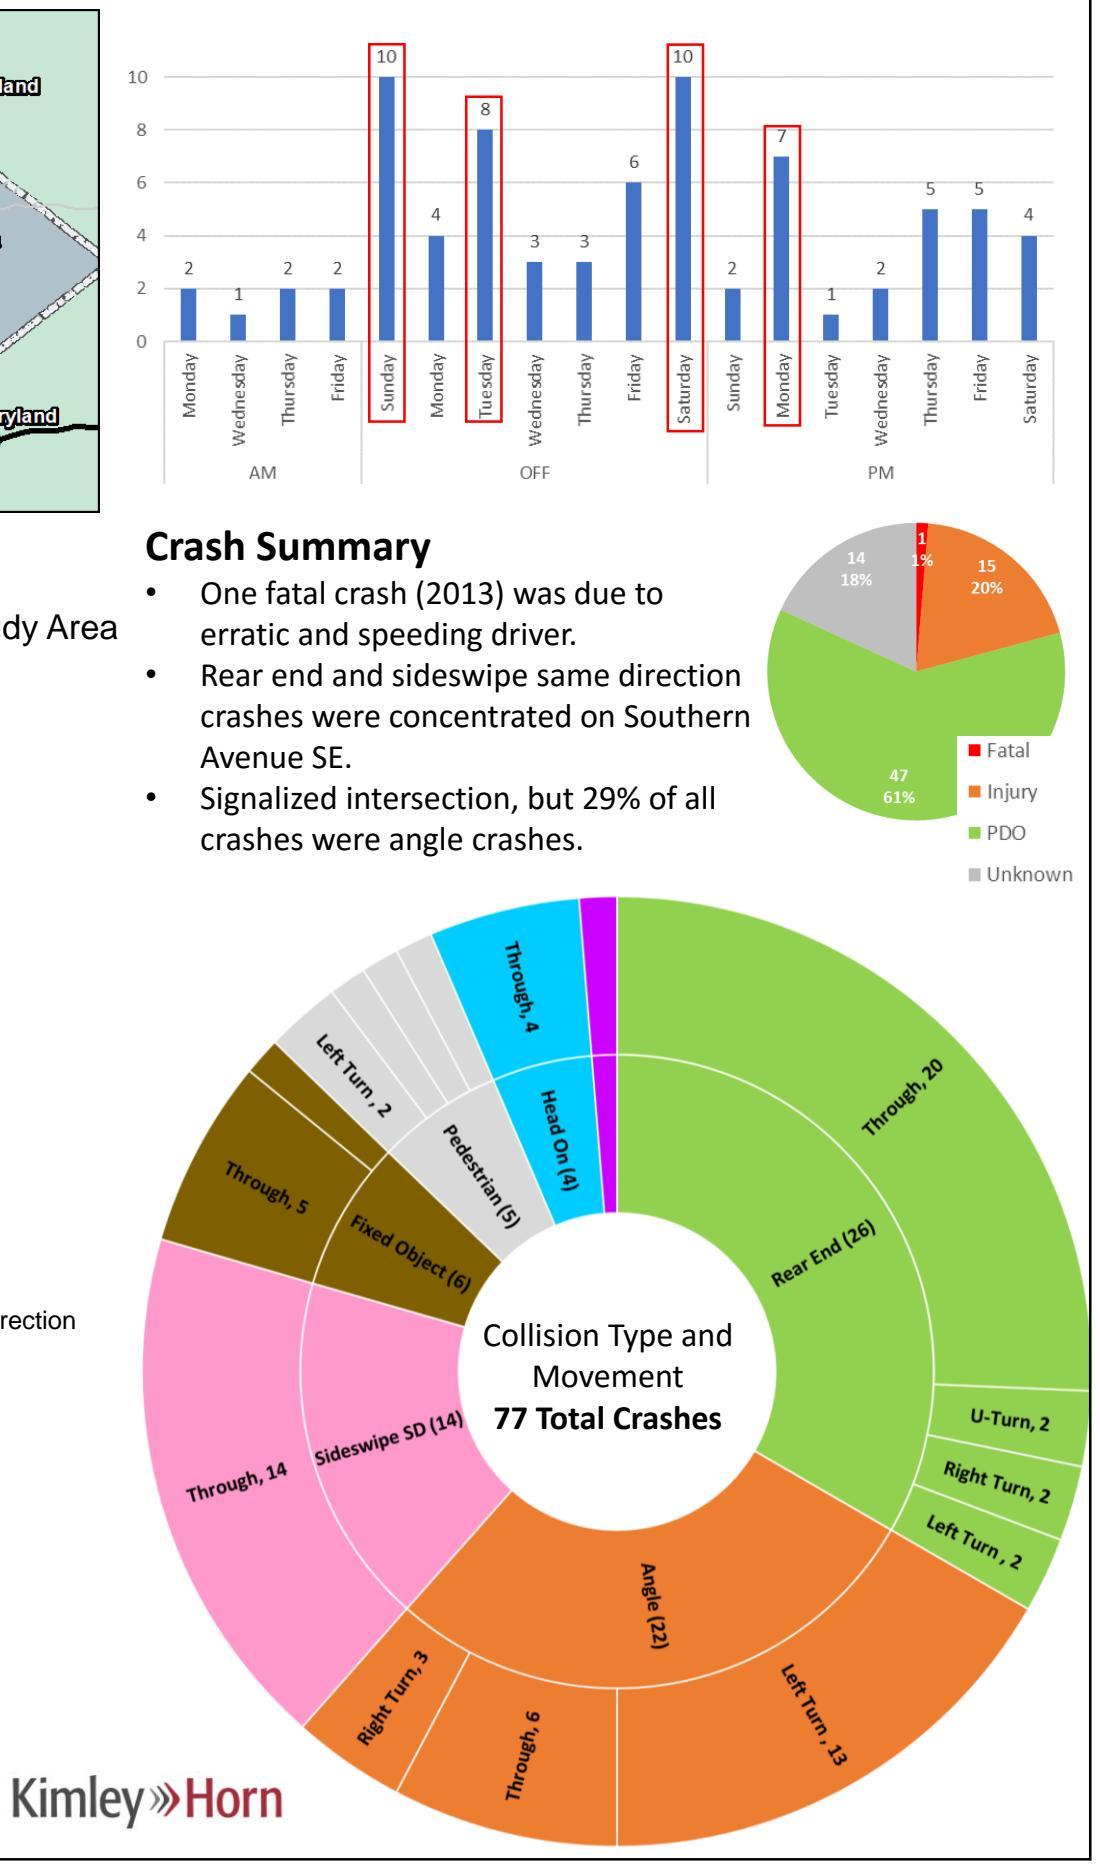
Figure 3: Summary of Field Observations and Associated Crash Types – Southern Avenue SE and Wheeler Road SE

Figure 3 further identifies some key crash types and indicates other field observations noted during the site visit that relate to safety issues at this intersection. Field observations indicated that there are many enforcement issues at this intersection including red light running, queue jumping, failure to yield to pedestrians, and parking. Red light running and queue jumping are made worse by a lack of dedicated left-turn lanes to store left-turning vehicles and allow through traffic to move through the intersections. This has contribued to 13 left-turn crashes, 4 right-angle crashes, and 8 rear-end crashes, totaling 32% of crashes for the intersection. In addition, aggressive turning movements and failure to yield to pedestrians has resulted in 4 pedestrian crashes at this intersection. Lastly, illegal parking was observed on both Southern Avenue SE and Wheeler Road SE, which was observed to contribute to weaving issues involving cars and buses. Illegal parking has contributed to 2 fixed-object crashes and 5 sideswipe crashes.

Illegal parking causes weaving issues on Southern Avenue

Shell gas station has 5 entrances all within close proximity of the intersection. Southern Ave entrances have caused 6

Red Light Photo Enforcement should be considered.												Х
Traffic was very aggressive in all directions through this intersection.												
NE corner has 5 entrances in close proximity to the intersection.	Shell Gas Station											
EBR for A6 bus conflicts with vehicles on NB Southern Ave.	NB Southern Ave	Х					Х					
Pedestrian conflicts with heavy turning volumes, drivers observed not stopping for pedestrians in crosswalks during red phase.								Х				
Street light fixtures on the east curb of Southern Ave are located ~30 feet away from the crosswalk.								х				
No signage for parking restrictions on the east side or curb of NB Southern Ave and Wheeler Rd SE and on the west side or curb of SB Southern Ave, north of Wheeler Rd.		x	x	х

Illegal parking on Southern Ave SE recommended to be addressed with additional signage and parking enforcement

Figure 4 illustrates the short-term improvements for the intersection. To address enforcement issues with parking and failure to yield to pedestrians, it is recommended that additional no parking signs be installed on Southern Avenue SE and that "Yield to Pedestrians" signs be installed at each approach. It is also recommended that periodic parking enforcement occur by the Department of Public Works (DPW) at this location to monitor and address illegal parking activity. To address signal visibility, it is recommended that retroreflective backplates be installed on traffic signal heads and that trees be trimmed. To reinforce the allowable vehicular movements in each travel lane, it is recommended that through-right and through-left pavement markings be installed along all approaches to

Additionally, field observations noted that the eastbound right-turn movement for buses conflicts with vehicles stopped on the northbound approach to Wheeler Road SE. It is recommended that a turning template for a typical WMATA bus be evaluated for this movement. Based on the outcome of the evaluation, the northbound stop bar location may need to be adjusted.
