#### **OBJECTIVE**

This document represents the final Road Safety Audit (RSA) report for the Blair Road/Cedar Road/4<sup>th</sup> Street intersection in the District of Columbia. The RSA audit team identified several transportation issues related to the traffic and pedestrian safety. Based on the inputs of the RSA team, District Department of Transportation staff developed recommendations addressing pedestrian and traffic safety issues at the study intersection.

### **PROJECT LOCATION DESCRIPTION**

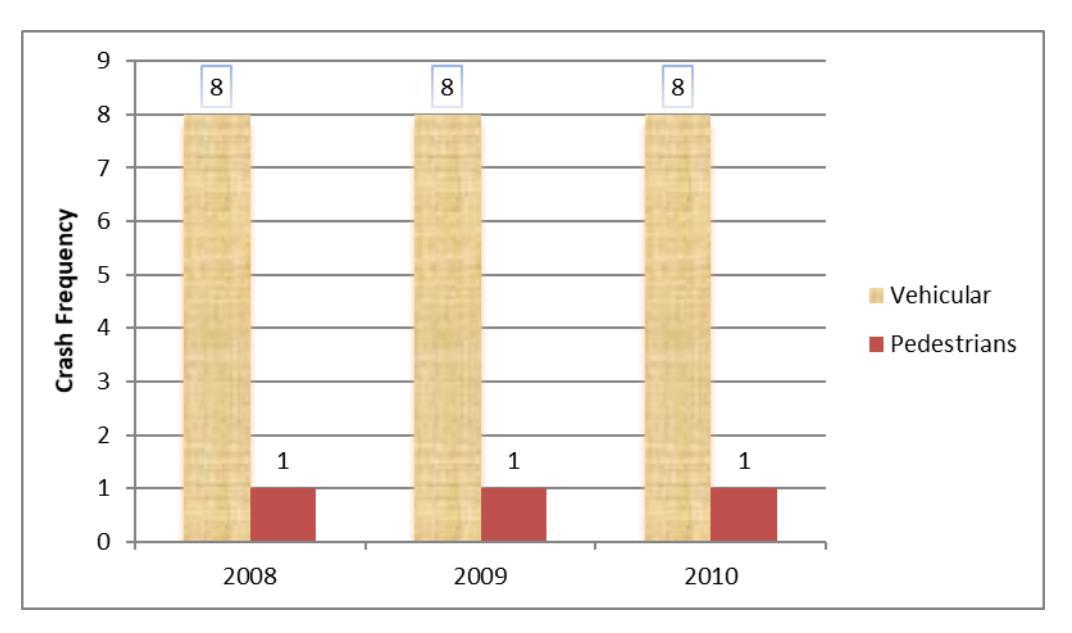
Accident data shows 11 out of the 24 crashes (about 50%) resulted in injuries. Nine of the eleven injury crashes (about 80%) occurred on Blair Road approach at Cedar Street while the remaining two of the eleven injury crashes (about 20%) occurred on 4<sup>th</sup> Street approach at Cedar Street. No injury crashes were reported on Blair Road approach at 4<sup>th</sup> Street. The crash frequency for the vehicles and pedestrians is shown in **Figure 2**.

Figure 3: Study Intersection Accident Frequency: 2008 – 2010

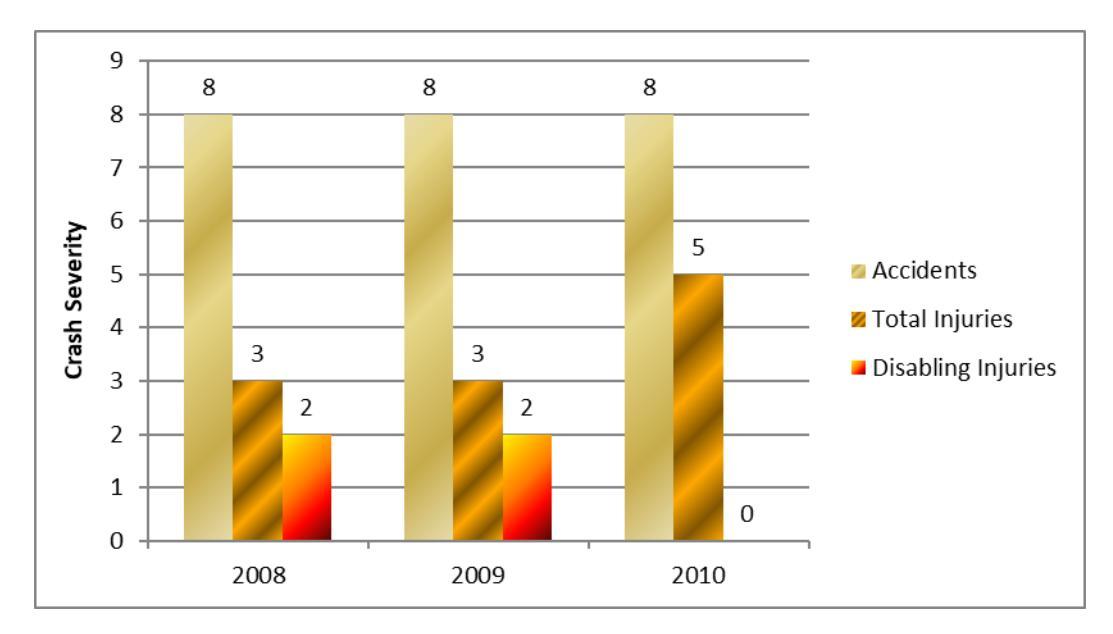
Majority of the vehicular accidents occurred during the day under adequate lighting conditions. Of the 24 crashes, 18 crashes occurred during the day, four crashes occurred during night, and the lighting condition for the remaining two crashes was unknown. A majority of the vehicular accidents also occurred under the dry road surface conditions. The accident severity at the study intersection is shown in **Figure 3**.

Figure 4: Accident Severity 2008 – 2010

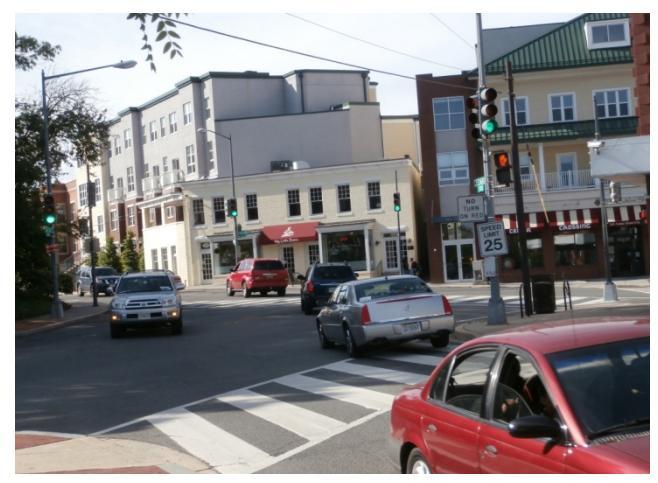
4<sup>th</sup> Street intersects at a sharp acute angle with the south leg of Blair Road. Also, both 4<sup>th</sup> Street and the Blair Road (south leg) have minor offsets south of the study intersection which makes it difficult for turning vehicles to maneuver safely to and from Blair Road and 4<sup>th</sup> Street. The northbound vehicles from Blair Road and 4<sup>th</sup> Street have to turn right and then left (like "snake pattern") to travel north on Blair Road as shown in Figure 1.

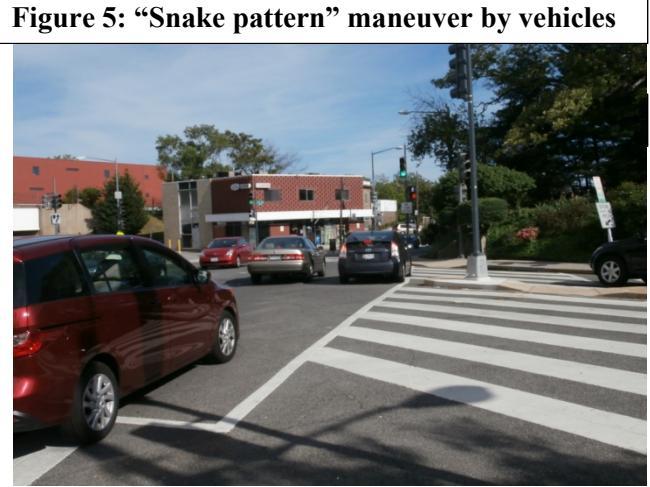
- significantly delay the thru traffic as they cannot find adequate gaps in the oncoming northbound thru traffic. Hence, the southbound thru vehicles cuts across the west crosswalk on Cedar Street, shown in **Figure 2**, to circumvent the left-turning vehicles creating direct pedestrian-motor vehicle conflicts.

Figure 6: SB thru vehicle cuts across west X-walk

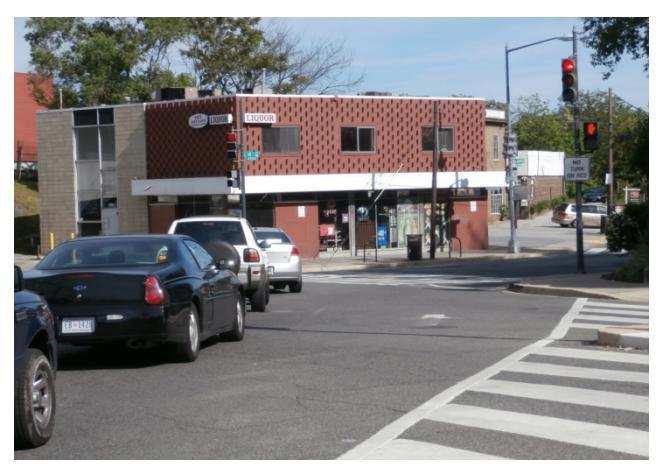
Figure 7: SBLT vehicles running red light

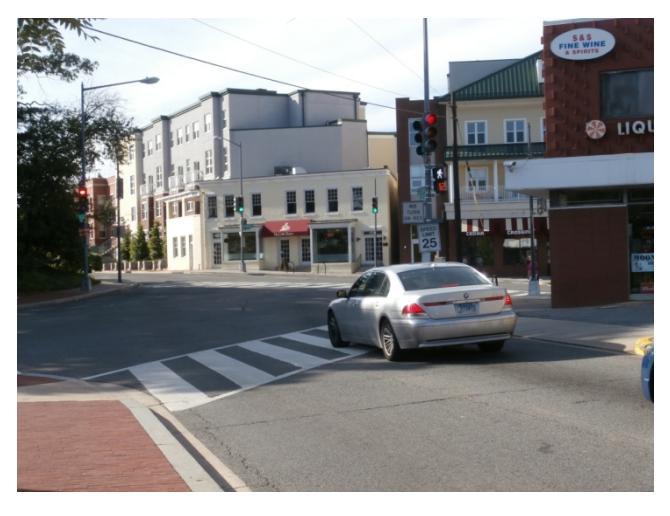
• The vehicular and pedestrian traffic signal heads are not properly aligned at this location. The traffic signal heads create confusion for motorists on 4<sup>th</sup> Street and the south leg of Blair Road in deciding (a) when to leave the intersection, and (b) who has the pertinent right-of-way.

**Figure 4** shows a confused motorist on Blair Road who leaves the intersection on red interval because he sees green interval on the other traffic signal. The green interval actually is actually assigning the right-of-way to motorists on 4<sup>th</sup> Street and not on Blair Road.

Figure 8: Multiple signals create motorist confusion

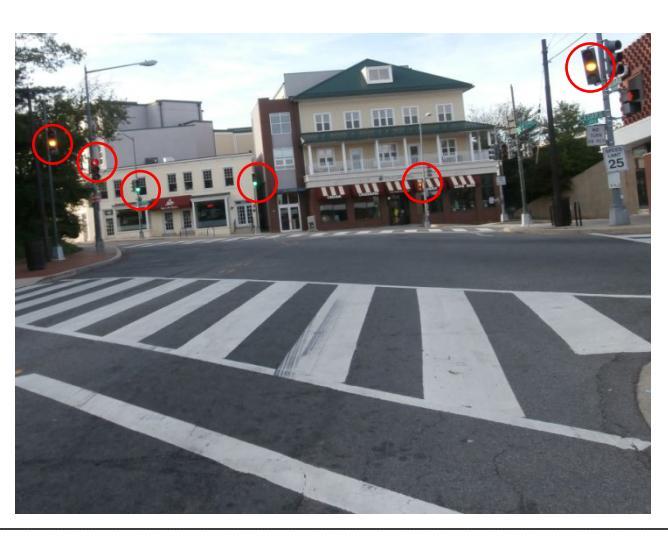
- **Figure 5** shows various traffic signals displaying red, green and yellow intervals. The display of all the intervals from several traffic signals creates significant confusion for motorists on 4<sup>th</sup> Street and Blair Road.
- There are no pedestrian signal heads for the crosswalk on 4<sup>th</sup> Street, as shown in **Figure 6**, which adds to the pedestrian confusion at the study intersection.
- The pedestrian ramps, as shown in **Figure 7**, do not meet the current ADA specifications.
- There are multiple curb cuts within the intersection influence area that impact the traffic movements, pedestrian access and the sight distance implications

Figure 9: Signals showing Red, Green & Yellow lights

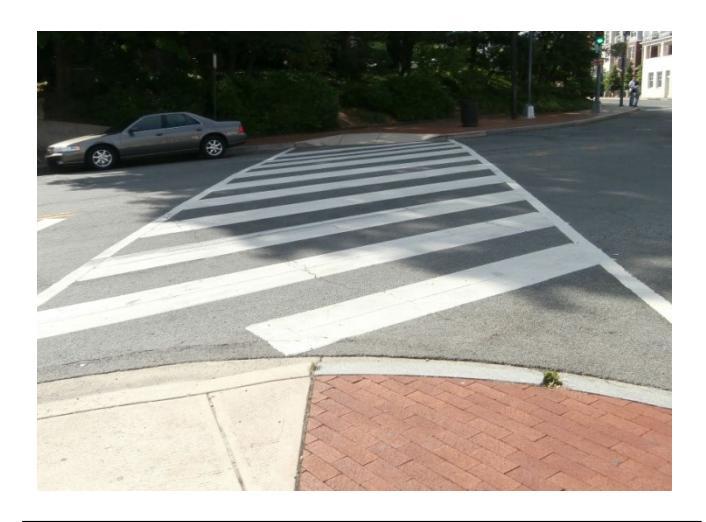
Figure 10: No Pedestrian Signals for 4th St X-walk

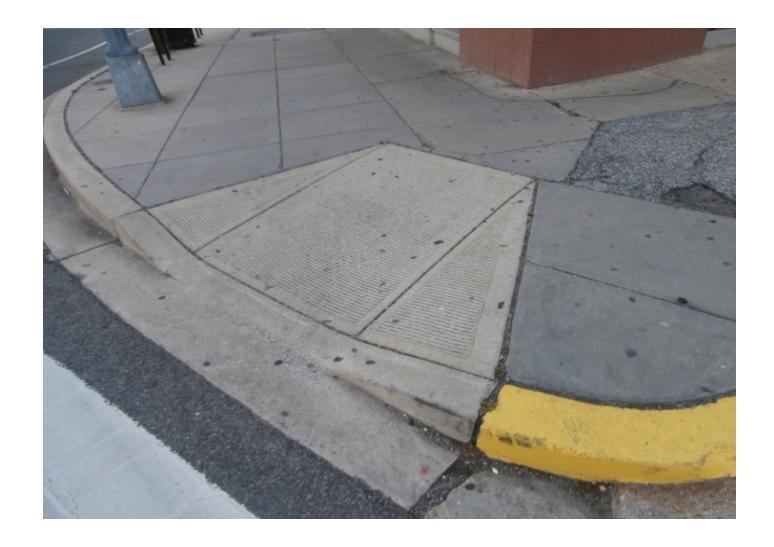
Figure 11 – Ped Ramps don't meet ADA specifications

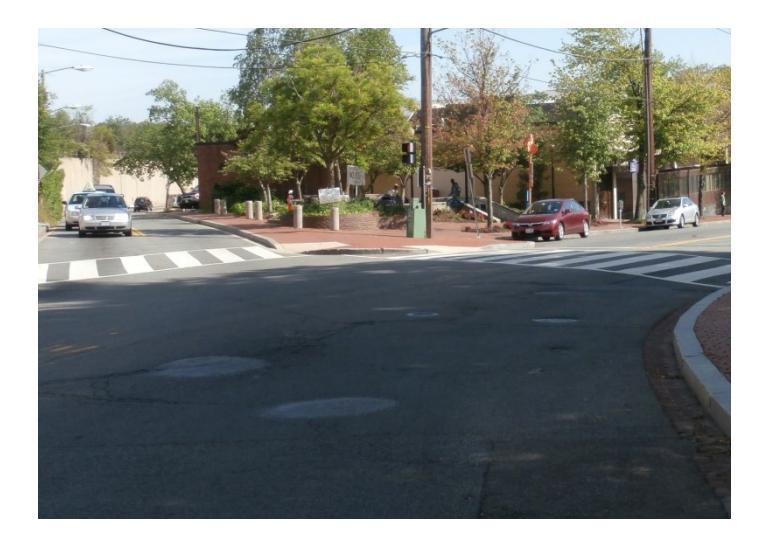
Figure 12 – 4<sup>th</sup> St and Blair Rd intersect at acute angle

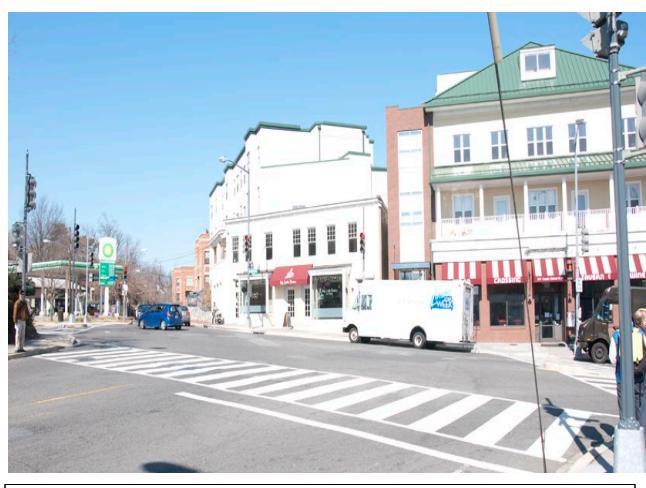
The north crosswalk on Blair Road, as shown in **Figure 9** is located far behind the study intersection. There is inadequate sight distance for the westbound right-turning vehicles from Cedar Street to observe the pedestrians in the north crosswalk after they leave the intersection. The businesses located at the corner of this intersection further obstruct the sight distance triangles and visibility of the pedestrians. In addition, the green interval for westbound right-turning vehicles coincides with the walk interval of pedestrians in the north crosswalk which results in simultaneous direct conflicts between pedestrians and motor vehicles at the study intersection.

Figure 13: North X-walk far from intersection

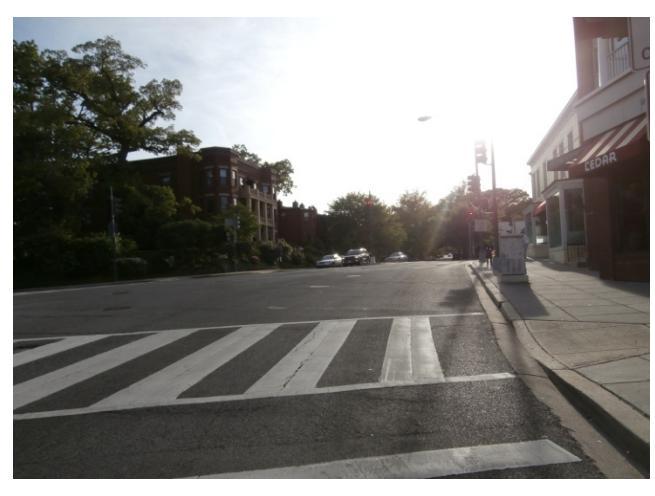
Figure 14: WBRT can't see peds on North X-walk

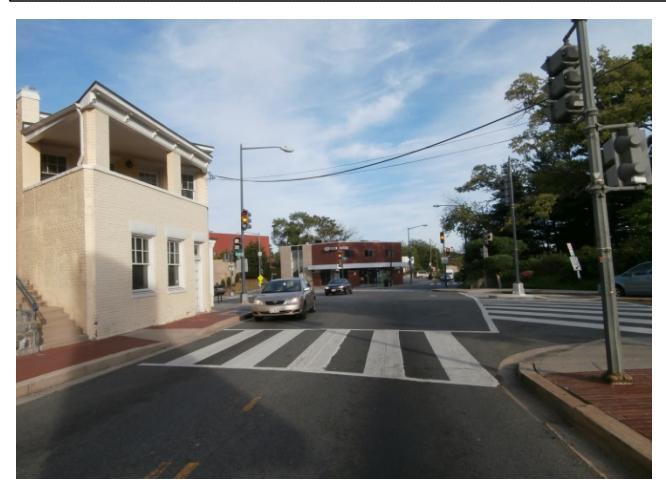
The east crosswalk on Cedar Street is also located behind the study intersection. There are sight obstructions that restrict the visibility of southbound left-turning vehicles (on Blair Road) to observe pedestrians in the east crosswalk on the Cedar Street. The limited available sight distance, in conjunction to concurrent pedestrian movements results in direct pedestrian-vehicle conflicts between the southbound left-turning vehicles and pedestrians at this location.

Figure 15: SBLT can't see peds on East X-walk

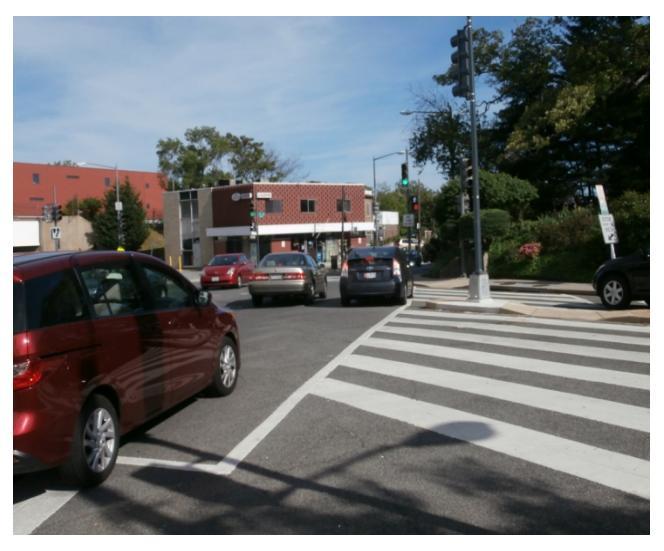
As mentioned above, the southbound left-turning vehicles cause significant delay to the southbound thru traffic on Blair Road because they cannot find adequate gaps in the oncoming northbound thru traffic. Hence, the southbound thru traffic cuts across the west crosswalk on Cedar Street, as shown in **Figure 16**, creating direct pedestrian-motor vehicle conflicts, to circumvent the left-turning vehicles and travel south on Blair Road.

Figure 16: SBT vehicles cut across west X-walk

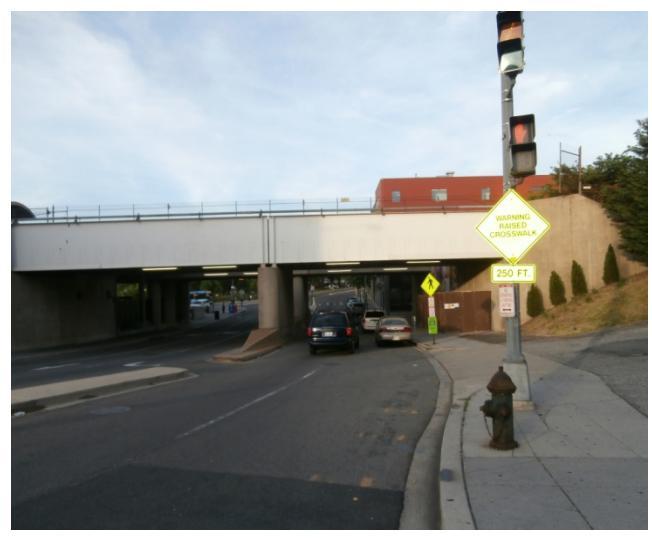
RSA team observed pedestrians jaywalking along the opening in the raised medians on Cedar Street between the Takoma Metro station and the study intersection. Vehicles traveling at higher speeds on Cedar Street often have inadequate sight distance to stop for the unexpected jaywalkers at this location. As shown in **Figure 17**, the RSA team also observed a SUV making U-turn on Cedar Street via this opening in raised median on the Cedar Street.

Figure 17: SUV making illegal U-turn maneuver

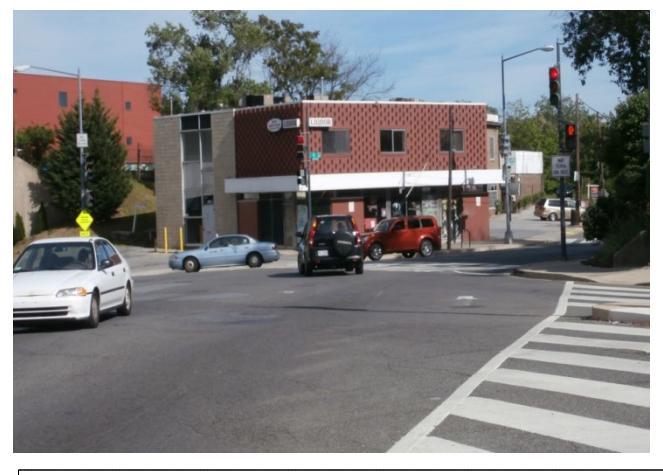
Figure 18: SBLT in conflict with Cedar St vehicles

The 3-year accident data shows 15 accidents including one pedestrian crash at this location. Sight distance is the primary traffic safety concern at this approach. The southbound left-turns have been frequently observed to run the red interval at the intersection. This puts them in direct conflict with vehicles on Cedar Street, as shown in **Figure 18**, which results in right-angle and side-swipe collisions at this location.

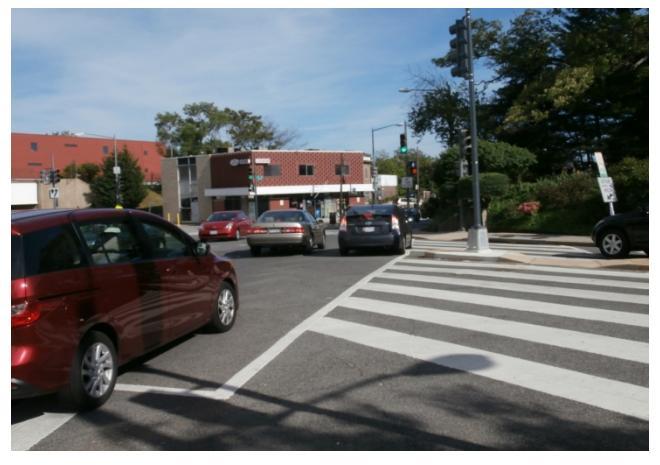
As shown in **Figure 19**, vehicle traveling southbound thru circumvents the left-turning vehicles to travel south on Blair Road which creates direct conflict with pedestrians in the west crosswalk on the Cedar Street. This also creates potential for rear-end accidents at this location.

Figure 19: Ped-Vehicle conflicts on West X-walk

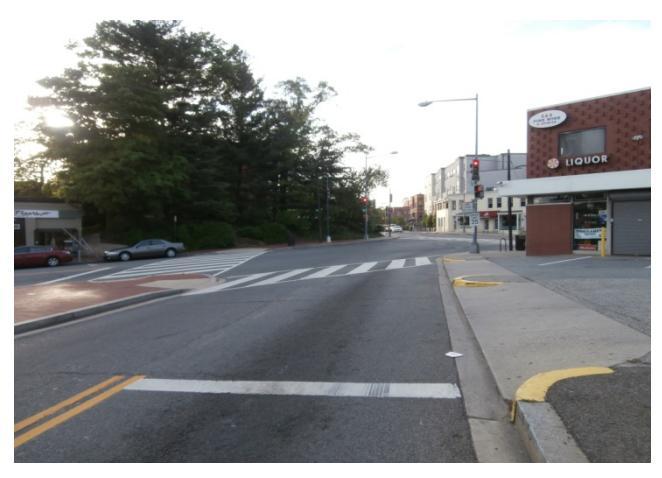
There is inadequate sight distance on northbound approach of Blair Road. As shown in **Figure 20**, the northbound vehicles on Blair Road cannot view pedestrians on the east crosswalk on Cedar Street which can also create potential pedestrian-vehicle conflicts.

Figure 20: Inadequate sight distance on NB Blair Rd

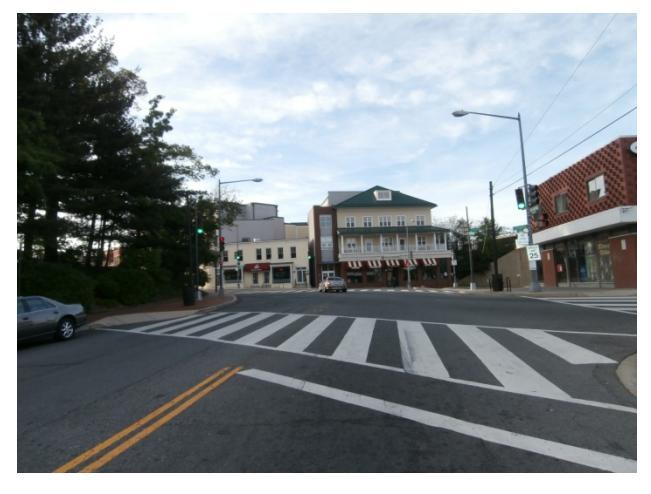
The 3-year accident data shows 7 accidents including two pedestrian collisions at this location. There are about 120 vehicles desiring to turn left from 4<sup>th</sup> Street to Cedar Street during both AM and PM peak-hour. There is inadequate sight distance on northbound approach of 4<sup>th</sup> Street. As shown in **Figure 21**, the northbound left-turning vehicles on 4<sup>th</sup> Street cannot observe pedestrians on west crosswalk of Cedar Street which creates direct pedestrian-vehicle conflicts at this location.

Figure 21: Inadequate sight distance on NB 4<sup>th</sup> St

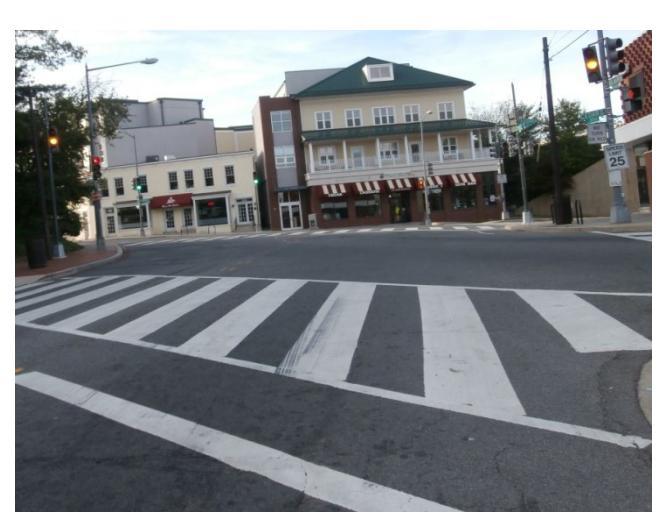
Figure 22: Confusing traffic signals on 4<sup>th</sup>/Blair

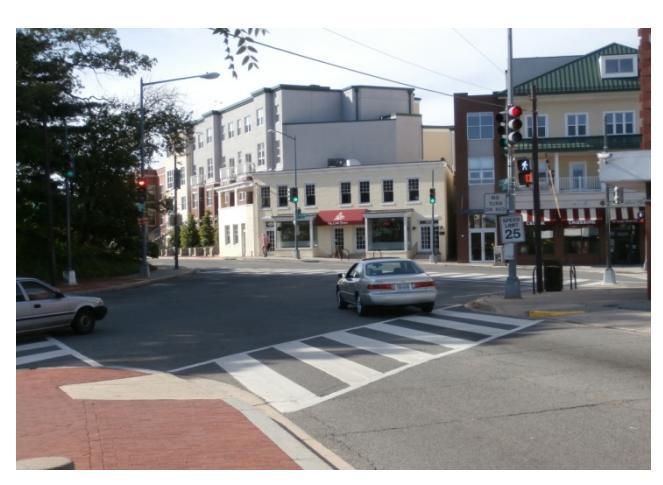
**Figure 23** shows potential right-angle collision between the vehicles on Blair Road and  $4^{th}$  Street. The green interval on multiple traffic signals gives false signal of relevant right-of-way which results in vehicles simultaneously entering the intersection from Blair Road and  $4^{th}$  Street.

Figure 23: Potential right-angle collision on Blair/4th

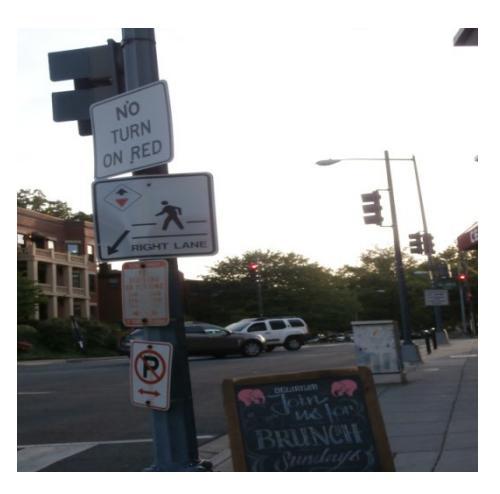
Figure 24: Confusing "Right Lane" Sign

- 3. Replace the "right-lane" pedestrian crosswalk sign with "Stop Here for Pedestrians" sign (R1-5c, 2009 MUTCD) on westbound approach of Cedar Street (see Figure 27).

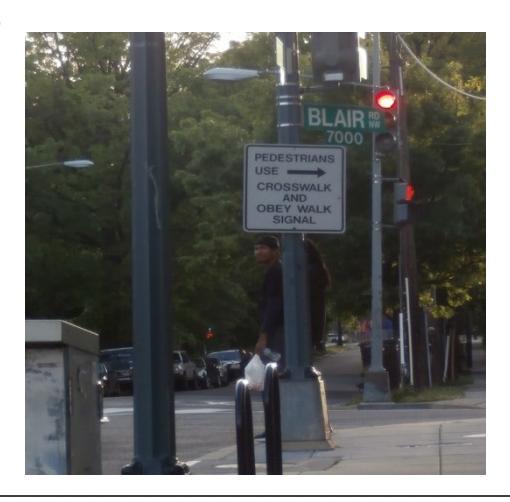
Figure 25: Confusing Ped Use X-walk sign

- 4. Replace the "pedestrian use crosswalk" sign with the revised "Side of Street Pedestrian" sign (R1-6(a)1) on the northwest corner of Blair Road/Cedar Street (see Figure 28).

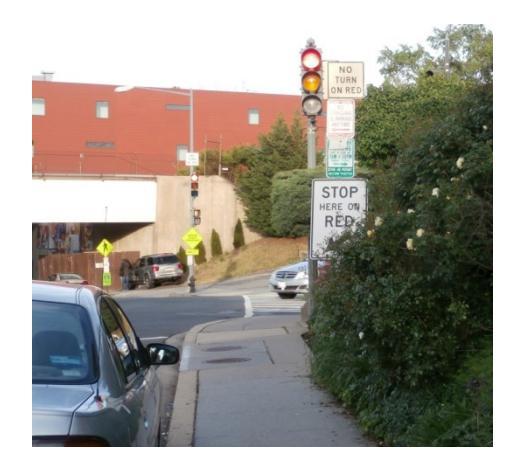
- There are no traffic signs for pedestrian crossings on all the approaches along Blair Road, Cedar Road and 4<sup>th</sup> Street.
- There is no advance warning sign for the north pedestrian crosswalk (along Blair Road) on the westbound approach of the Cedar Street.
- The "right-lane" pedestrian crosswalk sign on westbound approach of Cedar Street (see Figure 24) is confusing to the motorists.
- The "pedestrian use crosswalk" sign along the northwest corner of Blair/Cedar approach (see Figure 25) is also confusing to the motorists and needs to be removed.
- The MUTCD "No Turn On Red" regulatory sign is improperly placed making it difficult for motorists to observe.
- Vegetation restricts the visibility of traffic signage on the eastbound approach of Cedar Street (see Figure 26).
- Sign clutter of traffic signage at the study intersection.

Figure 26: Limited visibility of traffic signs

- 5. Provide advance warning signage for the north pedestrian crosswalk on the westbound approach of Cedar Street.
- 6. Reorganize the traffic signage to reduce sign clutter on the westbound approach of Cedar Street.

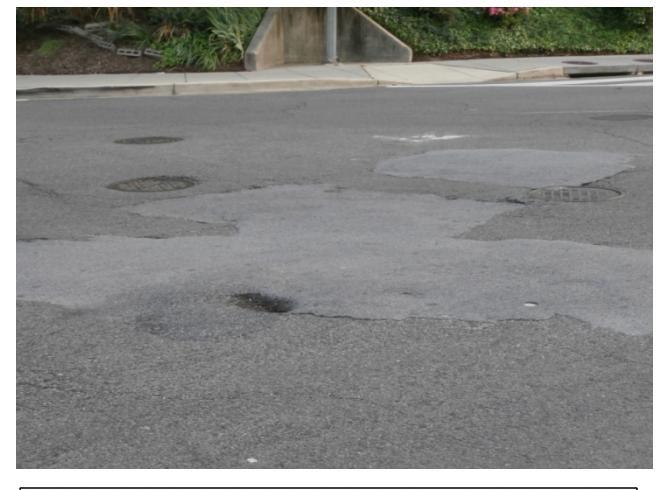
The RSA team saw numerous longitudinal and transverse cracks in the roads at the study intersection. The pavement conditions are generally poor at this location which can create additional safety hazards for pedestrians and cyclists crossing the street.

Figure 30: Cracks and Potholes in Pavements

- 1. Restripe and maintain durable pavement markings at the study intersection.
- 2. Ensure pedestrian facilities are designed to the new ADA specifications in the revised traffic signal design for the study intersection.

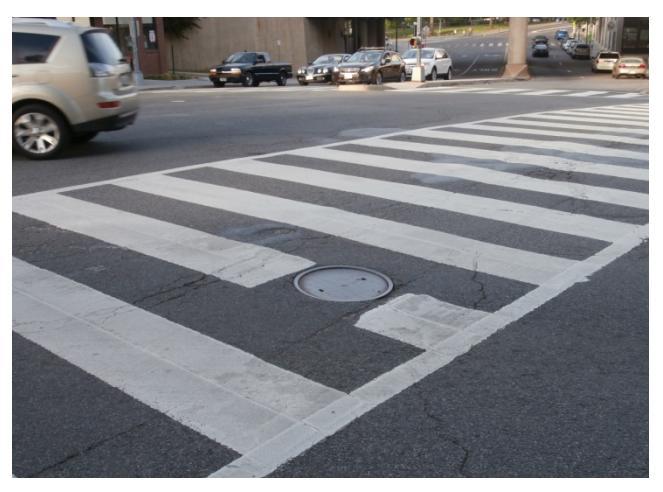
Figure 31: Storm Drain facility in Crosswalk

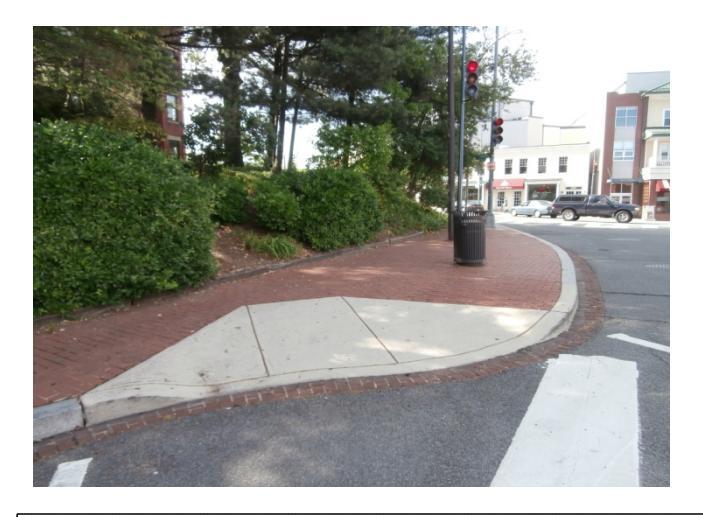
The pavement markings at the study intersection are either worn or missing at the study intersection which adds to the confusion of motorists driving through the intersection and reducing the visibility of the existing pedestrian crosswalks. The pedestrian crosswalks are in conflict with the storm drainage facilities at this intersection which is a significant issue during the inclement weather. The ADA facilities at this location need to be upgraded to the new specifications.

Figure 32: Ped ramps don't meet ADA specifications
