Figure 7-12

Potential Transportation Problems Seward Square

Figure 7-13

Recommended Improvements Seward Square

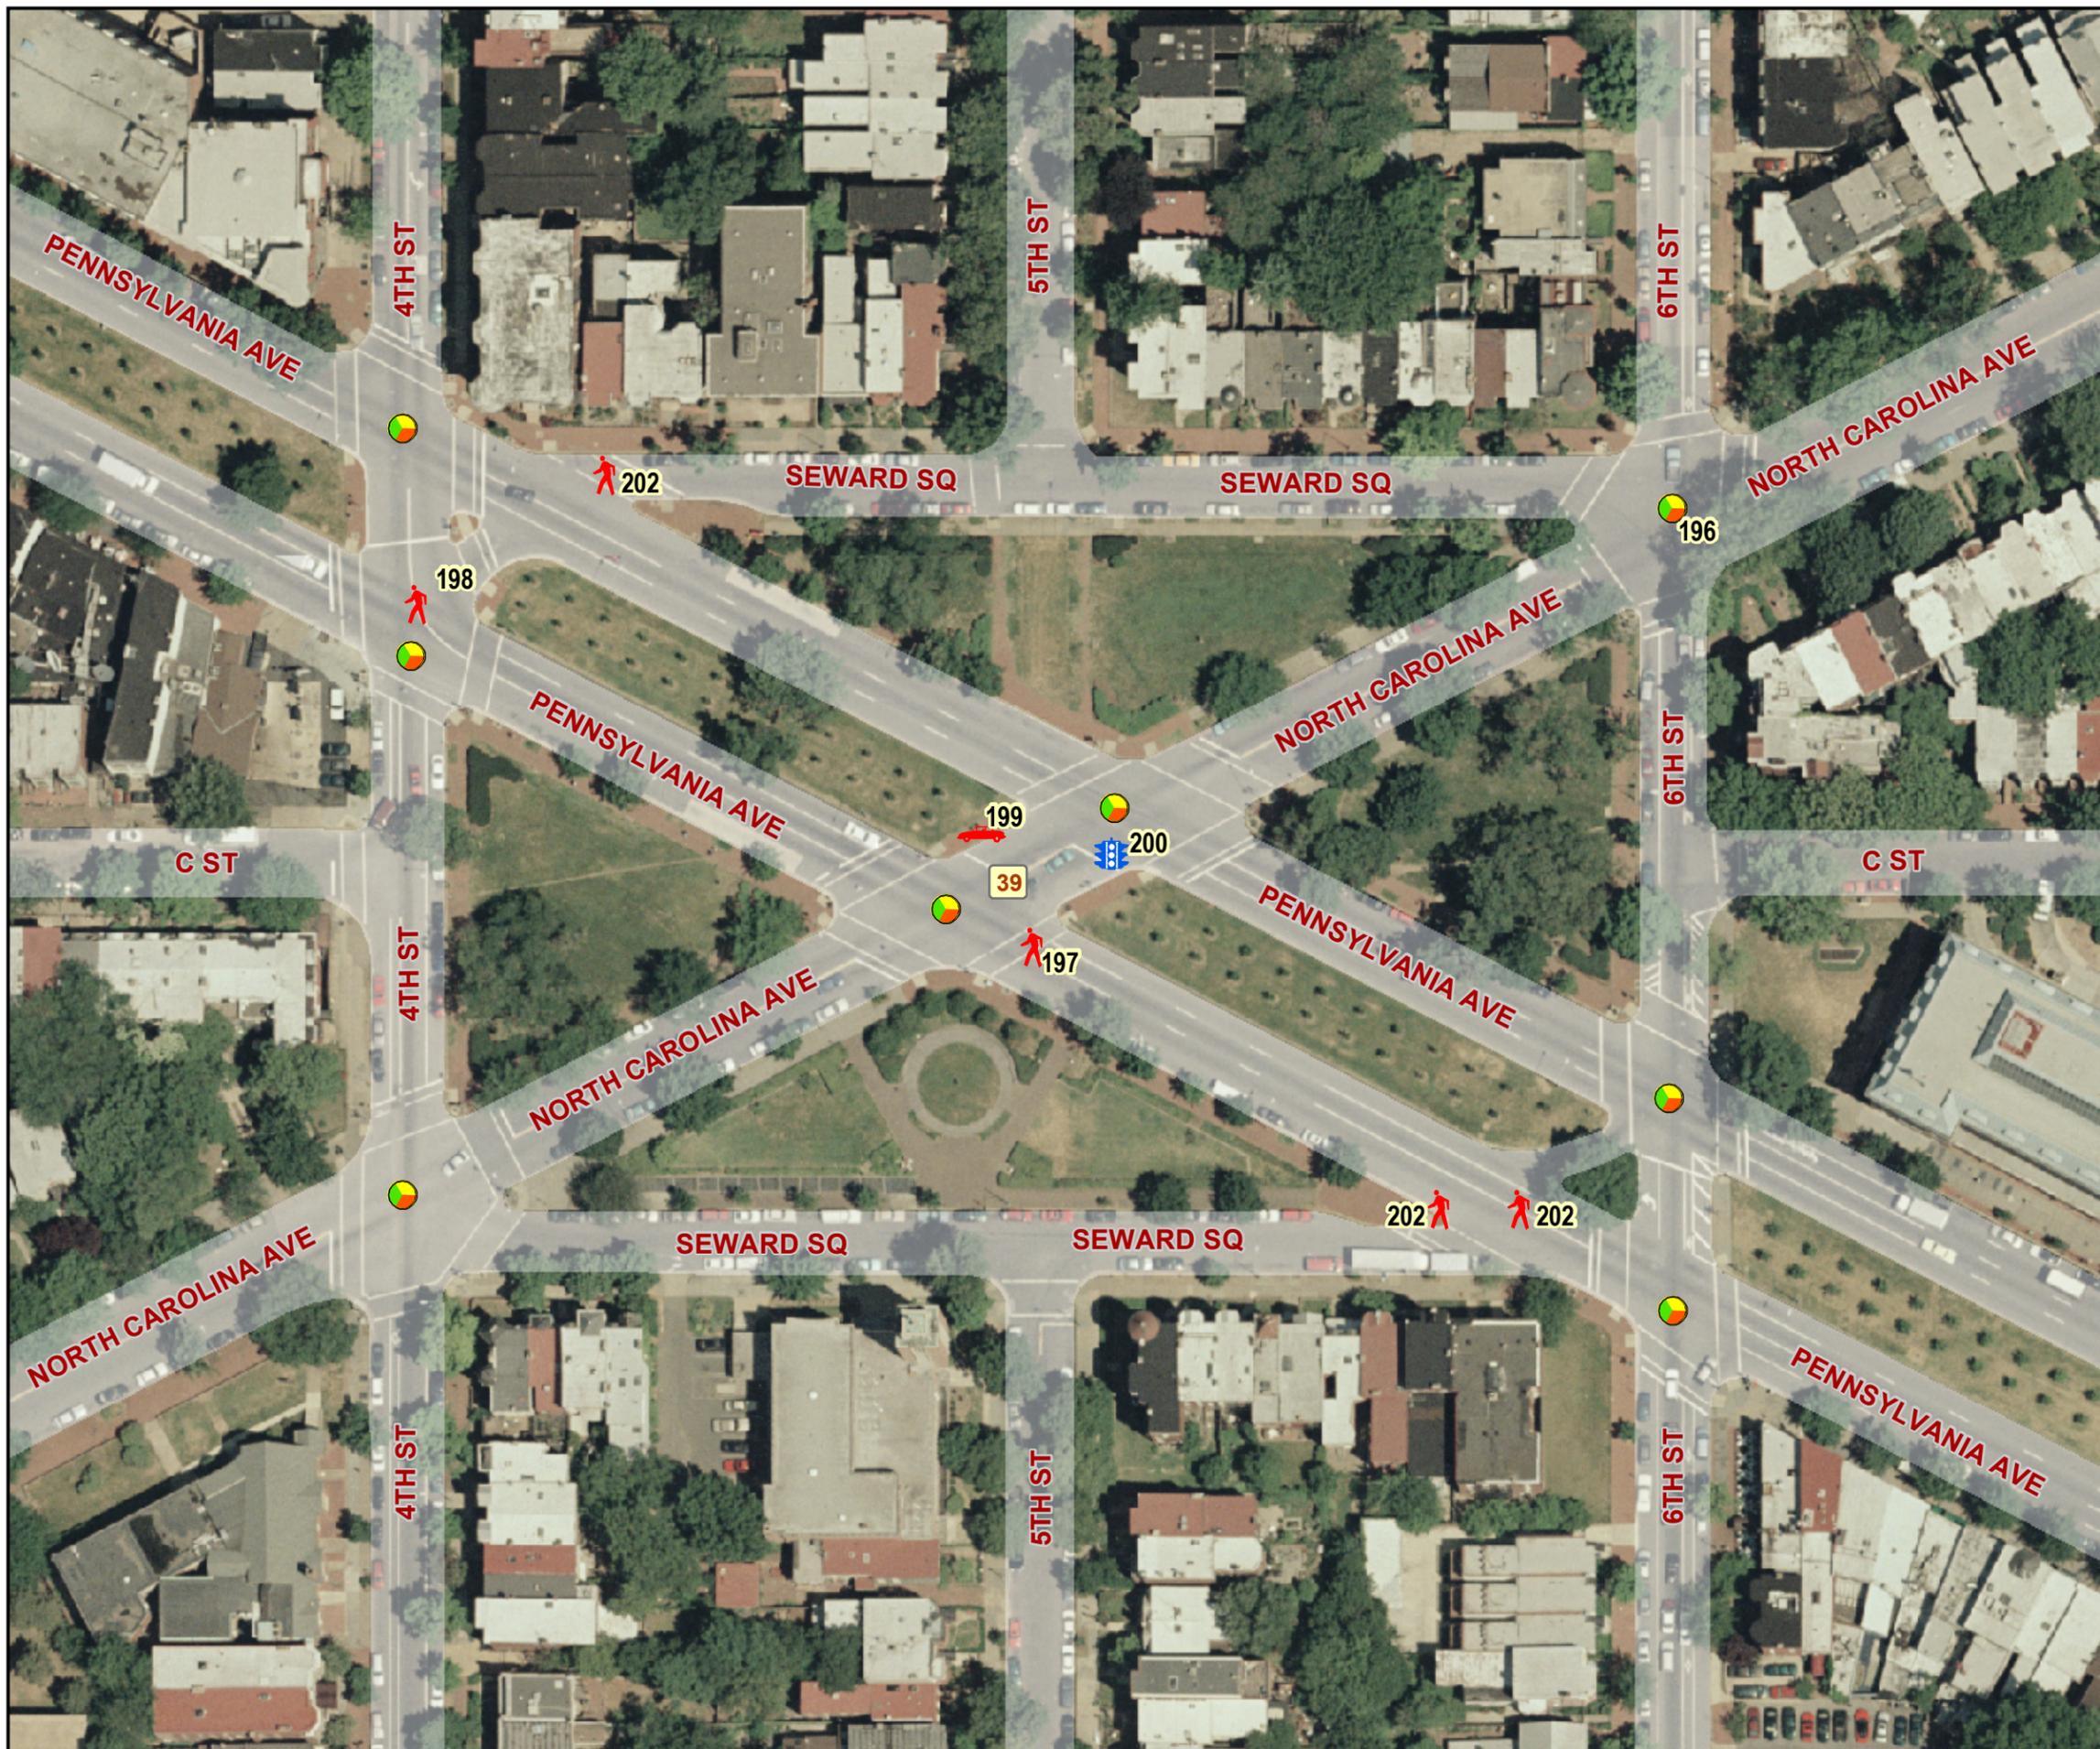
- 196 Sidewalk is in poor condition.
- 197 No pedestrian signals.
- 198 No pedestrian signals.
- 199 Traffic waiting to turn left from Pennsylvania Ave to North Carolina Ave. backs up affecting through lanes on Pennsylvania Avenue.
- 200 Inbound Pennsylvania traffic turning left onto North Carolina Ave has extended green time to allow left turns -- but it is not signed anywhere and there is no turn signal phase.
- 202 Pedestrian crosswalk signs missing, crosswalk is hard to see by motorists looking over their shoulder to turn right; ADA ramps do not line up with crosswalk.
